BUFFALO
GROVE
PARK
DISTRICT

Comprehensive Master Plan

2017 and Beyond

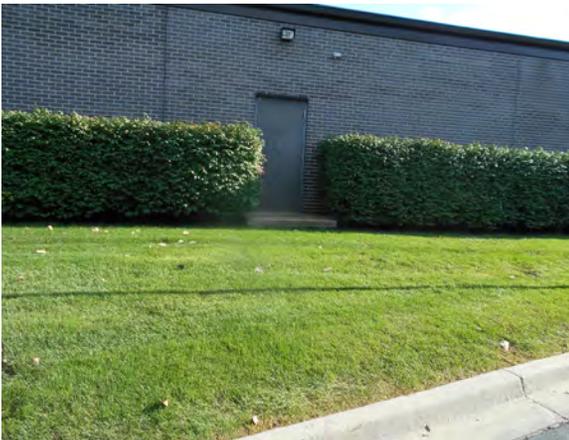
The sidewalk access around the facility is in decent condition. There are several exit door locations that only have a concrete stoop provided. These exits require a path to a public way for emergency. A sidewalk should be installed at these locations and maintained during all weather conditions to ensure proper exiting requirements.

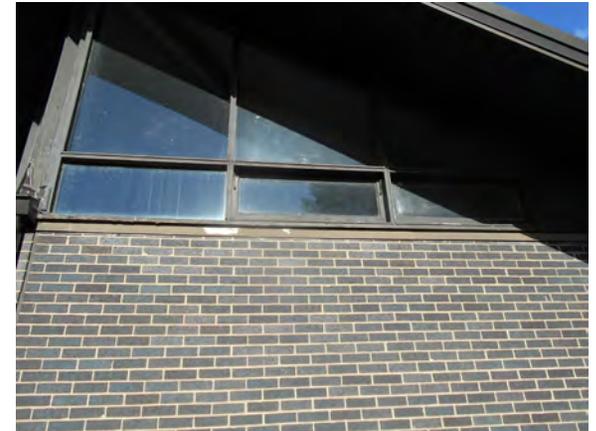
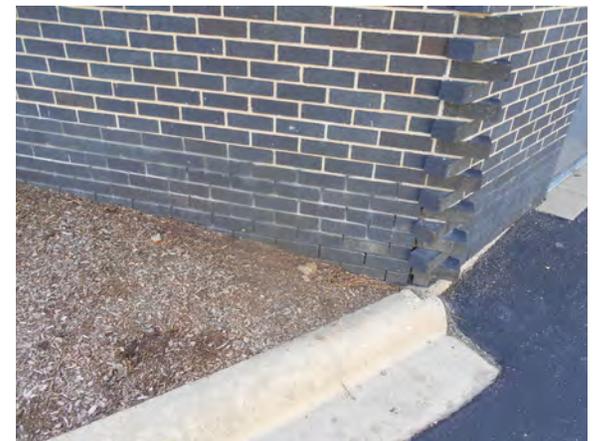
The facility is masonry construction with a face brick veneer. There is a steel structure interior and at some exterior walls that support the roof structure of the facility. The majority of the brick veneer appears to be in decent condition. There are several lower areas near pavement and on exterior corners of masonry piers that show excessive mortar recession between bricks. This mortar has deteriorated over time, and is typically a result of freeze/thaw cycle with respect to moisture. The lower elements near the pavement is a result of ice and salt. All of these areas will require tuck-pointing repair of the mortar.

There are some hollow metal doors and frames that are dented up and rusting to the point that they could impact exiting. These doors and frames should be repaired or replaced in kind.

The aluminum window system is in good condition around the entire facility. The west elevation of the facility has several of the frame covers shifted or moved either through expansion/contraction or as a result of vandalism. These covers can cause issues with the longevity of the frame system and their operation. They also provide a potential location for wasps and other pests to nest. These covers should be adjusted and system checked for proper operation.

Given the construction of the original building, there is exposed unpainted steel column flange edges near window fenestrations. Most of these edges were originally covered and protected by caulking which has since deteriorated. These edges should be cleaned up and re-caulked around the entire original building perimeter envelope.

The original building's gymnasium, now the facility's multi-purpose room has some major exterior envelope concerns. This entire perimeter is very evident of the deteriorated masonry mortar brought up earlier in the report. The clerestory glazing and framing is single pane glazing that has deteriorated potentially past the point of repair. If this portion of the building is to be salvaged, these windows should be fully replaced and the exterior fully tuckpointed. The connection of this building to the rest of the facility also has large open joints in the exterior brick veneer that needs to be sealed. Adjacent pavement on the east side, where there must have been an old entrance originally, is sloping towards the facility, which can cause larger issues if the water is allowed to continue the freeze/thaw cycle.

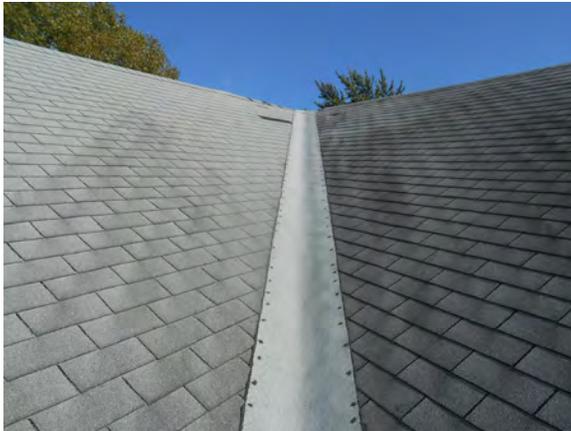
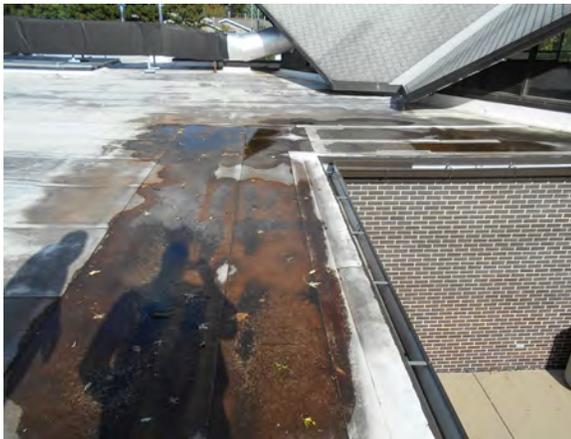
The roof was replaced a couple of years prior to the large mechanical system replacement project on this facility, so it appears to be 5-6 years old. The roof has not fared well, and has only compounded its issues with the limits of the mechanical system install on the roof. The roof membrane appears to be under-sloped in many areas that have resulted in standing water in multiple areas. The installation of the mechanical system has thrown in other diversions that potentially slow water flow and have helped to contribute to the roof issues. There are several areas around the perimeter that have de-laminated cap sheets and have water infiltrating through the membrane and potentially into the facility/ structure. An example is near the edge of the administration offices and about on the west end of the facility near the middle.

There are several areas where gutters are not pitched properly and holding water. This will continue to cause issues, especially during the winter period when ice damming can occur.

The roof membrane installed requires regular maintenance to ensure that the water flows properly. This means that the roof membrane should be cleaned twice a year at a minimum. Confirm with the manufacturers recommendations. The condition

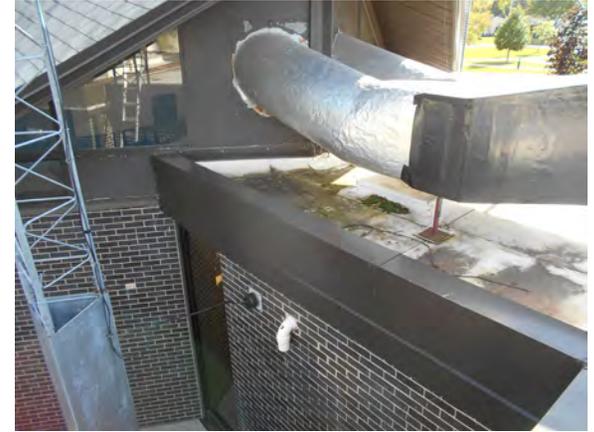
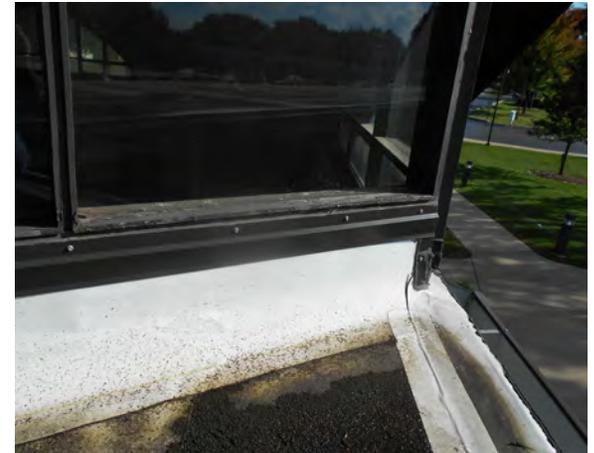
The installation of the mechanical equipment chiller and electrical panels in the southwest corner of the building has created a condition that has allowed vandals to access the roof. They have damaged the roof and equipment and pose a potential liability to the District. This area should be fenced off from public and the roof edge gated off from access to prevent vandal access.

The rooftop units had air filters that were displaced and/or full of debris. Regular maintenance of the filters for the units should occur to prolong the life of the units.

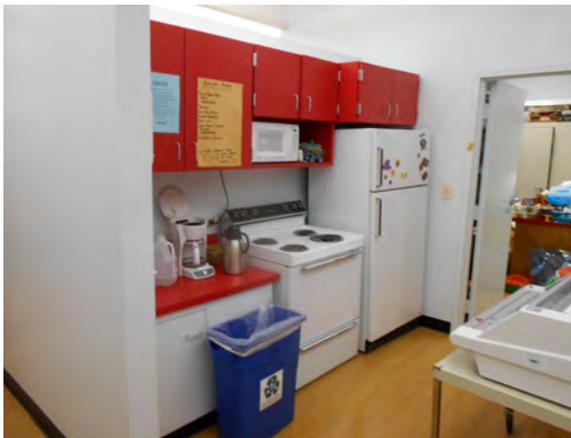
The small kitchen area in the pre-school wing has a stove that has no exhaust hood provided.

There are signs of some settling in the masonry of the existing building at the pre-school wing. The cracks are minimal and appear stable. This settling is not structural, but continued monitoring should be completed to determine if there is concern in the future.

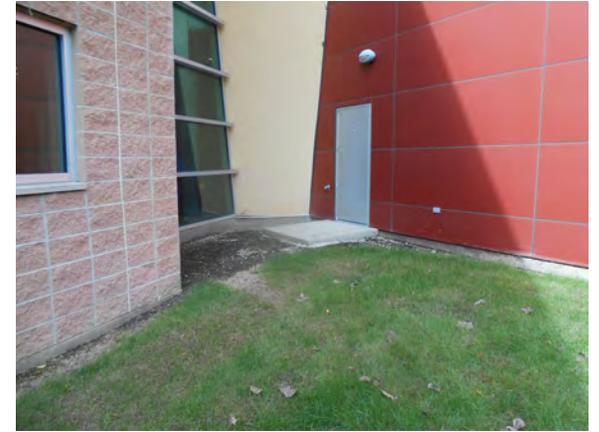
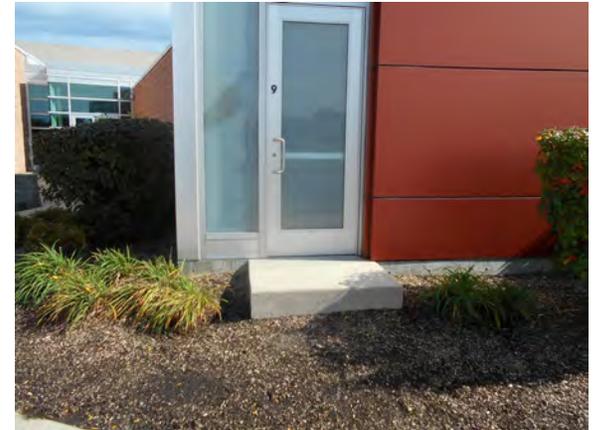
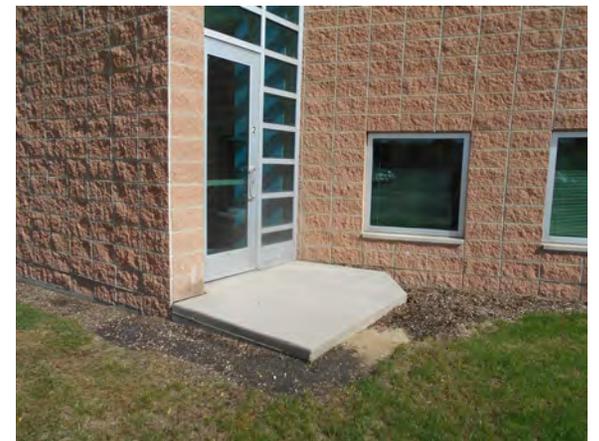
The pavement is only located to the north and west sides of the building. The east and south end is open to turf, park, and trail.

There are several emergency exit doors around the facility that open to a stop condition. All exit doors need to provide a clear path to a public way by code. A sidewalk should be provided at all of these locations in order to meet code.

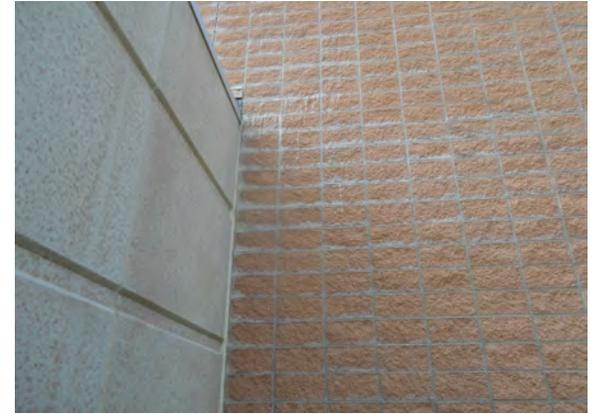
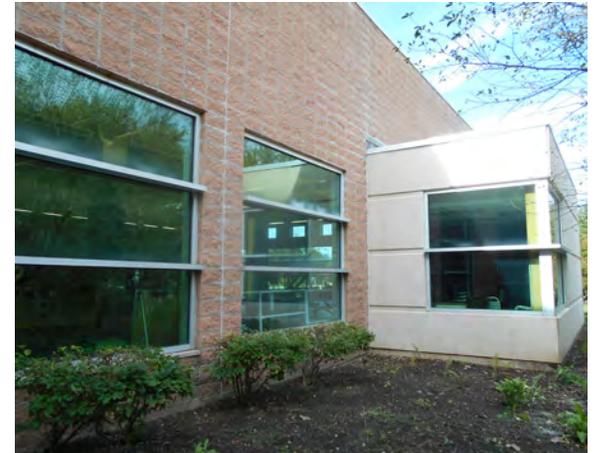
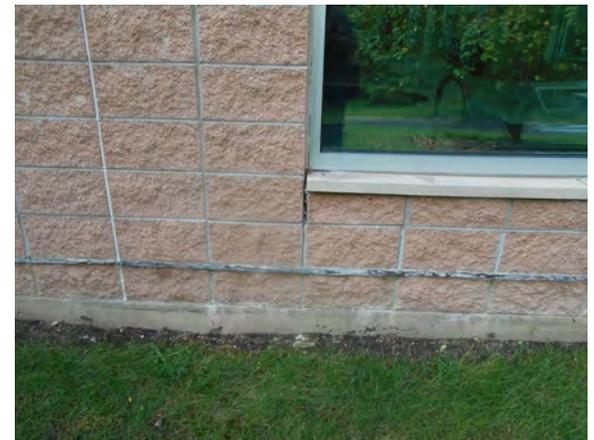
There are cracks in the split-face masonry above the entry covered walk that are a result of settling. These areas should be addressed and caulked. They should then be monitored in the future. With the tall screen walls on the roof to block the rooftop mechanical units, there are cracks that are evident in the EIFS system and masonry at various locations. Each of these need to be addressed and monitored.

Caulking between dissimilar materials and control joints have evidence of caulking deteriorating. Old caulk should be removed and new caulk installed around the entire facility to maintain weather tightness.

The exterior wall of the pool has excessive efflorescence that is a result of the pool and mechanical pressure. The pool does not appear to be at a positive pressure, but it is pushing the moisture into the wall, which is coming out the masonry around the pool. The exterior wall should be reviewed near the joints to determine where the breach is if the mechanical system is not causing the pool to be a positive pressure. Any breaches in the wall should be sealed to protect the wall. The moisture has caused the lintels at the windows to rust. The lintels should be looked into further to ensure that no structural concern is evident. The exterior of the masonry should be cleaned and continued to be monitored. The joints in the mortar at the window sills has deteriorated and is open to the weather and moisture. All of this should be addressed in a study with a game plan developed on how to proceed.

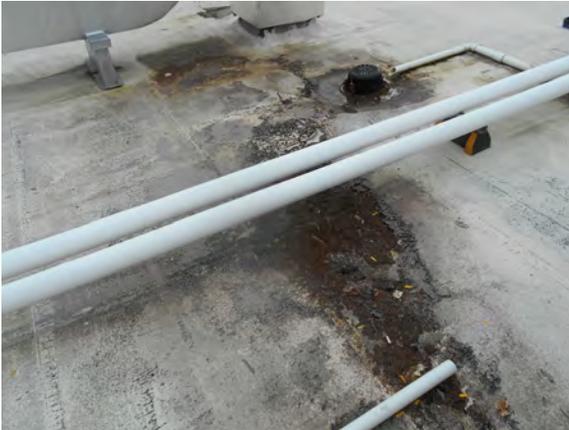
The roofs on the facility is a mix of different products. The EPDM/ modified bitumen roof system on some areas was attempted to be coated to improve reflectivity and seal leaks in the roof. The coating has de-laminated and caused further damage to the roof membrane itself. This coating should be cleaned and removed from the membrane and the roof surface evaluated on options to salvage the roof without replacing the membrane completely. There is evidence near drains and other choice areas that show water infiltration into the roof through the membrane.

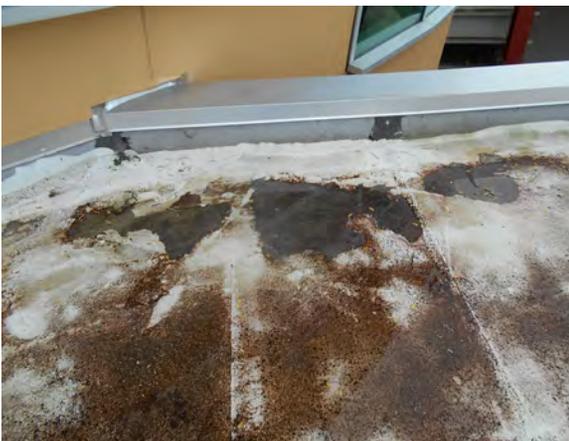
The entry covered walk roof has a modified bitumen roof surface that has several large bubbles in the roof that will break the membrane and damage the roof. The District should hire a roofer to come out and address the bubbles and patch the roof to keep the roof in good condition.

The District would benefit from a roof evaluation and plan on addressing the roof condition of the entire facility and develop a plan to address the roofs prior to them deteriorating past the point of salvage.

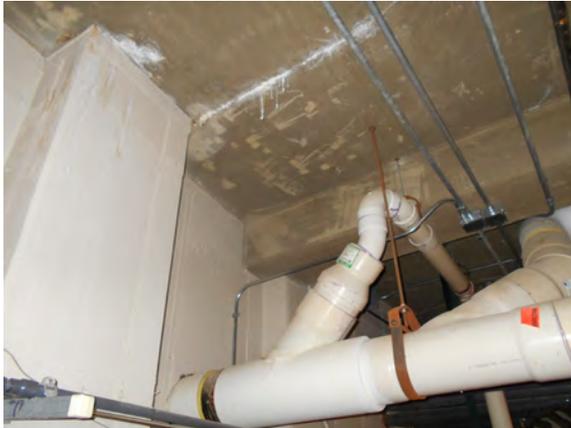
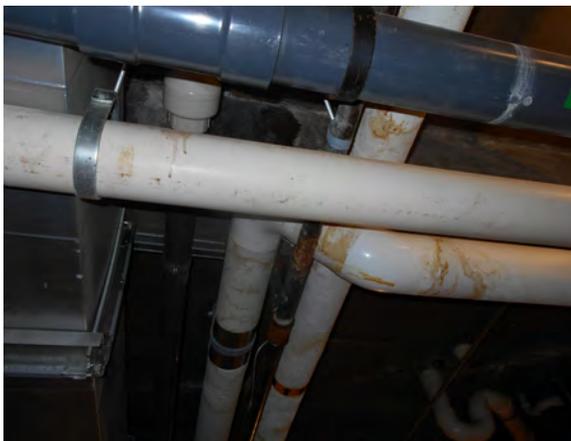
The mechanical system is original to the facility. All rooftop units, chillers, etc. are operating in good condition. The units are half of their expected life with proper maintenance. The units should be considered to be replaced in 10 years. Continue proper maintenance or replacement will be heavily reduced.

The electrical service of the facility appears that the main service is original to the building. Typical manufacturer recommended useful serviceable life for service boards and associated equipment is approximately 30 years in most installations. Recommend routine maintenance including lug torque check for all panelboards and feeders.

The building is completely protected by a fire suppression system and fire alarm system. The general coverage for detection and annunciation appeared typical and adequate for a building of this type and use.

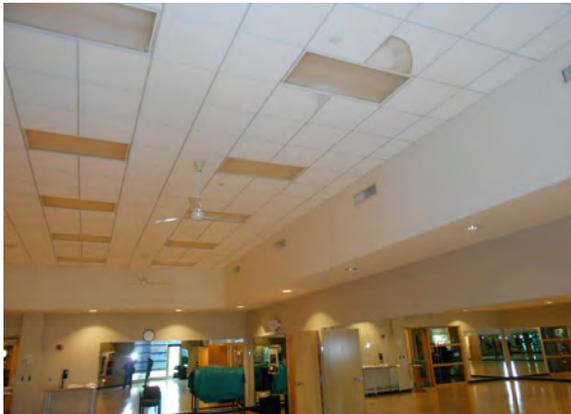
The basement that houses the mechanical and pool equipment has excessive calcium stalactites forming from the cracks in the first floor concrete slab. These are a result of water infiltration from the first floor shower areas and pool deck. The only way to correct this is to fully remove finish on the first floor and install a proper waterproofing membrane to prevent moisture and water from infiltrating the slab. Continued issue will result in the slab to begin to fail/ spall initially. This condition should continued to be monitored.

Storage needs to be removed from the electrical room and the stair ways in the facility. These areas are not allowed to have storage of any kind via code. In the stair from the basement at the north end of the building, there is evidence of rusting at the landing deck. This appears to be a result of water infiltration at the exit door. This door should be properly sealed and any damage to the structure addressed.

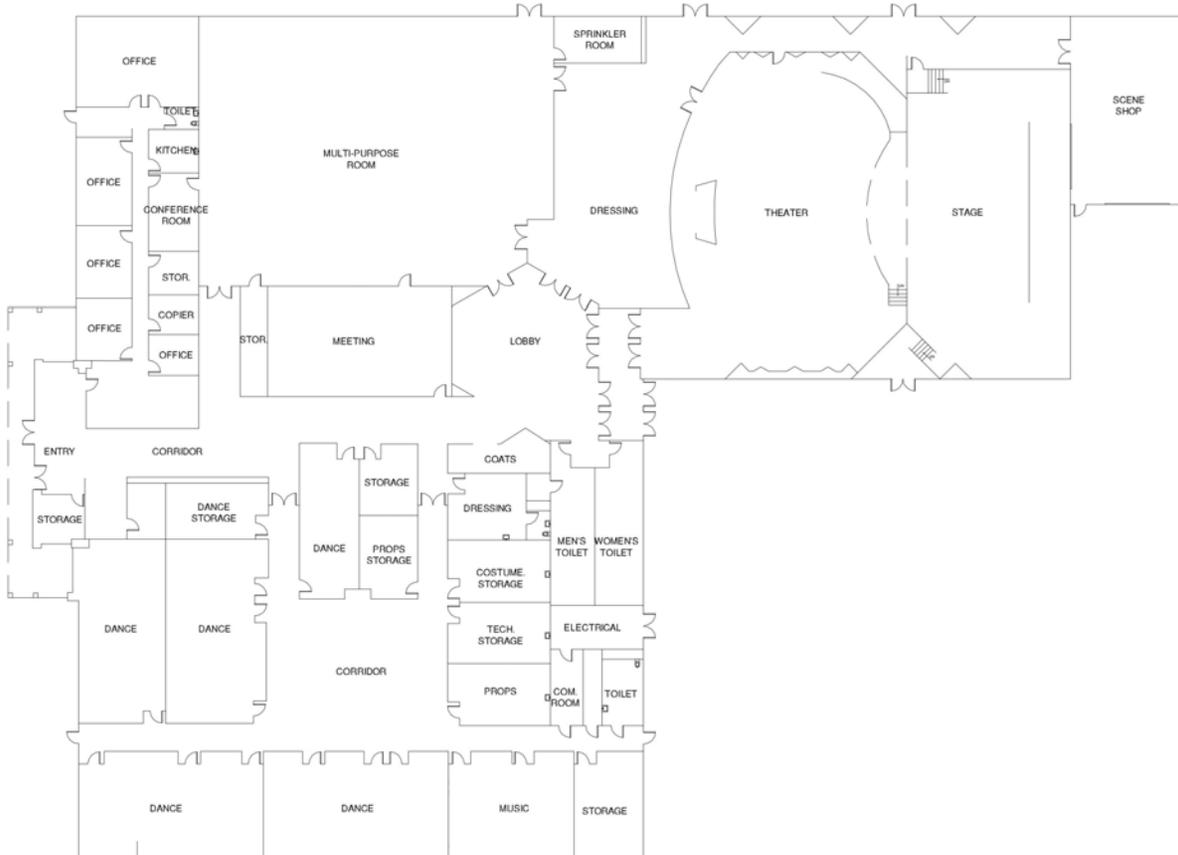
Figure 23- Community Art Center FLOOR Plan

The Community Arts Center was originally built as a lumber center. It was converted to a synagogue prior to the District purchasing it and converting it to the Arts Center in 2014. The facility is a steel structure facility with brick masonry veneer. The facility is used for performing arts, drama, dance, and similar function. It houses a theatre for presentations and a multi-purpose room for rentals. There is an administration office suite for the staff that operate the arts center. The facility is 41,395 sq.ft. in size.

Circulation:	6,805 SF
Multi-Purpose/Support:	10,260 SF
Storage/Equipment:	9,525 SF
Theater/Support:	13,690 SF
Toilet Rooms:	1,115 SF

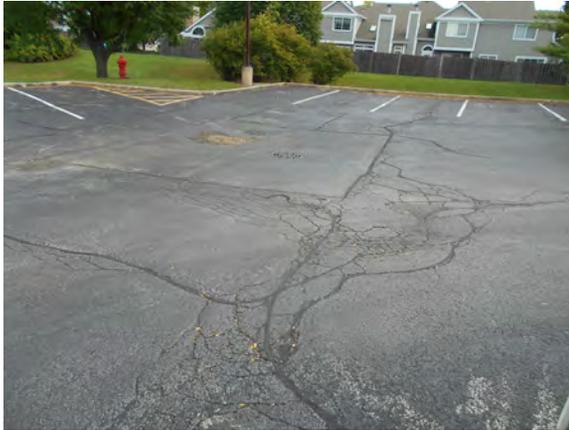
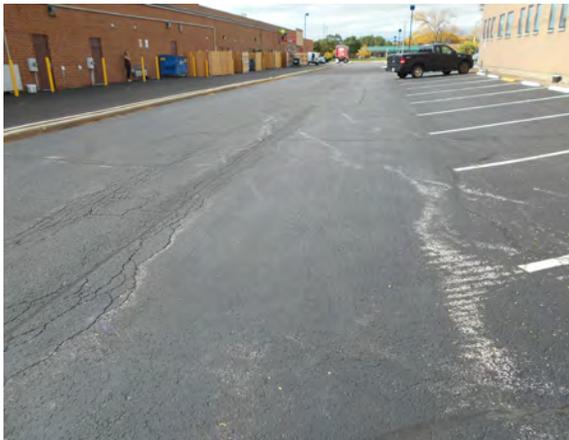
The parking lots at the south and north have some large cracking issues in the main drive aisles. The front entry was being revised during the time of the inspection, and that pavement was in good condition, as well as the pavement under the covered area at the rear of the facility. The pavement might be able to be maintained for a couple of years, but replacement or re-surfacing should be considered within the next 5 years. The base was probably undersized for the amount of traffic it received from the lumber operation function, which resulted in the cracking shown. The facility operation should not receive that level of traffic or weight loading.

At the rear of the site is the old lumber covered area that is currently being used for parking. This structure is mainly in good condition with the exception of the window infill and trim. These items should be repaired and sealed to keep all weather out of the structure and keep the wall construction in good condition.

A fence might be considered to further develop that separation. The parking to the west must maintain a through passage for business access. A study should be considered to develop a better flow pattern in the parking lot that will keep the business traffic out of the majority of the facility parking and promote drop off condition.

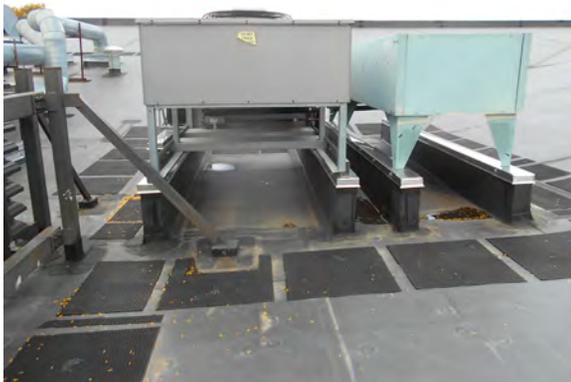
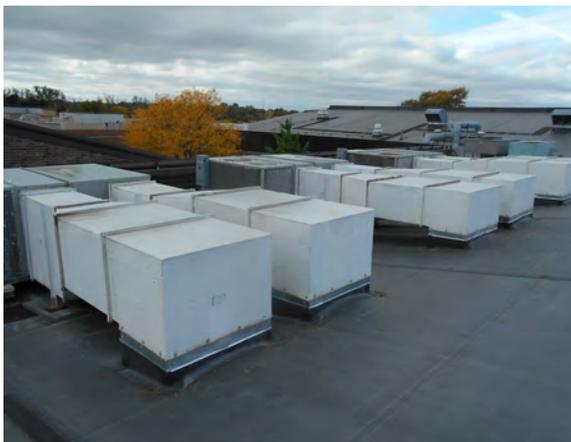
The roof was recently replaced and is in excellent condition. The install appears to be a top notch application and the District should have a good amount of life out of the roof if maintained regularly. The shingle roof on the rear sparking cover has some damage and it can be repaired for the short term, but the roof should be considered to be replaced in the next 5 years.

The exterior of the building is masonry and is generally in good condition. Control joints in the masonry have evidence of the caulking deteriorating. Caulking needs to be removed and recaulked. There is some damage to the masonry near the new stage bay where it appears something either hit the building or there was some water damage that broke out the masonry. This area should be tuckpointed to maintain weather tightness.

The rear entry cover is generally in good condition. The area directly above the rear entry has evidence of damage that is believed to be prior to the new roof work being completed. This area will need to have the steel cleaned up, primed and painted. Any rusted steel

The large louver opening on the north side of the building is deteriorating and should be replaced with a maintenance free type of material.

should be looked at further to determine if replacement is required prior to resurfacing.

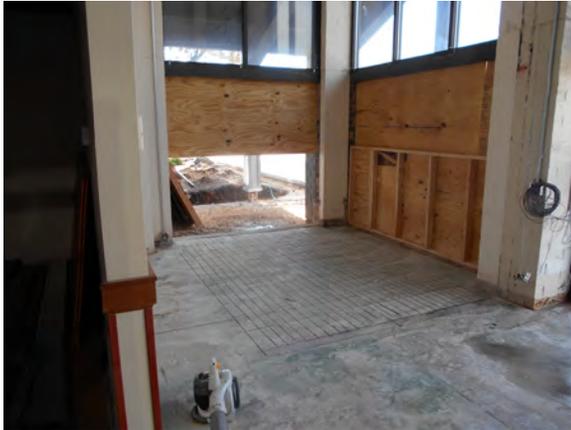
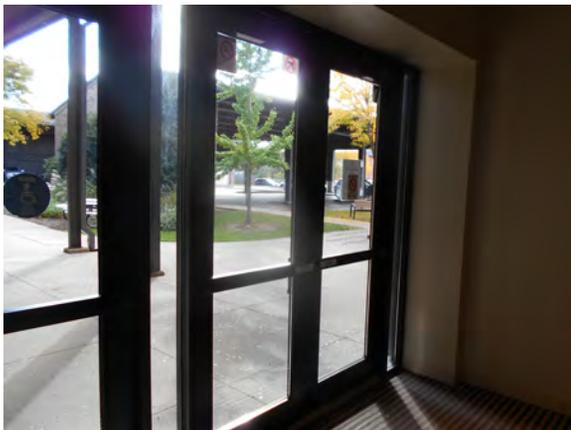
The inner portion of the facility was built out inside a large steel structure. As such, there are areas like the administration area has its walls only extended above the ceiling. While this works for function, it may result in noise issues and concerns between offices and adjacent functions. This is something that may need to be addressed in the future by the District depending upon the administration operation.

The stage is developed for performance. The sound system for this setup is housed in one of the exit stairways reducing exit width and egress capacity. This equipment should be relocated and placed in a more developed location.

The exit doors from the dance wing of the facility are located in the exterior walls and have a large jamb dimension. This exceeds the IAC and ADA code requirements. These areas should be looked at and remedied.

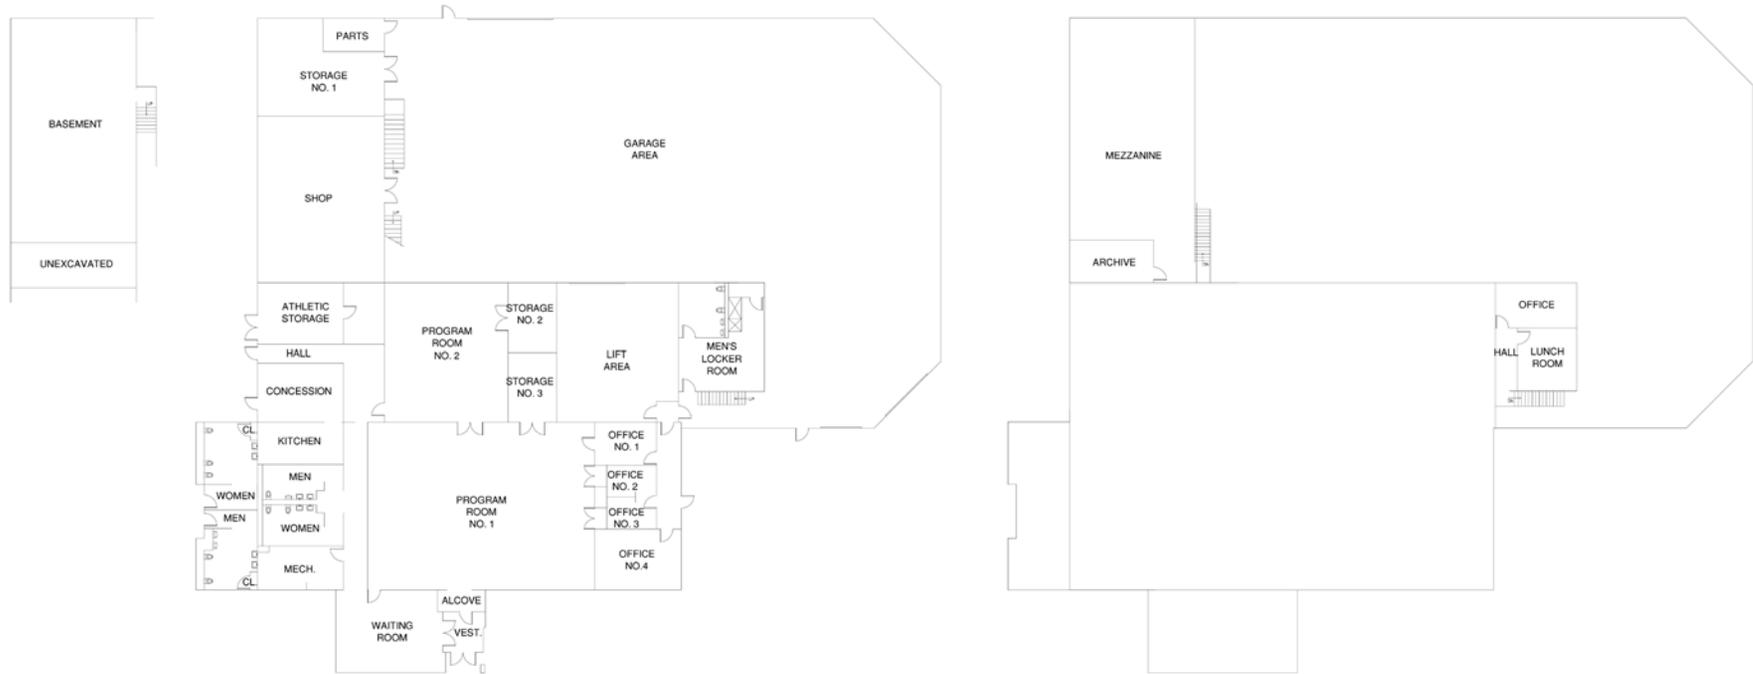
FIRST FLOOR PLAN

First Floor:	20,160 SF	Breakdown by Use:	
Basement:	1,560 SF	Administration:	1,300 SF
Mezzanine:	2,340 SF	Circulation:	1,333 SF
<i>TOTAL:</i>	<i>20,060 SF</i>	Facility Support:	422 SF
		Garage/Support:	12,250 SF
		Program Spaces:	3,050 SF
		Storage/Equipment:	4,255 SF
		Toilet Rooms:	1,450 SF

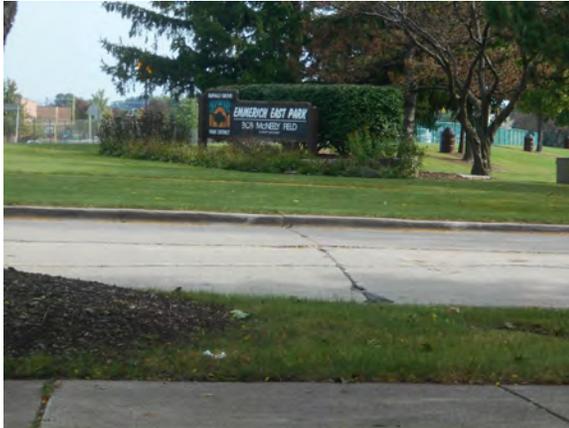
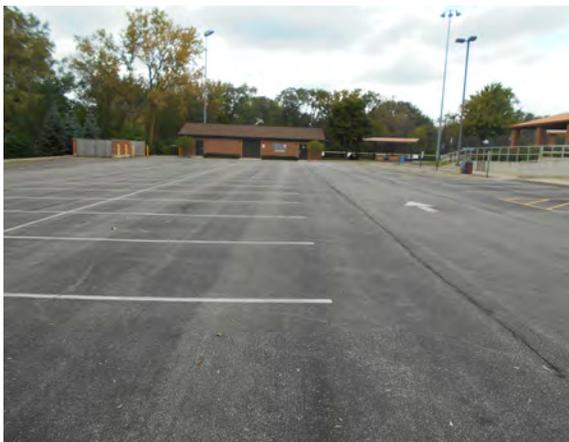
The facility is located in the southwest corner of Lake Cook Road and Raupp Boulevard, with access off of Raupp Boulevard. It is located across Raupp Boulevard from Emmerich East Park. The immediate grounds around the building are athletic fields and further bound by Buffalo Creek. There is parking provided at the south side of the facility that serves the program space, athletic fields, and maintenance staff parking. There is additional parking provided across Raupp Boulevard for Emmerich East Park, and athletic fields. Typically, there is not a conflict between operational staff parking and busy times for fields, but there can be occasional periods where the parking lot will be used to its limits. There is a separate drive entrance for the maintenance fleet vehicles that is isolated from the main parking lot. This access is limited and has conflict regarding ingress and egress. Most vehicle operation can be worked within the confines of the site, but occasional use during peak periods and use of trailers, large vehicles, or deliveries can cut off access for operations. The location of the facility limits potential expansion to improve

The parking lot and pavement surface is in good condition. Regular maintenance should be completed to maintain and extend the life of the parking lot surface.

this condition, but it is recommended that the site use of the facility be studied to determine if improved site circulation and flow can be achieved.

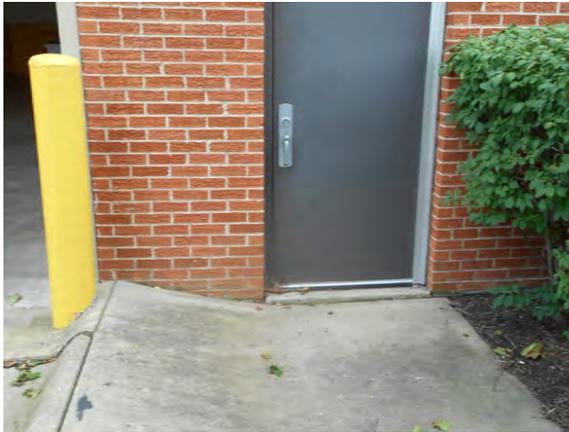
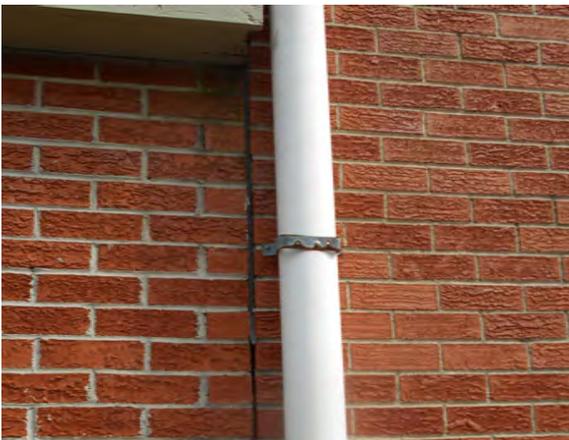
The control joints in the brick veneer shows evidence of old cracking caulk. These joints should have the old caulk removed and re-caulked around the entire building.

There was an issue in the past at the Athletic storage doors near the concessions with ice damming and water infiltration. This area is the lower flat roof that picks up the partial water from the high flat roof, the pitches roof, and the area of the lower flat roof itself. This all pitches to a single perimeter gutter and downspout. This gutter and downspout is undersized, and most likely resulted in the ice damming and backup. The damming entered the wall and caused lots of damage to the interior block and brick. This drainage condition needs to be improved, then the wall addressed and properly sealed.

There are various wasps nests around the perimeter of the facility that should be removed and addressed.

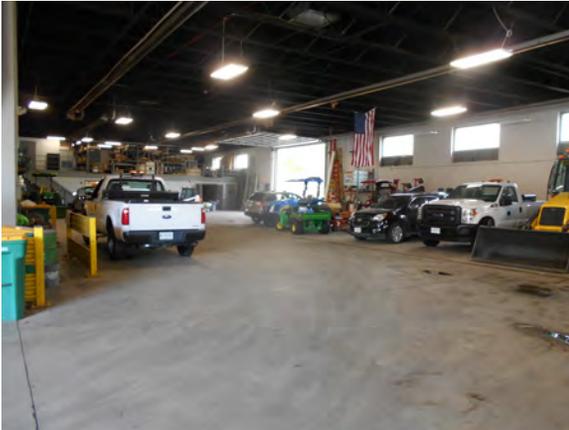
The garage space is used for general storage, parking, equipment storage, and maintenance. The majority of the large garage space only utilizes the ground for storage. Consideration should be taken into providing perimeter shelving for additional storage to maximize the height storage, which in turn will clean up and organize the daily operation of the space. The concrete floor is in fairly good condition with the exception of the north rear overhead door where excessive salt damage has occurred to the slab. This area should be monitored and if additional damage continues, replacement of the concrete slab should be considered or a grinding and resurfacing option. There is evidence of settling in the CMU masonry at various places in the facility that appear to be stable and not structural concern. These areas should be cut out and caulked to allow movement, while continuing to monitor in the future to ensure there is no further concern. Just like the exterior, all control joint caulking has deteriorated and should be cleaned up and re-caulked.

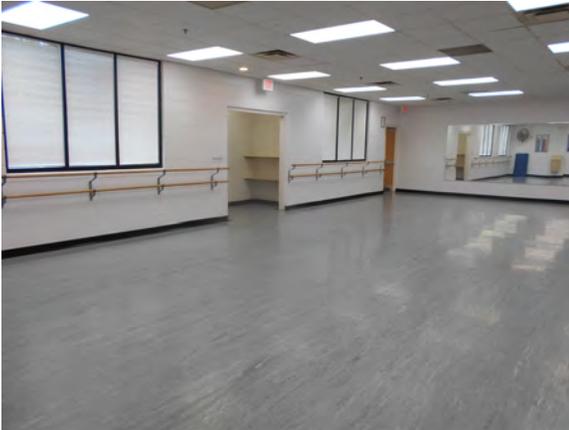
The main program dance room has a closet that houses the IT hub and network for the facility. This is accessible to occupants and should be separated and secured.

The renovated toilet rooms have air hand dryers that do not meet IAC and ADA code requirements and extend into the accessible route. A maximum 4” projection is only allowed. These units should be replaced with a unit that meet requirements.

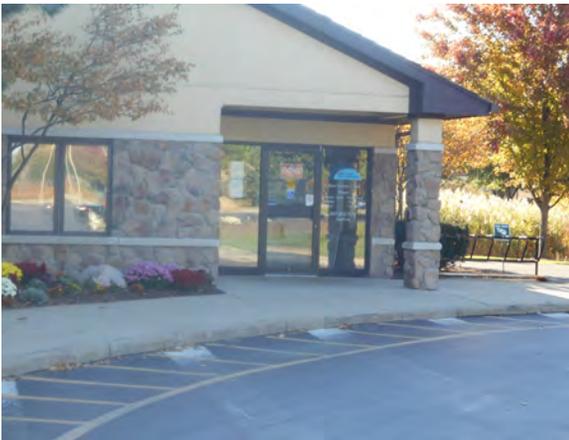
The exterior of the building is mostly in good condition. The roof is a shake shingle that is probably in need of some maintenance. These shingles can last a long time, but it appears that there have been some issues with birds that have picked at the shingles. Upgrading and replacing the

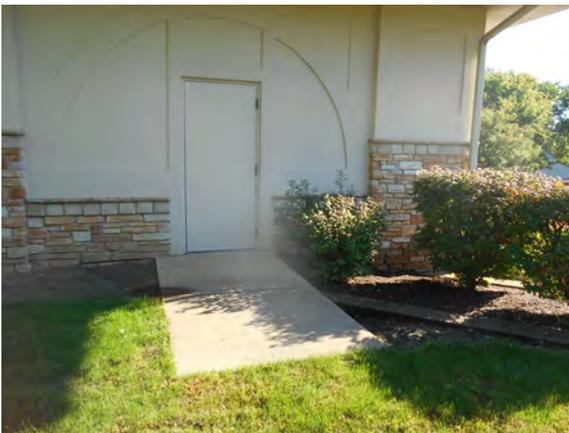
The access to the building is past the mechanical condensers and electrical transformer. The entrance to the facility could be improved to give better appeal and entrance strength.

The secondary exit from the upper level gallery opens to an exterior stoop. This requires a walk to a public way for emergency exiting.

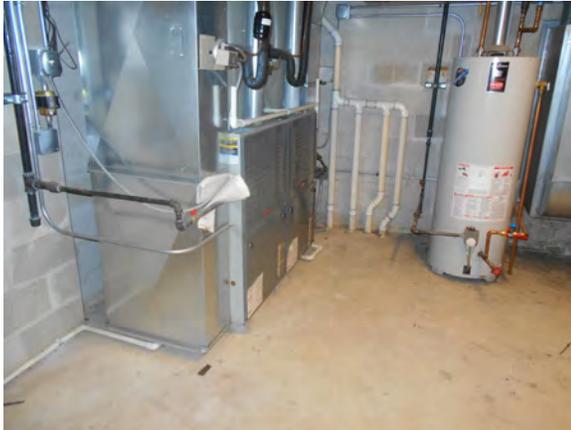
The upper level furnaces are older and probably near the end of their life. Plan on replacing these within the next 5 years. The lower level furnaces are newer and appear to be in good condition.

The lighting in the facility mainly consists of fluorescent lighting fixtures. The District may consider replacing the fixtures and upgrading to all LED in the future for energy costs and quality of lighting.

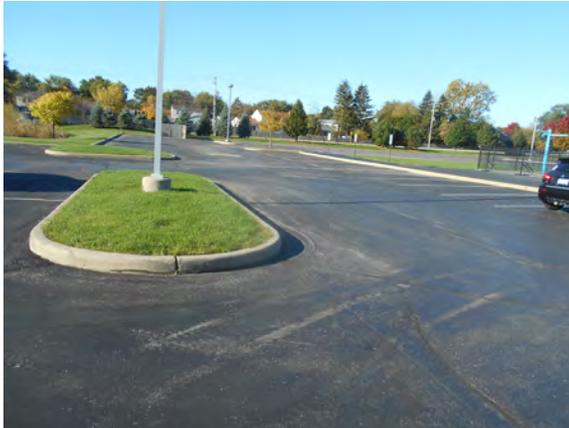
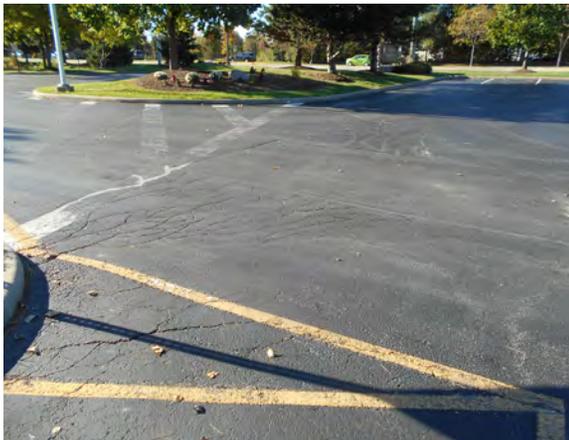
The Spray N' Play is part of the Mike Rylko Community Park, located centrally in the park. It is accessed off McHenry Road, and is connected via parking lots to the District's Golf & Sports Dome, as well as the Fitness Center. The parking lot is used for this facility and the park use. Parking is well oversized for the operation of this facility.

The parking lot is generally in good condition. Standard maintenance should be completed on a regular basis to prolong the life of the pavement.

The main entry has a sidewalk and pavers installed that is experiencing some settling. This is most likely due to its sub-base installation. This is a tripping hazard and does not meet IAC and ADA code requirements. This area should be removed and re-installed within the allowable tolerance, to meet requirements.

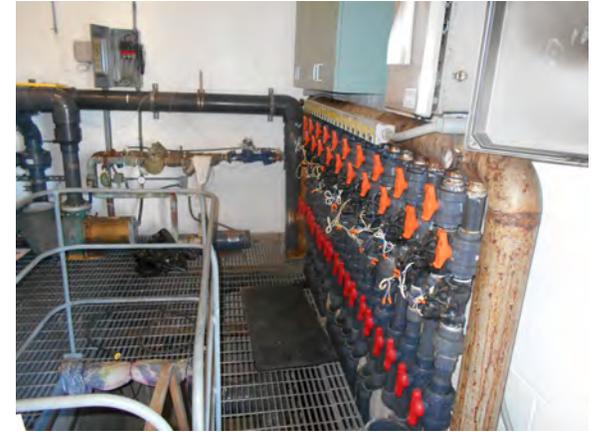
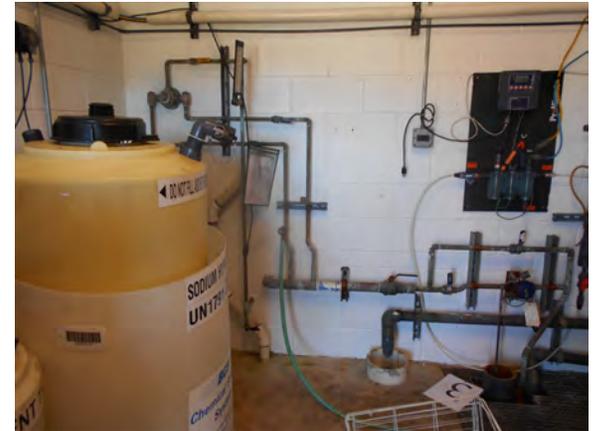
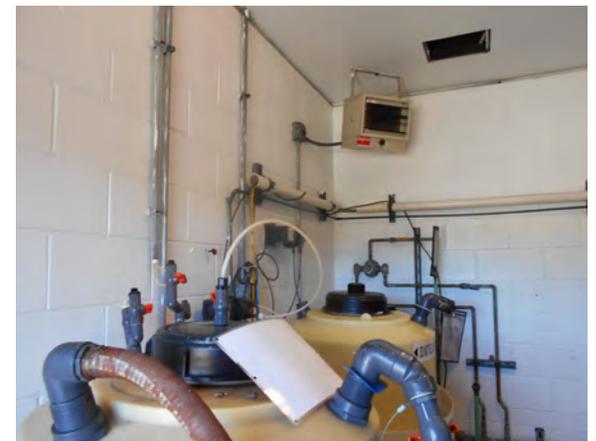
The electrical service of the facility appears to be original and in decent condition. Typical manufacturer recommended useful serviceable life for service boards and associated equipment

is approximately 30 years in most installations. Recommend routine maintenance including lug torque check for all panelboards and feeders.

The building is not protected by a fire suppression system or a fire alarm system. The addition of a fire alarm system should be considered since it is open to the public. Smoke detectors should be installed in the ticket office, equipment room, and storage room.

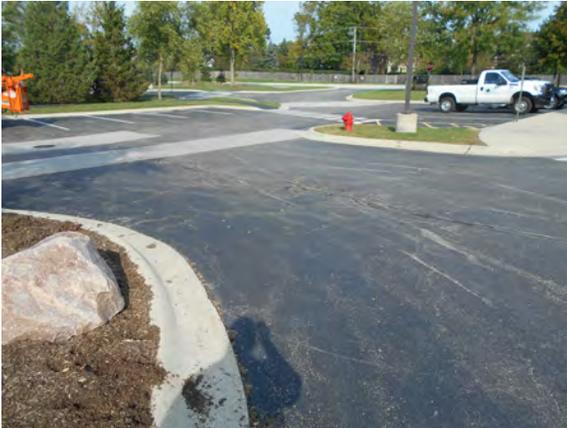
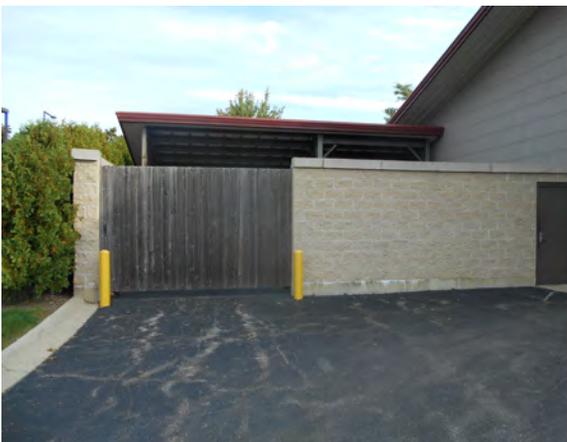
Twin Creeks Park facility is in the northeast corner of Twin Creeks Park, located at Aptakisic Road and North Buffalo Grove Road. It is accessed off Aptakisic Road. The use of the facility and its operation makes access congested at times. A circle drop off is provided for patrons, but it is also used by staff accessing the maintenance garage. Parking is provided for the facility and the park, which is more than acceptable for the facility. The access to the maintenance garage requires immediate turning, which has resulted in damage to the pavement and showing large cracks.

The base in the pavement is undersized. The area should be replaced with the possibility of replacing it with concrete to prevent further damage based upon operation. There is examples of areas in the pavement that have been replaced recently that look like result of pavement damage. This could be due to bad base when installed or potential for leaks in the structures. Further investigation should be completed so that a proper remedy can be implemented.

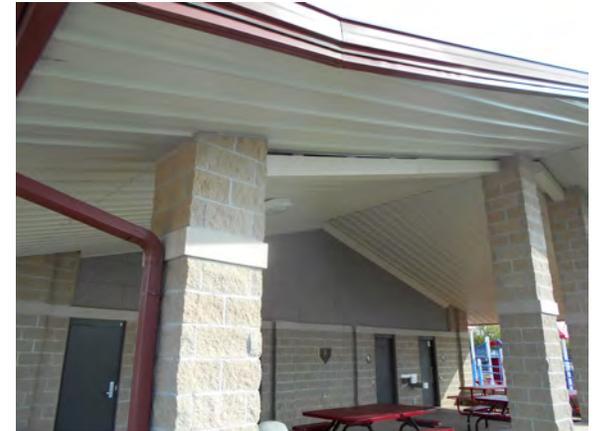
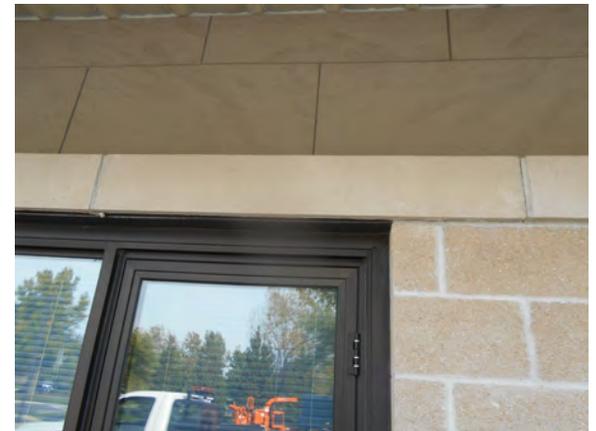
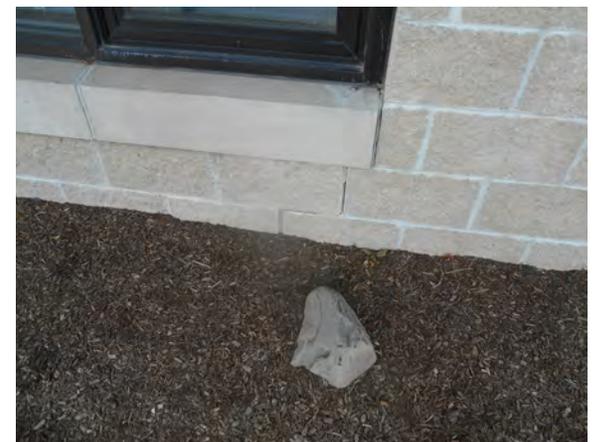
The roof is typically in good condition. The valley's on the roof were done incorrectly and are completely susceptible to water damage and potential ice damming. All valleys should be opened up and redone to a water tight condition per manufacturer standards. There are several areas where the gutters are pitched incorrectly, run too long, or have undersized downspouts. This is clearly evident at the playground area. The gutter at the main entry has evidence of being undersized as well. Gutters should be replaced, re-pitched, and additional downspouts provided to properly drain the roof.

The exterior of the building is mainly in good condition. The control joints around the entire building have evidence of the caulking deteriorated. All caulking should be removed and re-caulked to maintain a weather-tight envelope.

Some soffit panels over the covered shelter have separated and are open to pests. These panels should be repaired and closed up to prevent damage.

At the main window at the meeting room has evidence of settling. It appears that the lintel is undersized and the foundation settled. The lintel should be investigated, repaired, and reinforced. The steeling should be addressed and monitored in the future.

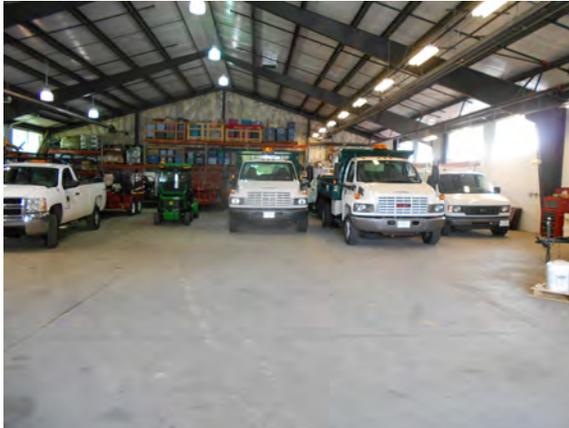
The mechanical and electrical system is original. The units are in decent condition. Units should be considered to be replaced in the next 5-10 years.

The electrical service of the facility appears to be original and in decent condition. Typical manufacturer recommended useful serviceable life for service boards and associated equipment is approximately 30 years in most installations. Recommend routine maintenance including lug torque check for all panelboards and feeders.

The building is completely protected by a fire suppression system and fire alarm system. The general coverage for detection and annunciation appeared typical and adequate for a building of this type and use.

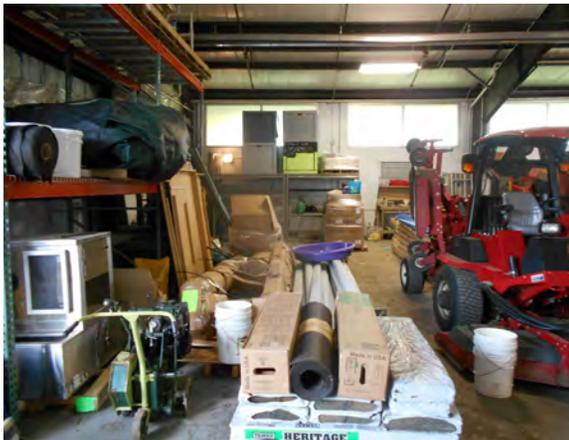
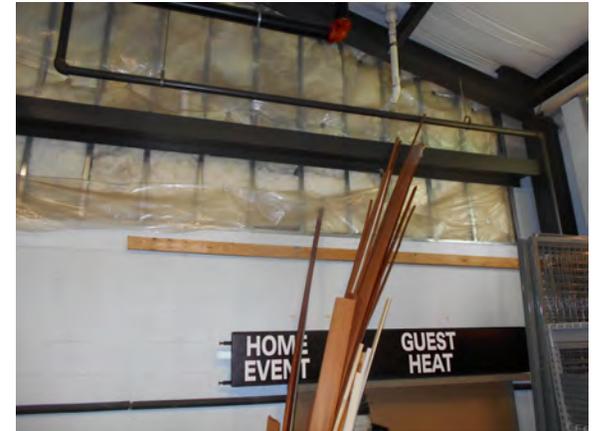
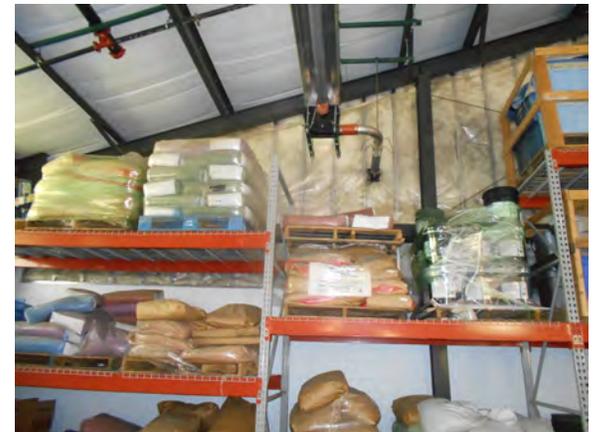
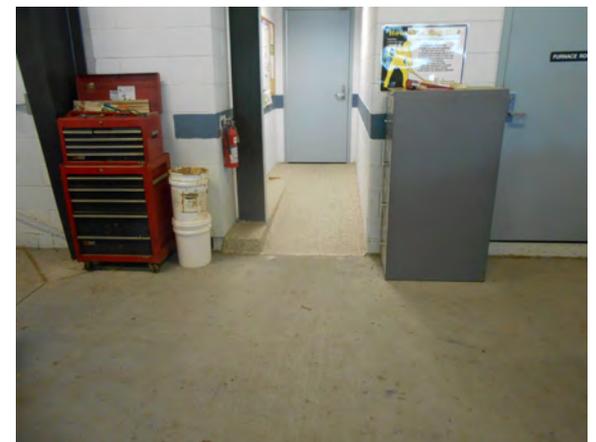
The maintenance garage is unfinished at the top of the wall, and has the vapor barrier and insulation exposed. Several locations have the vapor barrier pulled back and not sealed. The conditions are not allowed per the flame-spread and should be sealed off. This will also help operation with air leakage and energy savings. The maintenance garage has doors that exit inward and they should be exiting outward for egress purposes. Both doors and frames should be replaced and reversed. The access to the secondary rear entrance needs to be kept clear for exiting purposes. The floor of the maintenance garage is in good condition.

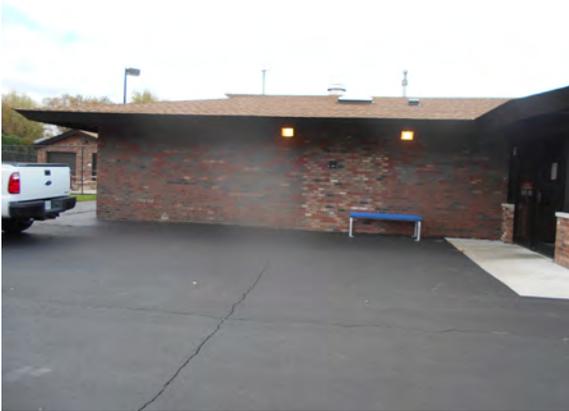
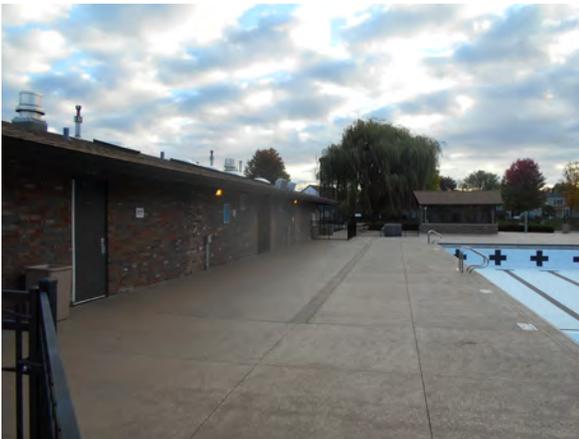
The parking lot is generally in good condition. Standard maintenance should be completed on a regular basis to prolong the life of the pavement. There are some cracks in the pavement outside the main entrance. These cracks should be addressed sooner than later.

The roof appears to be in decent condition. There are areas near the edge that have the shingles raised. This is a result of install, but could pose problems in the future. The edges should be looked at further and addressed.

The drinking fountain and bottle filler on the lifeguard building does not meet IAC and ADA code requirements and should be replaced to meet requirements
