BUFFALO
GROVE
PARK
DISTRICT

Comprehensive Master Plan

2017 and Beyond

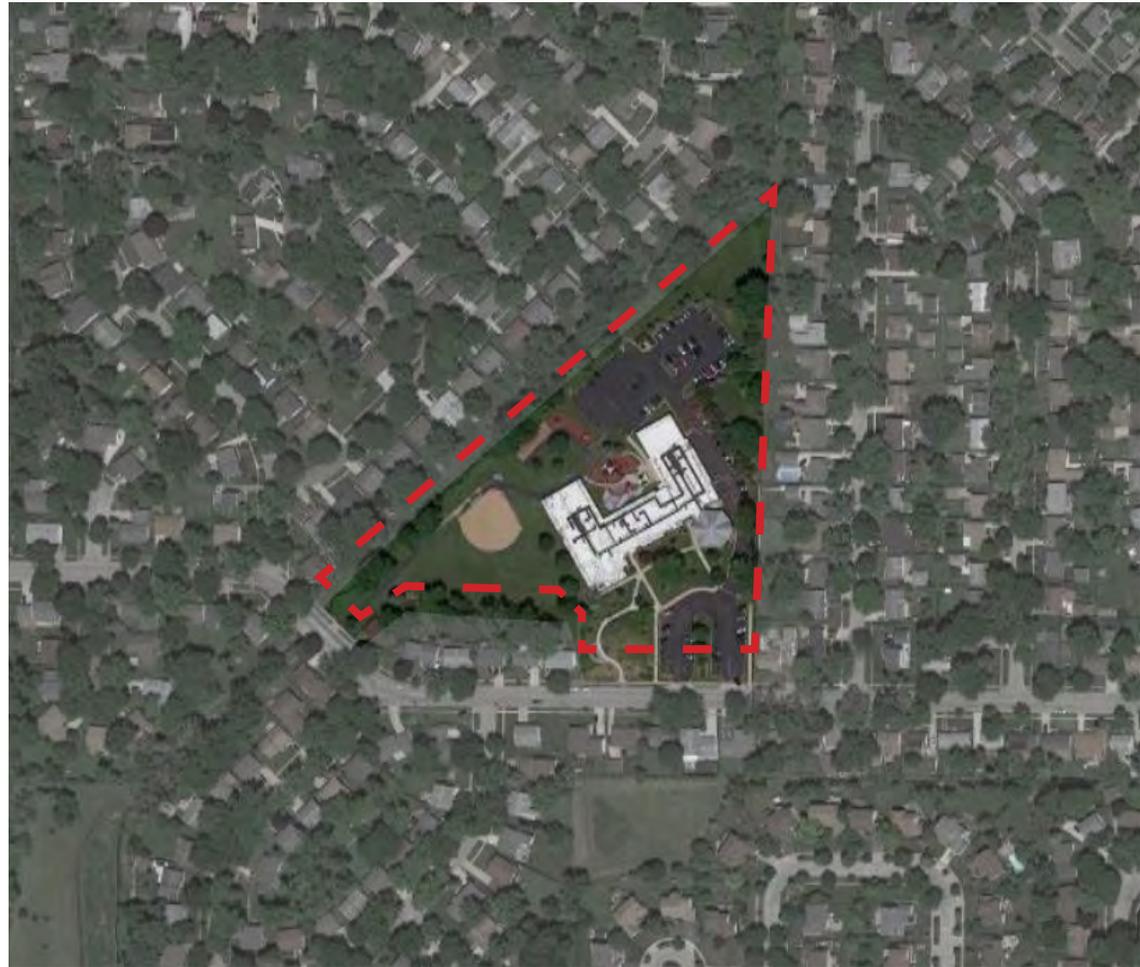
The ball field has an older out of date backstop and fencing that should be replaced. Additionally soil containment should be considered along the west side of the ball field. There is a significant loss of infield mix being washed out onto the walking/bike path creating a slip hazard. Older bike racks are present along the side protection fencing on the west side of the field. There several separate play areas one

with a five bay swing set, four bays with traditional swings and one bay with two bucket swings. This area does have a loose fill surface in the fall area.

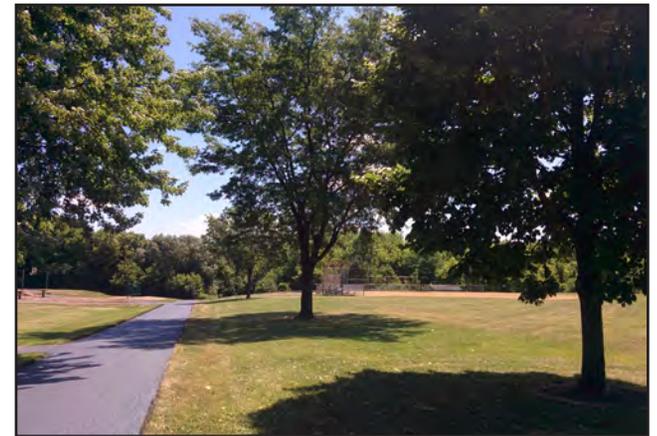
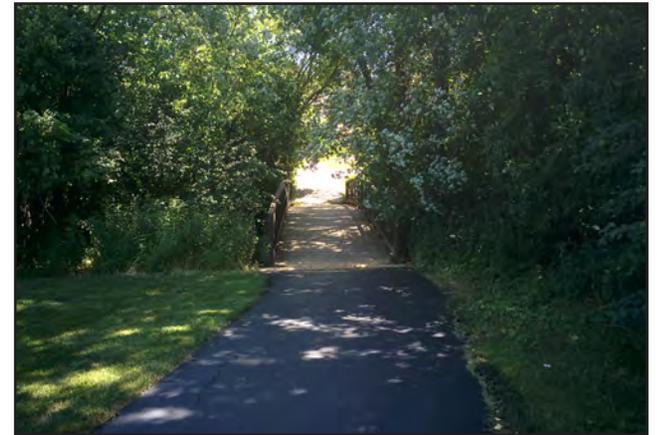
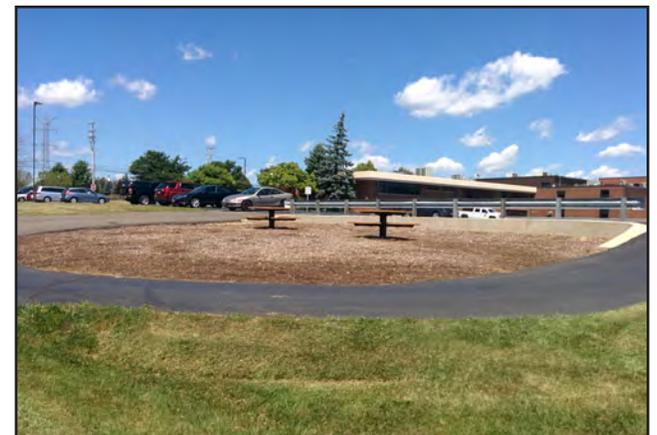
Apple Hill Park

The ball field is in good condition. All components of the fence are in good condition with no post heaving and very little rust. The infield is good with very little turf encroachment along the margin. However, the mix is built up above the bottom of the backstop behind home plate. This could eventually end up on the asphalt behind the backstop. A review of historical aerials shows this has occurred in the past. The aluminum player benches and bleachers as well as the equipment storage box are in very good condition.

The volleyball court is in fair condition. The sand is an adequate depth and free of weeds. There is no containment for the sand; the turf edge is uneven. The turf edge essentially represents a regulation court. The change in surfaces is a tripping hazard for a player attempting to play a ball out of bounds.

The picnic shelter is in good condition. The brick clad columns are free of cracks and the wood shake roof is intact with no visibly missing shakes.

condition. The loose fill woodchip surfacing is an adequate depth, however there are areas of decomposition, compaction and weeds. The apparatus is designed for the 5-12 age group and is accessible for those with limited mobility. There are also two belt and two bucket swings, and two spring toys that are in good condition. A portion of the playground is bordered by a concrete wall and fence. The wall is in good condition and the fence is fair; the rails have significant peeling.

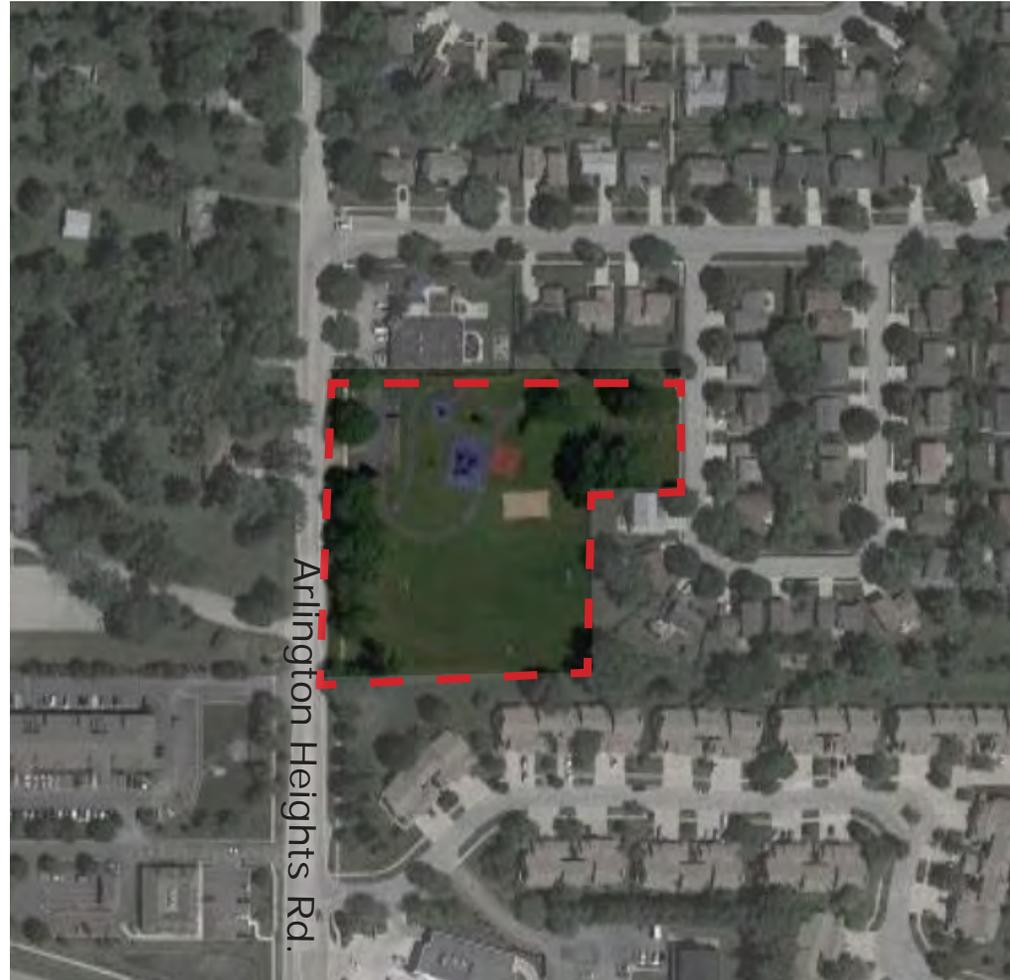
An asphalt path system bisects the park and provides pedestrian access from Logsdon Lane to

Arlington Heights Road. This path is in fair to good shape. There are areas requiring seal coating and crack filling to prevent further pavement deterioration.

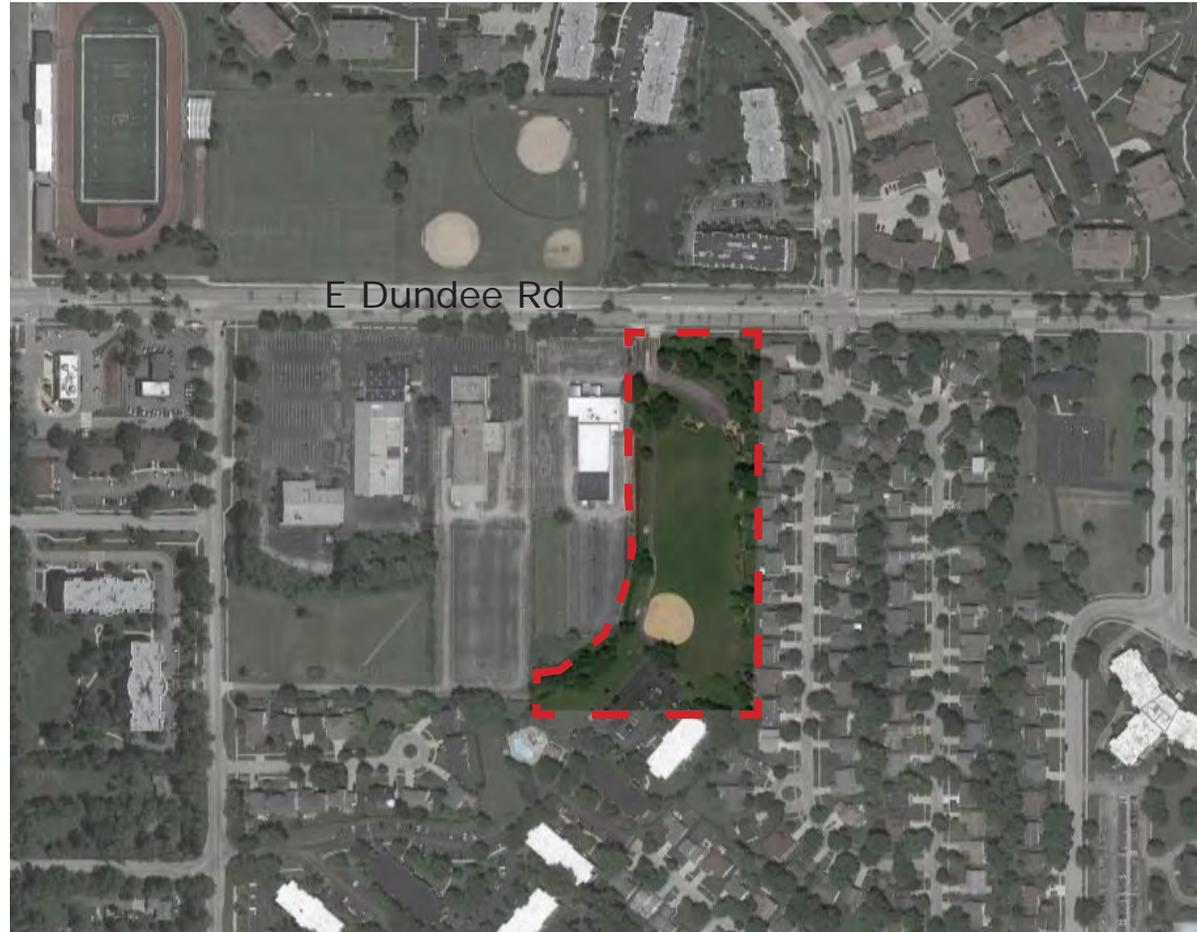
The parking lot is constructed in a sweeping arc fashion for aesthetic and visual interest. Parking circulation is restricted to a "one way in - one way out" configuration. The parking lot provides 24 spaces with one accessible stall. The drive aisle of the parking lot appears to have been recently replaced

as a result of storm sewer repair work. However, the remaining surface area (parking stalls) needs to be crack-filled and resealed. The entire parking lot needs to be restriped to help keep parking stalls and handicap parking area clearly visible. Illinois Accessibility Code (IAC) requires a sign with the international symbol of accessibility mounted high enough so it can be seen while a vehicle is parked in the space – no such sign was evident at the time of our site tour.

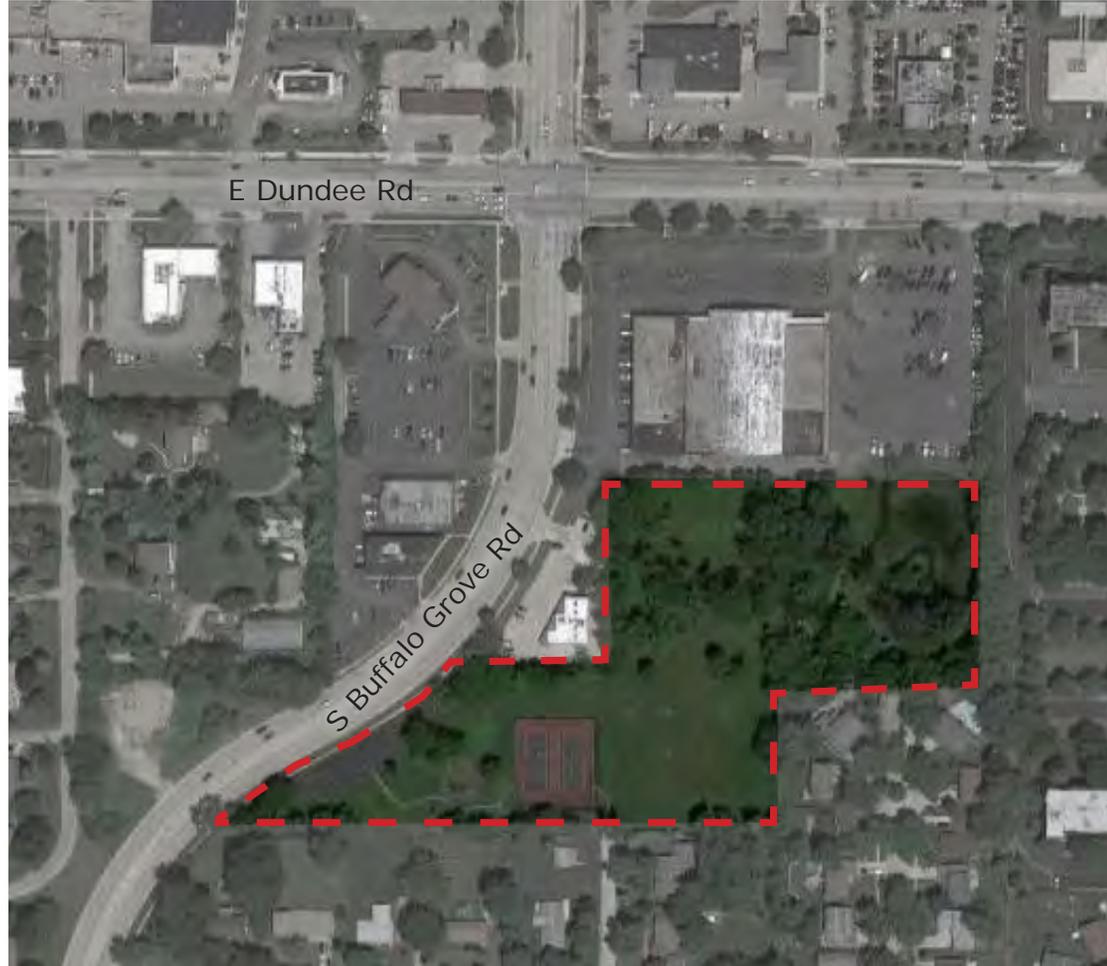
There are two benches that are in good condition located in the park one with close access

to the playground surface providing an accessible route to the seating area. Another bench is located close but is within a turf area and has no accessible route of access. Turf under the bench can present additional maintenance needs.

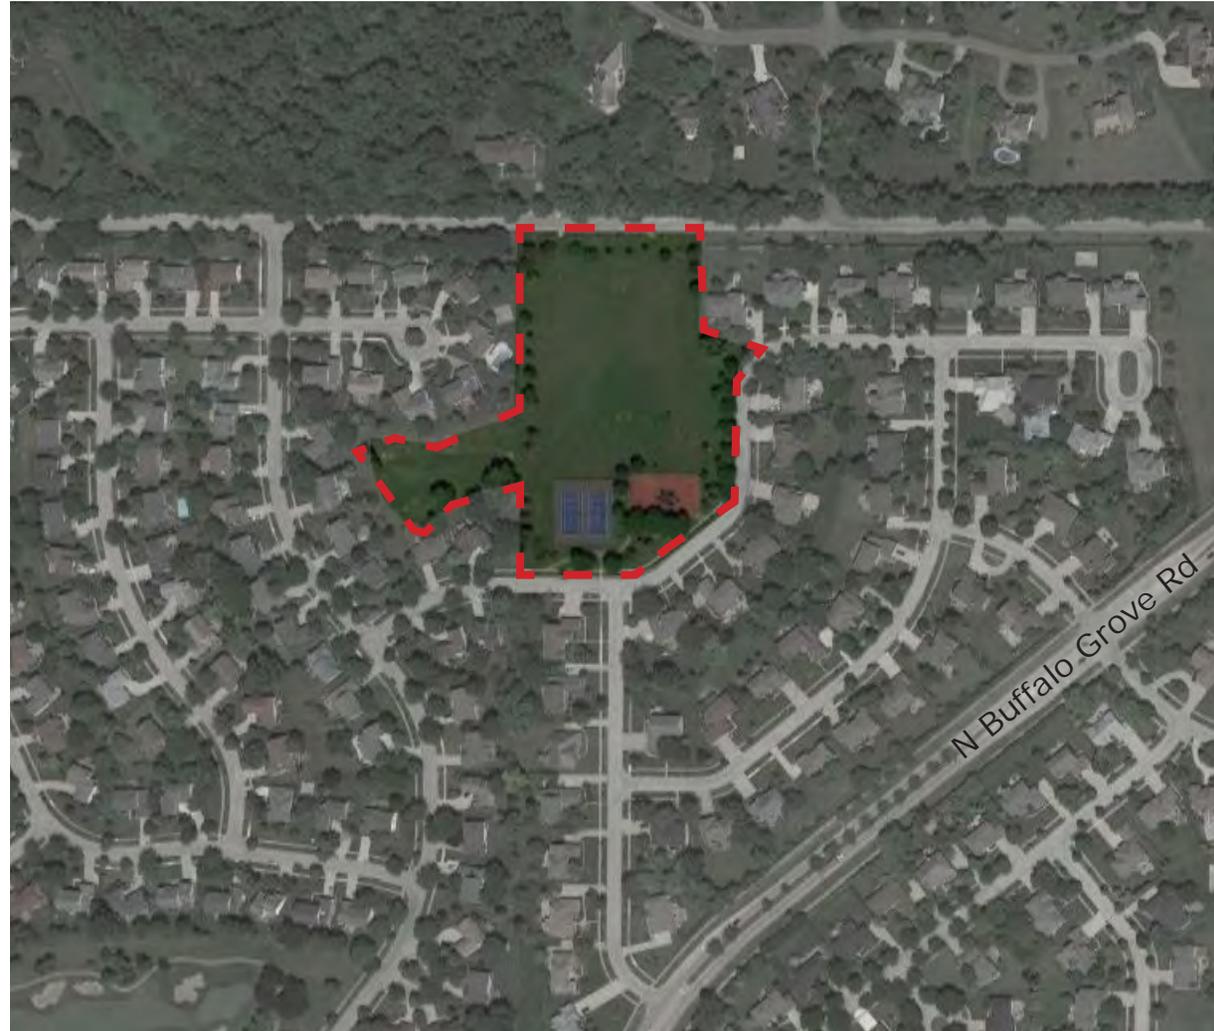
Tennis court surface and fencing is in good condition. Backstop available for neighborhood pick-up games. Pathways are due for seal coating.

Trees in good condition but need mulch rings to protect trunk, maintain moisture, improve soils, and improve mowing efficiency.

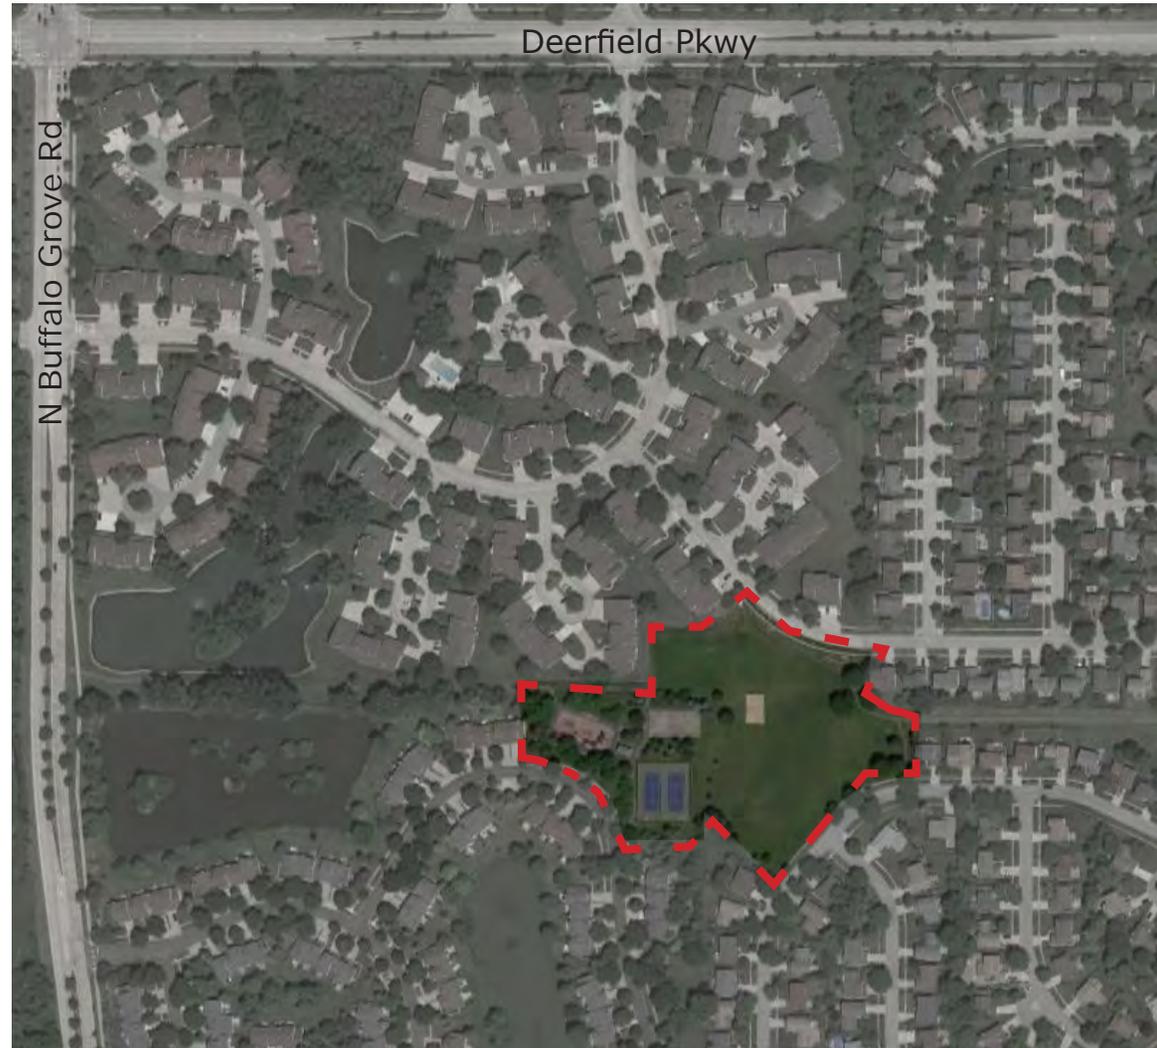
Cherbourg Park is a 5.60 acre neighborhood park featuring two tennis courts, two basketball half courts, one sand volleyball court, a large open area used for soccer practice, and one large playground area. The sign at the park's main entry from Marseilles Circle appears to be newer and in good condition. The plant bed at the base of the sign is poorly defined and is in need of additional mulch. The daylilies planted here have grown large enough to block views of the lower portion of the park's sign. The asphalt path that spans the perimeter of the park is in fair condition and wide enough to accommodate maintenance vehicles. Adjacent to the playground there is a covered shelter with two picnic tables providing seating for up to 16 people. Each table has two permanently attached chessboards as well. The playground area is partially enclosed by vinyl coated chain link fencing and provides play equipment by Landscape Structures for various age groups. The play equipment overall is in fair condition as the colors are fading and beginning to chip away. The asphalt path surrounding the play area has noticeable

cracking and fading and is in fair condition. Two of the permanent benches provided along the path lack any nearby trees to provide sufficient shade to the area.

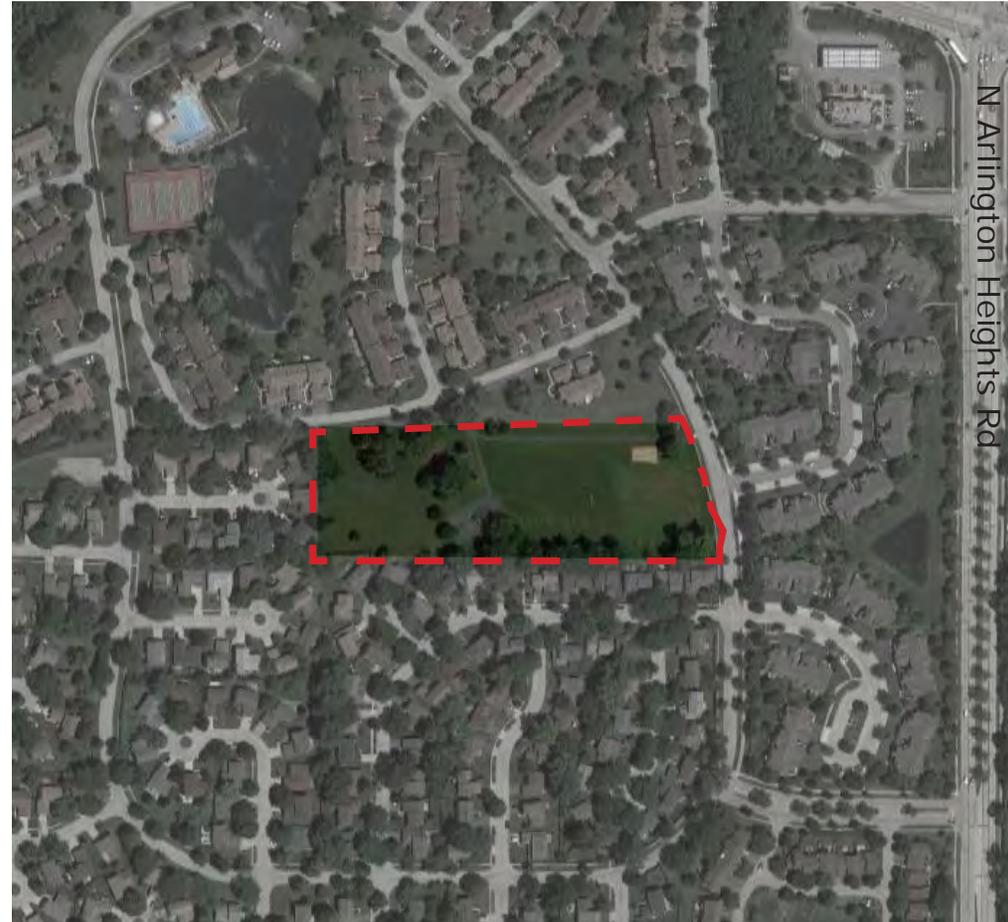
A soccer goal set (with no net) is in the middle of a 150x360 ft open turf area. The eastern half of the turf area shows signs of being slow to drain or intermittent standing water. This poor drainage limits the use of the eastern half of the turf area for sports practice areas or programmed activities.

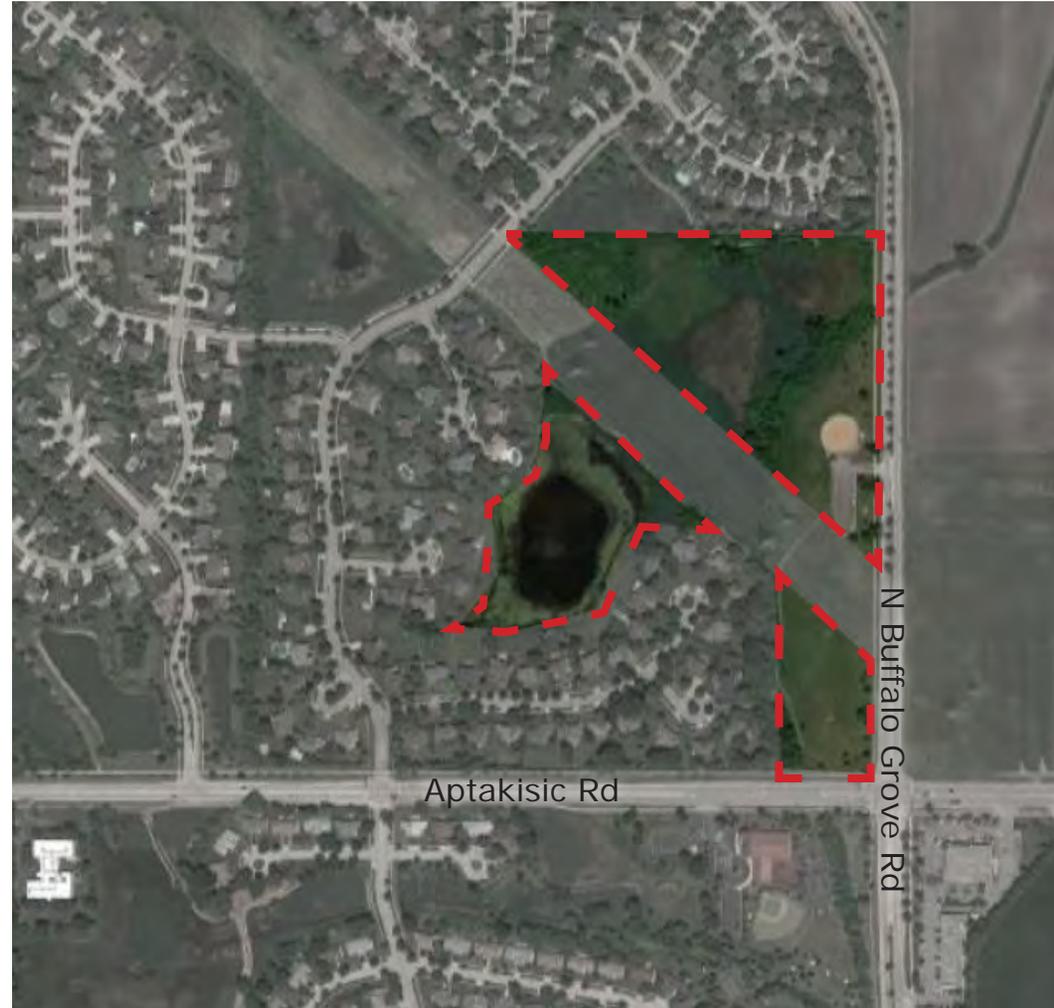
goal posts are in good condition. One picnic table is located near the parking lot in the middle of an open turf area without any paved access or any shade nearby. All receptacles have dated wooden enclosures and are in fair condition. The asphalt trail connects to a wooden bridge that spans over a small creek and three permanent benches are located along the trail. The trail and bridge appear to be in fair condition and require maintenance in the near future.

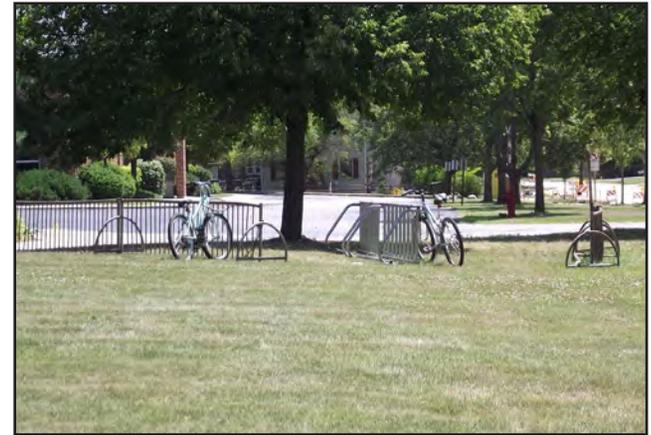
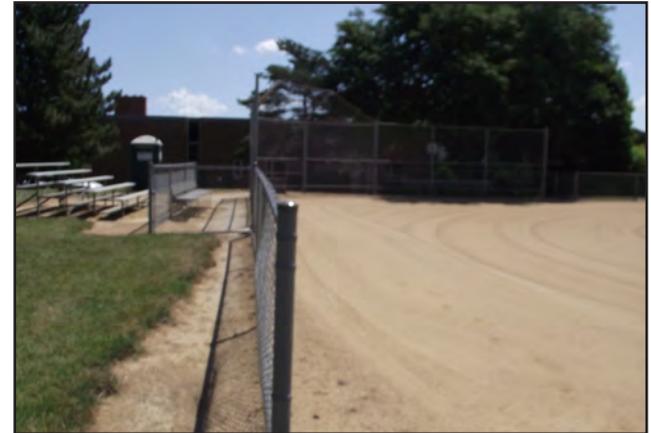
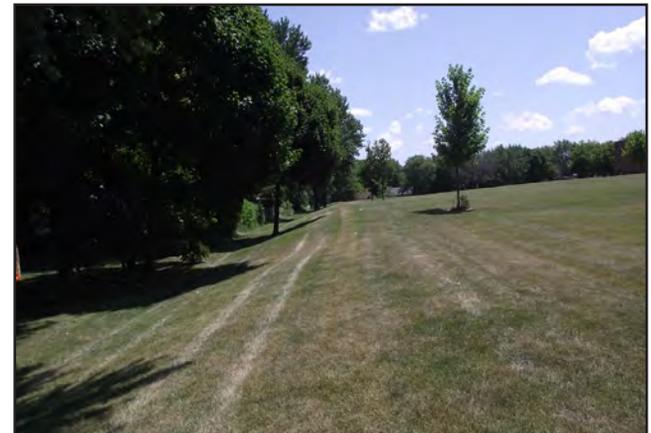
The ballfields generally are in good condition. However, cow paths are evident in and around the spectator areas leading to both backstops. Generally the turf is good – clover patches were evident with only

for the intended use. The larger ball field has an overgrown burning bush hedge located in the outfield providing a safety concern both physically and visually. The ball field fencing and backstops are in fair to good condition. The fence fabric is mostly level and straight. However, there are a few areas where the “diamond” of the fabric extends beyond the top rail. Several fence posts are heaving.

The skinned infield is generally well maintained. There are a few areas where loose soil from the skinned areas has begun to build up at the circled edge creating a “lip” which will need to be addressed so these areas will not hold water from the skinned areas.

Spectator bleachers appear to be in good condition, though they are inaccessible. Other site furnishings consist of 55 gallon drum waste recepticle, player benches, and multiple bike racks clustered within the turf.

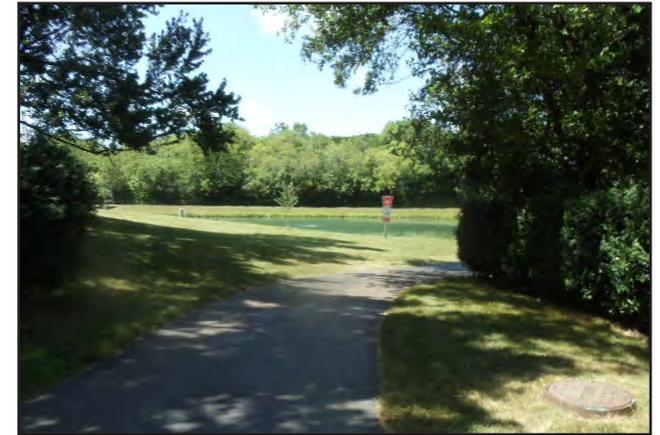
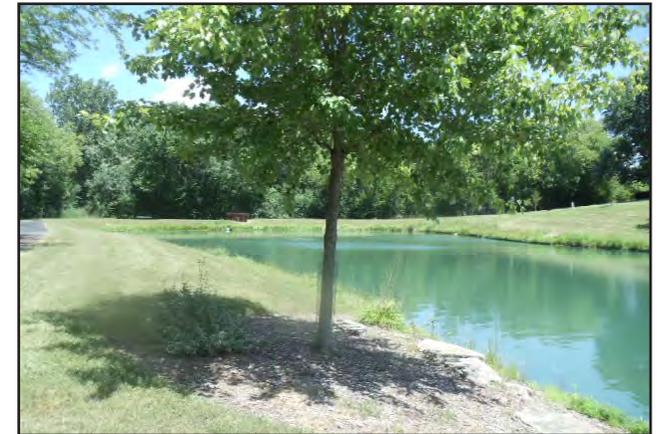
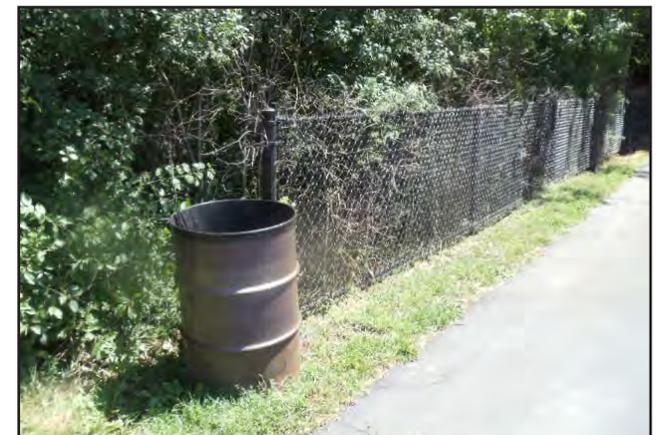
Crossings Pond

The pond appears to provide stormwater management for the adjacent residential development. A creek runs parallel to the pond along the north and west side of the pond. The creek is deep with severe side slopes. Access to the creek is limited by thick vegetation. The limited access prevents degradation of the slopes and erosion.

The park signage is small and is not consistent with the District's standard.

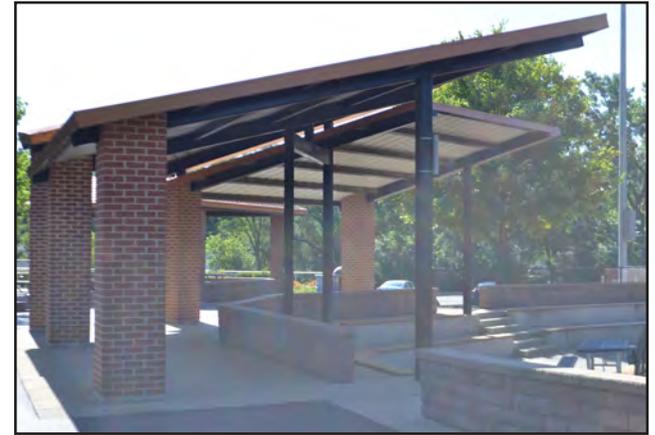
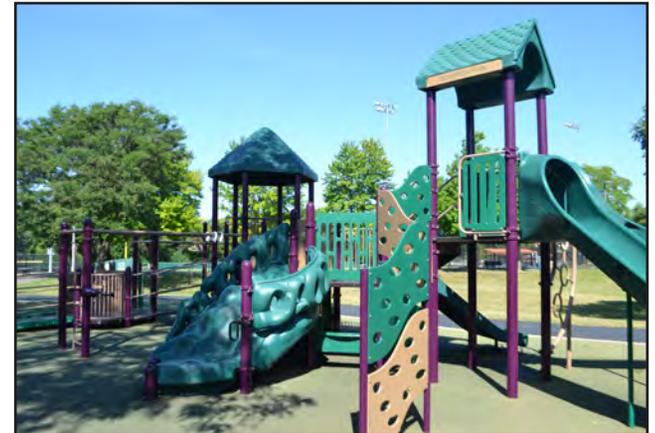
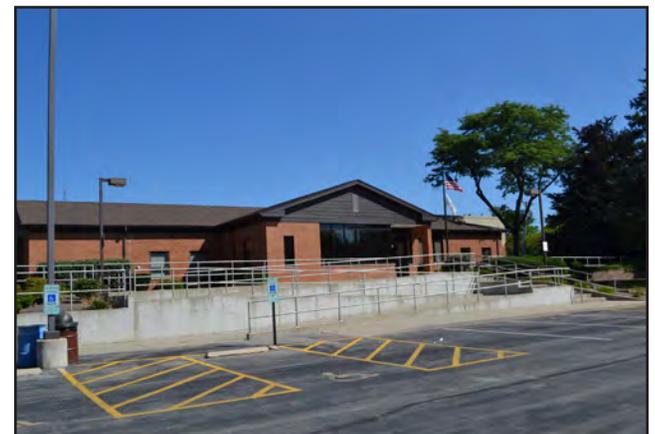
Emmerich Park West

The ball fields are in excellent condition with typical end of season worn areas in the outfield. Protective fencing is in good condition and the spectators have elevated viewing area and covered shelter. The player dugouts are enclosed for safety. Future considerations may include the removal of the arched dome backstop and construction of a high vertical backstop to eliminate foul balls being projected back at the batters box area.

The permanent structures at the ball fields present a sense of quality and pride for the Park District and the users. Scoreboards are in good conditions.

The playground is in good condition and by Landscape Structures. The play structure is located close to the ball fields and seating area.

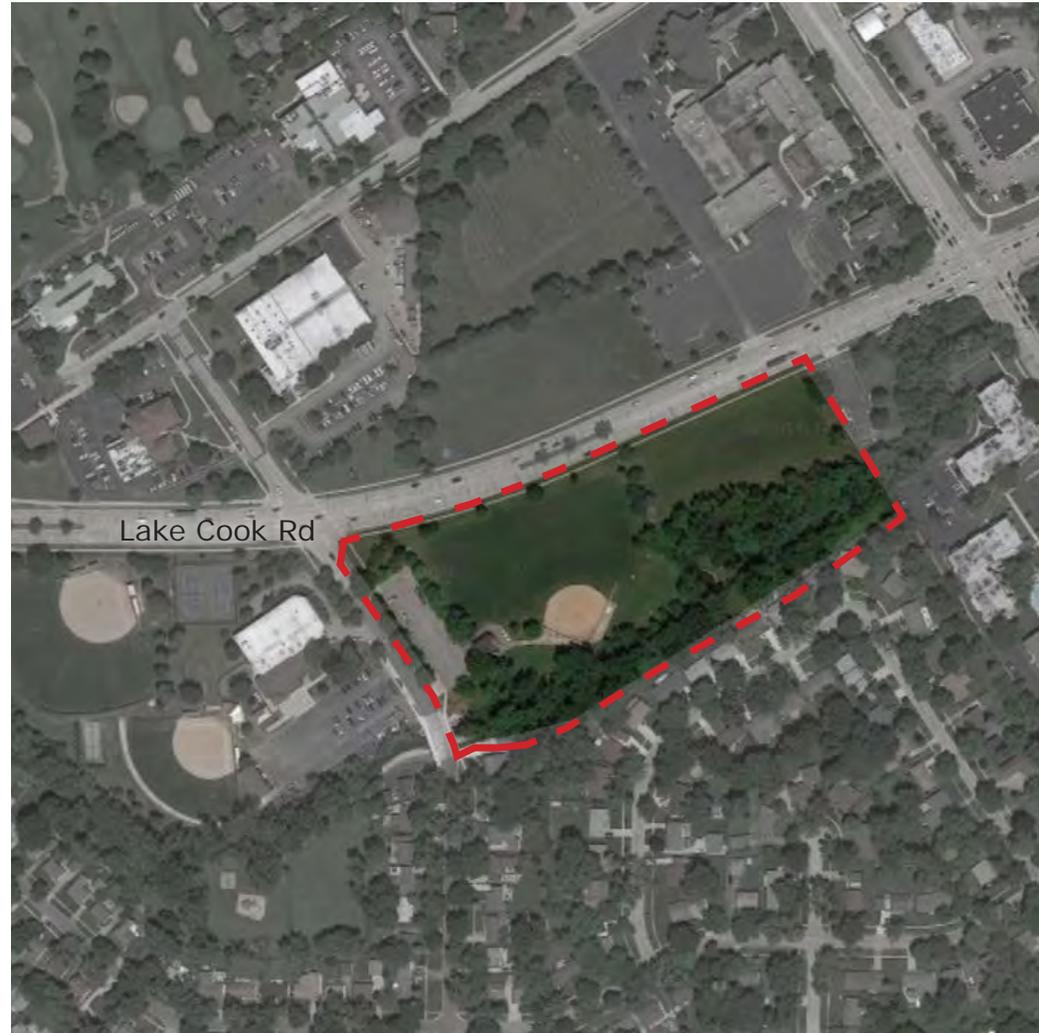
The skinned ball field has had several trees
178 Buffalo Grove Park District Master Plan

removed from the south side and replacement of these trees would be an enhancement. Due to typical field maintenance there is a lip forming at the infield dirt and outfield turf that should be monitored and corrected as needed.

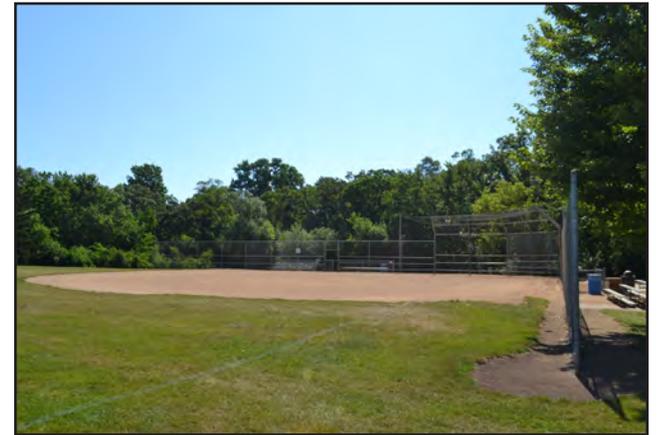
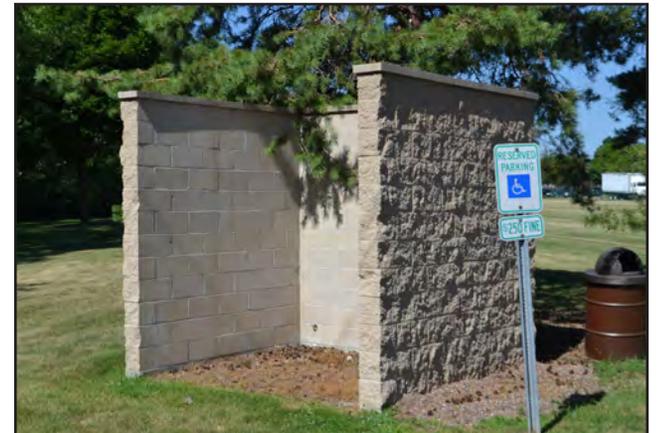
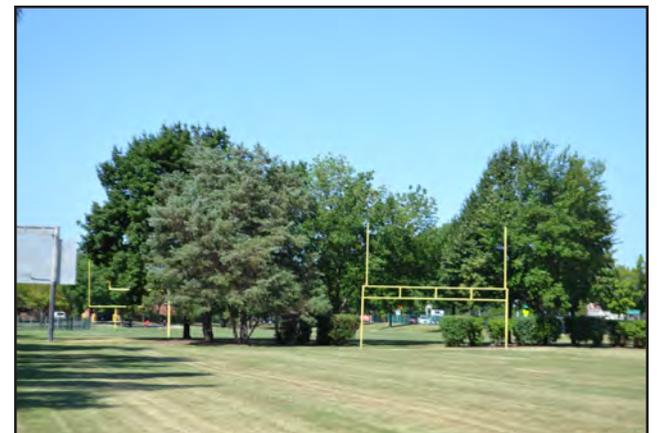
Emmerich Park East is separated from Emmerich Park West by Raupp Blvd. and has its own separate parking lot. There are areas of broken concrete that should be replaced. The park amenities include a dedicated football field, practice football field and one skinned infield ball field with fence at 110 feet.

The primary football field turf is in good condition. The secondary practice field has trees that encroach close to the play area. Buffalo Creek runs along the south side of the park. A tree risk evaluation could be conducted as several trees are noted to have dead and broken limbs. The far eastern end of the football fields has a new pump station constructed and land repairs were being made. Additional parking is available in this area. There is an area of cedar trees between the two football fields that are in poor condition and will most likely need to be removed in the coming years.

An equipment and score keepers box/concession stand is adjacent the ball field. This structure is in generally good condition.

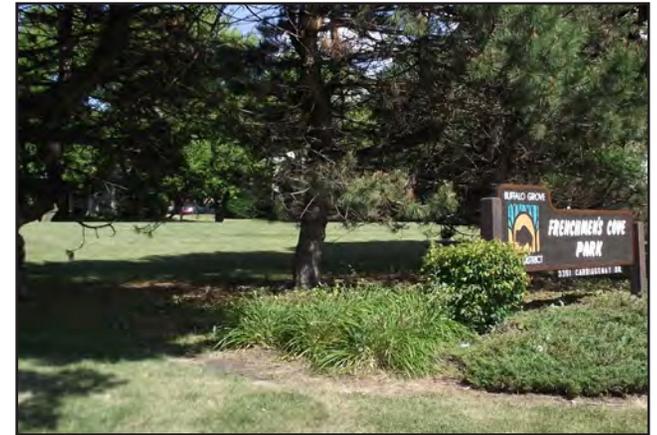
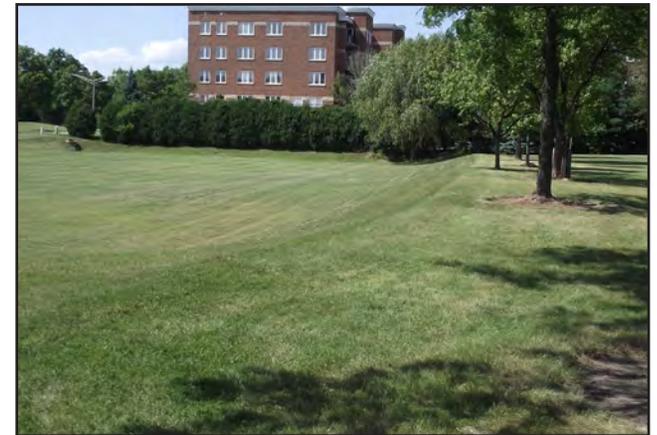
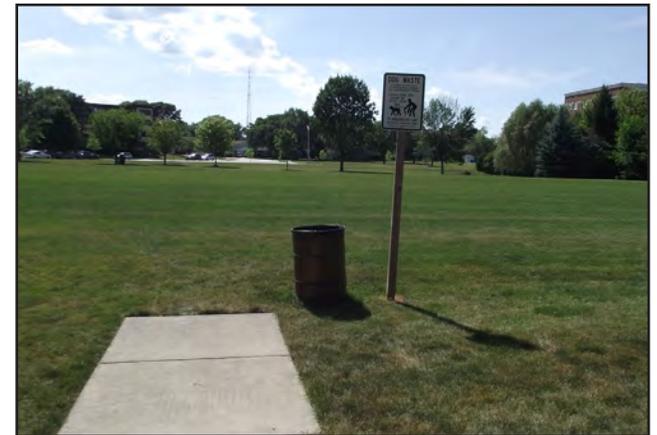
Frenchmens Cove

The park consists of one soccer field. The soccer field is oriented in a north-south direction to minimize the effect of a setting sun on players. The use of this field is by permit only. The field turf is in poor to fair condition. No accessible walks or pathways to provide an accessible route for spectators. Additionally, no designated spectator areas are provided.

The site is boarded by mature trees and vegetation providing a good backdrop to the soccer field and sound buffer to the adjacent residences. Two dead trees need to be removed.

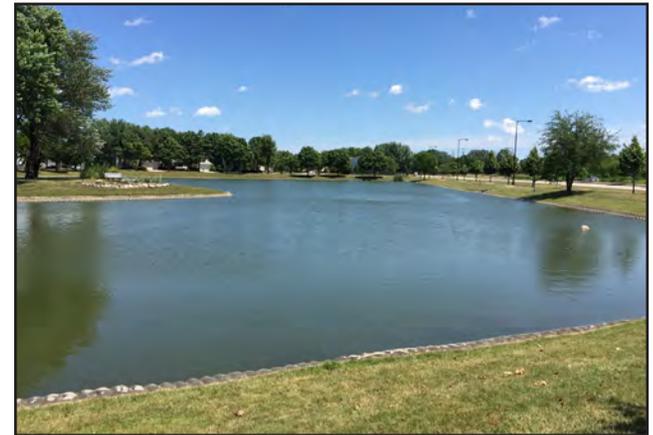
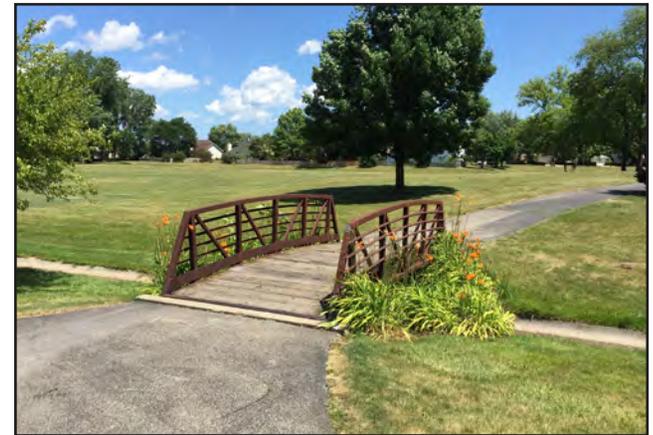
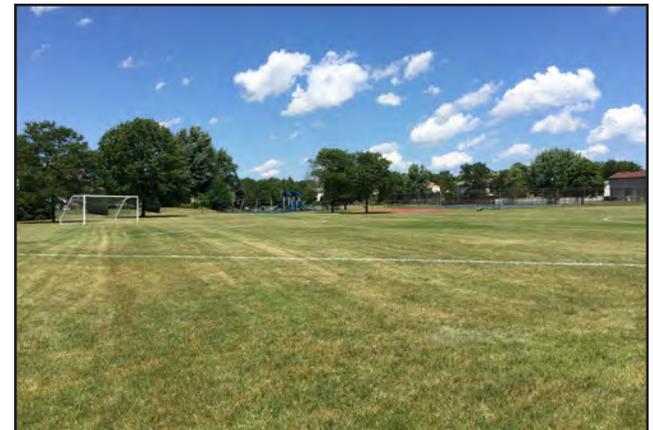
Green Lake Park

The park's front signage is in very good condition. The asphalt paved parking lot appears to be newer and in good condition as well. The retention pond's water line is concrete which provides a very distinct edge. The connecting drainage channel from the north is shaped by concrete as well. Fishing is the

only water activity permitted within this pond. Signage is present prohibiting swimming, boating and ice skating. Picnic table seating is located underneath several mature trees close to the pond which provide shade, comfort, and various unique views of the water and surroundings. There is an asphalt path connection from the parking lot in good condition but there is an older metal receptacle beginning to rust. Various other seating options (picnic tables and benches) are located randomly around the pond but do not have any paved access or base beneath each feature. Additional asphalt paths provide connections

to various surrounding areas as well as to the north for the more active use areas. A metal and wood bridge, in good condition, spans the concrete drainage channel. All remaining paths are in good condition, beginning to show minor cracks and fading.

The ball fields appear to be for recreational/practice use only and the chain link backstop and fencing are in fair condition showing signs of rust. Two spectator bleachers are located behind each dugout and sit on asphalt pavement.

The pavement is in good condition. The practice soccer area is located in the ball field's outfield and the soccer goals' nets and posts are all in good condition. This park features separate playground areas, the first being a multi-age Landscape Structures apparatus in good condition with poured in place rubber surfacing and is enclosed by the asphalt trail. A swing set with poured in place rubber, in good condition, is located nearby. A tot lot for 2-5 year olds is close by and is enclosed by a vinyl coated chain link fence. The equipment and fence are newer and in good condition. Two permanent benches and trash receptacles are provided within the enclosure, all in good condition, but lack shade. The two tennis courts' pavement is in very good condition, while the enclosing chain link fence is only in good condition as it is showing signs of rust. The nets appear to be sagging and need to be reset. The full basketball court is in fair condition due to significant pavement cracking, staining, and fading. The two basketball hoop posts are in fair condition, however both are beginning to rust and are not level. The hoops should be reset or replaced. Two irregularly shaped concrete benches are provided between the tennis and basketball ball courts and are in good condition.

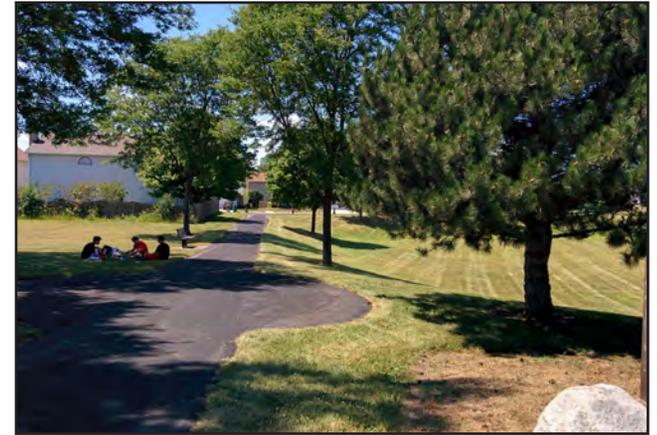
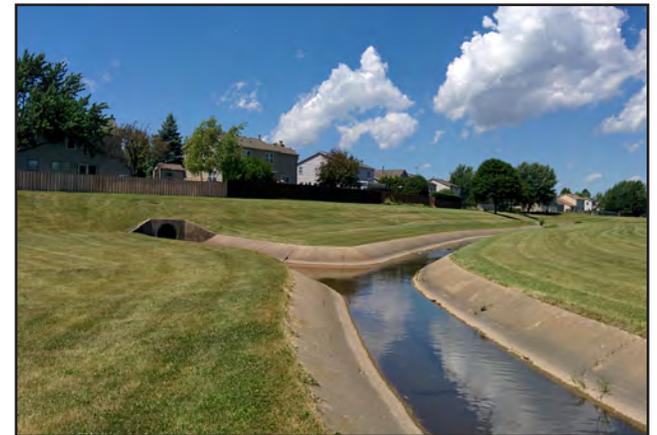
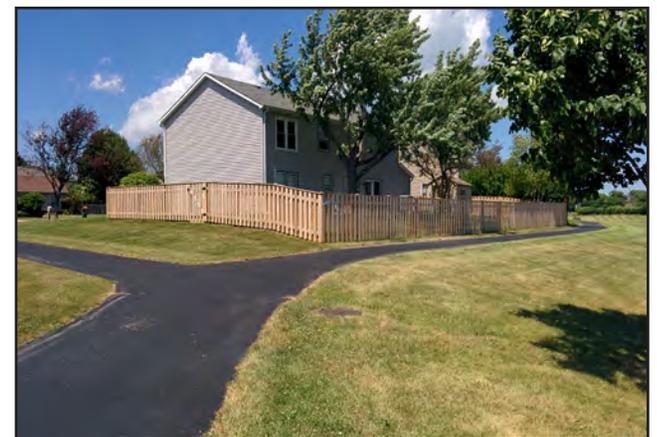
Ivy Hall School and Park

There are no accessible routes to the either the 2-5 or 5-12 play apparatus or the ball diamond. The diamond has a minimal backstop the infield appears abandoned. The poured-in-place rubber surface is in good condition.

The soccer field is sufficient to accommodate up to a U19 size field. The goal mouth areas are in good condition.

Turf is in good condition. General landscaping is fair to good. Trees need mulch rings to improve soil, preserve moisture, and improve mowing efficiency.

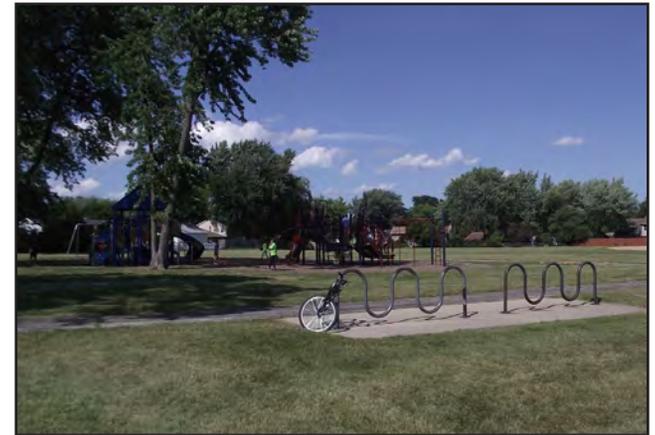
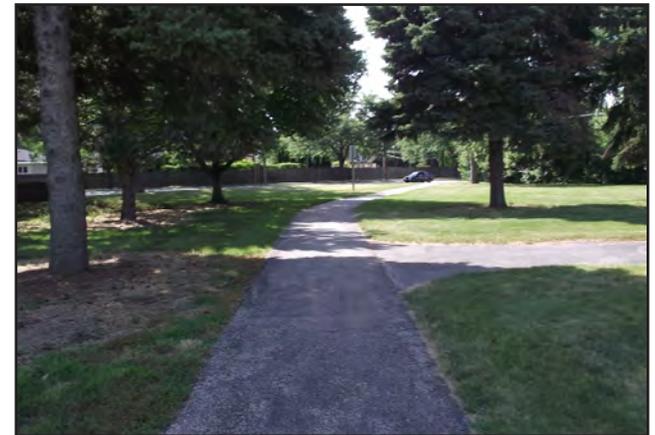
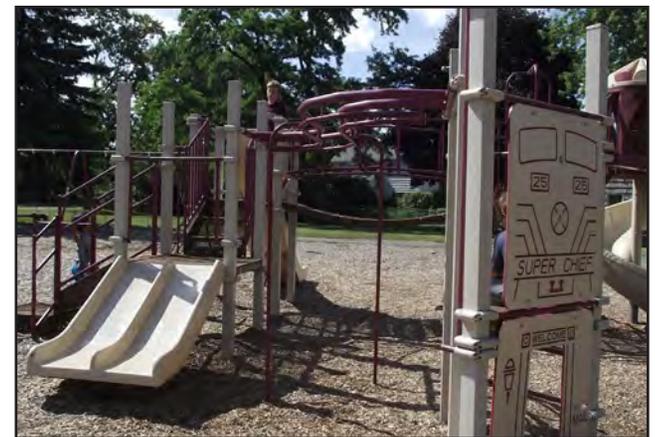
Martha Weiss Park

All the equipment is in good condition. Some of the colors have faded, which is typical of the red play equipment.

The play areas are poured in place rubber surfaces that is in good condition except at the end of the slides, where the surface is beginning to delaminate and peel off.

The turf area is in good condition. The asphalt pathway was recently seal coated.

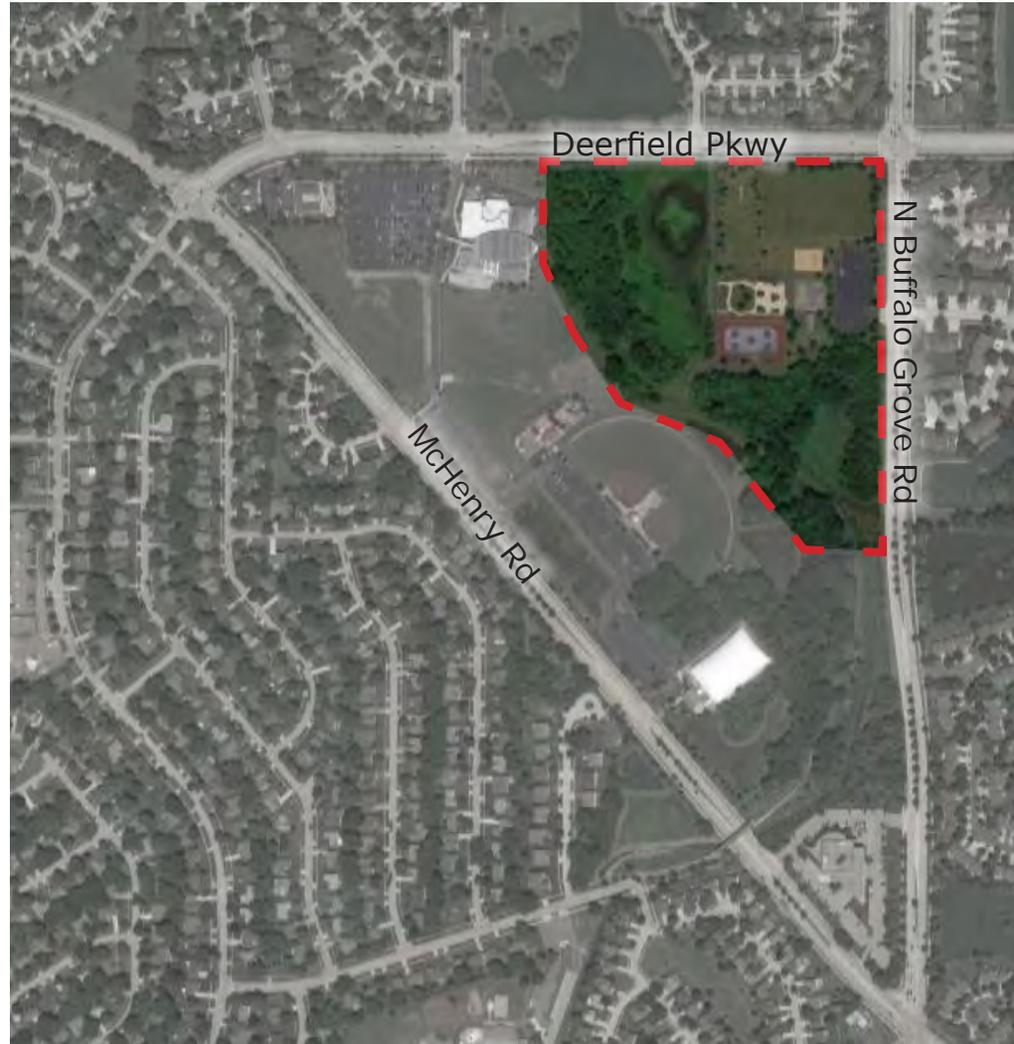
equipment and feature several permanent benches along the routes. The basketball court area is fenced in but has asphalt pavement in fair condition with cracking shown throughout. The basketball hoops themselves appear to be in good condition. The sand volleyball court areas are in good condition with a good amount of sand essential for play but the nets and poles appear to be older and in need of repair/replacement. The non-striped soccer
