BUFFALO
GROVE
PARK
DISTRICT

Comprehensive Master Plan

2017 and Beyond

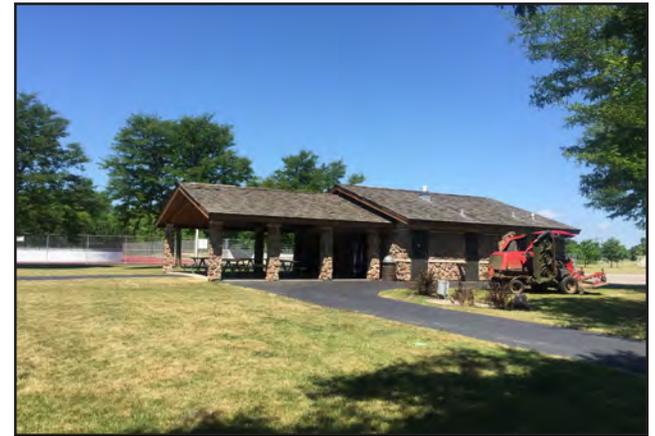
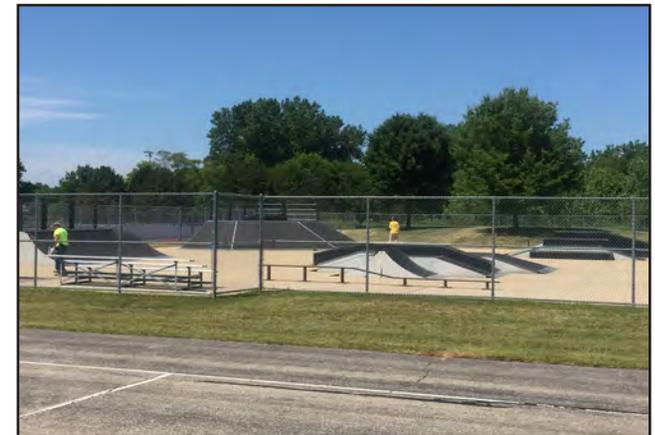
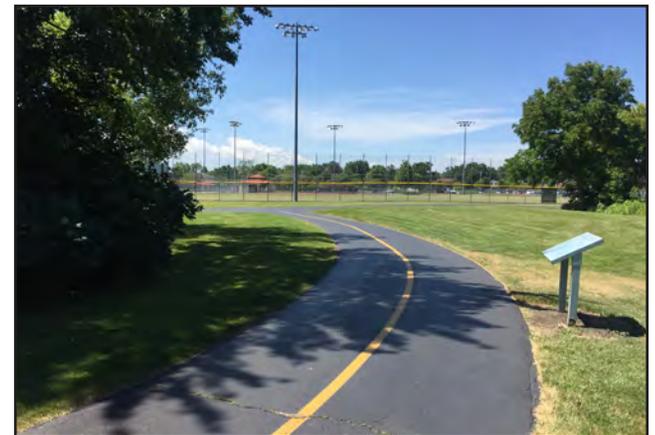
Mike Rylko Community Park

The park's sign at the entrance from Buffalo Grove Road is in poor condition as the graphic has begun to peel away. The large asphalt parking area is in fair condition with several cracks visible throughout. The main asphalt path along Buffalo Grove is wide enough to accommodate two-way bicycle/pedestrian traffic and is in excellent shape with proper striping to designate direction. The route also features wayfinding signage in good condition. The connecting asphalt trails are in good condition, are wide enough to accommodate maintenance

equipment and feature several permanent benches along the routes. The basketball court area is fenced in but has asphalt pavement in fair condition with cracking shown throughout. The basketball hoops themselves appear to be in good condition. The sand volleyball court areas are in good condition with a good amount of sand essential for play but the nets and poles appear to be older and in need of repair/replacement. The non-striped soccer

field is a very large lawn area and looks to be well-drained. The main attractions to this park are the skate and BMX parks as they showed a consistently high usage during the evaluation process. Each is completely enclosed and separated from one another by 10-foot high fencing. The in-line rink for rollerblading and hockey is surrounded by fencing as well and all three areas appear to be in very good condition

The landscaping at this park consists of a variety of mature vegetation along the perimeter of the space. The plant material around the building and other park elements is lacking and in overall fair condition due to lack of visual interest. The turf areas show prominent browning and are in fair condition as well. Existing taller tree groupings and native vegetation serve as a buffer to the surroundings and provide some shade along the asphalt trails. The plant material at the park's entry signage is minimal and in fair condition.

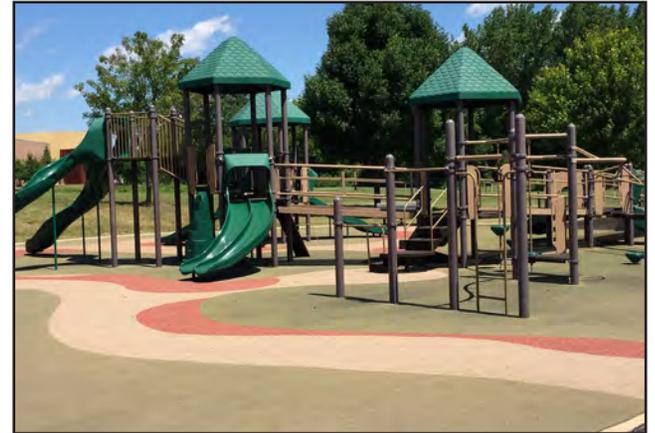
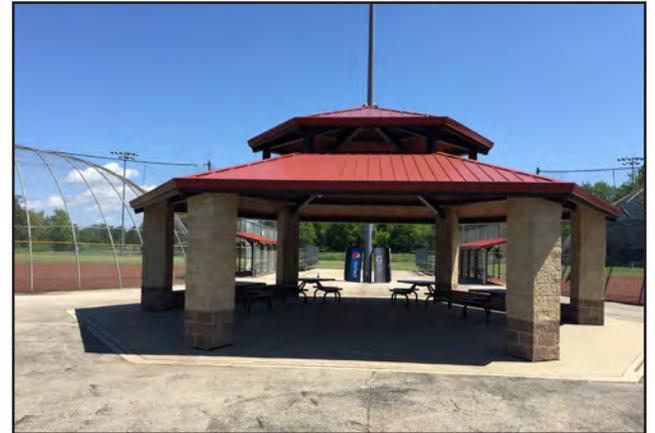
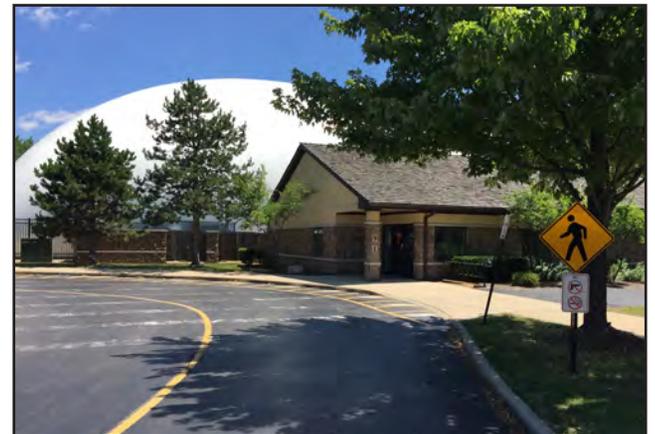
Another portion of the connected parks is the Golf and Sports Center which features a large indoor golf practice facility, two lit softball fields, a newer playground area and a large parking lot for the two activities. The previously mentioned asphalt trail, which is in very good condition, links this portion to the Community Park to the north. The park's sign at the entrance appears to be newer and in excellent condition with surrounding foundation planting below.

The site consists of two specific programs: an indoor golf practice facility and softball. The softball fields feature a covered seating area with room for up to 20 people, vending machines and plenty of bleacher seating. The asphalt paving between the fields and around the shelter appears older and is in fair condition. The fields themselves consist of all dirt infields in excellent condition. The fields have protective backstops, chain link fencing, protective netting and two covered dugouts per field. The outfield fencing also features protective netting and

a digital scoreboard for each field. The parking lot is in overall good condition, with minor cracking, but displays several dirt tracks and piles from maintenance vehicles.

The golf and sports center is bordered by existing forest and native grasses which serve as a buffer between this site and the community park to the north. Two large, raised planters made of concrete blocks are located near the softball fields with several large shrubs planted within. Both planters have large mulch areas that are unplanted mulch

areas around the perimeter. The mulch appears to be very thin and in need of replacement or additional mulch. Aside from that and the existing forested areas, the park exhibits very minimal landscape plantings around the softball fields and golf facility. Signage at the park's entry is in good condition. Tall grasses make up the majority of the large area between the parking lot and McHenry Road and serve as a visual buffer.

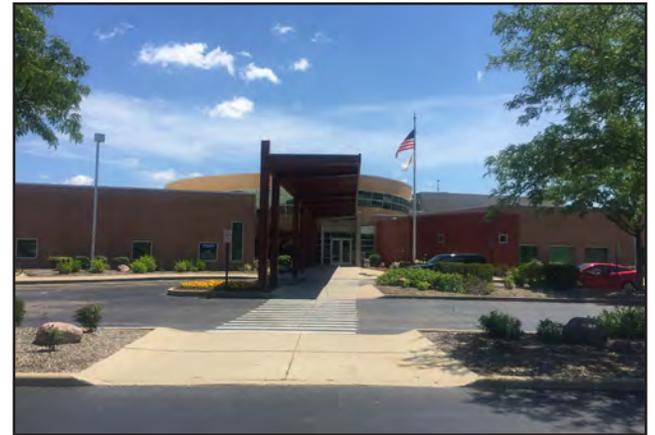
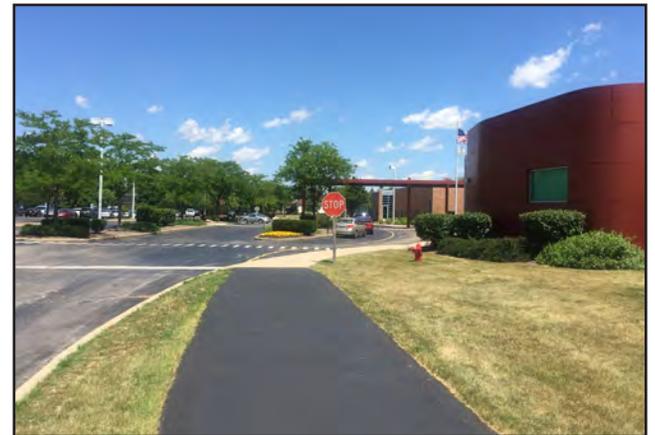
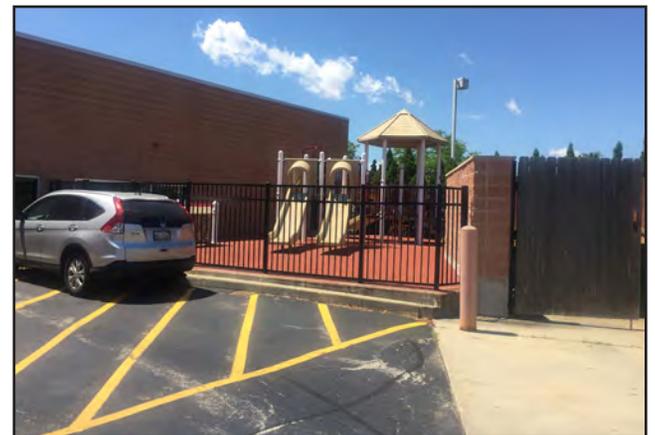
The Fitness Center is located at the northwest portion of the connected parks at the corner of McHenry Road and Deerfield Parkway. The site is a newer looking fitness center with a large parking lot to accommodate high level of use. The fitness center signage is in very good condition but the parking lot as a whole is in fair condition, showing several prominent cracks and is need of repair. The asphalt trail continues to connect this facility to all other parks of this area and is in very good condition. A smaller playground area is visible from the outside but is completely enclosed by ornamental fencing. The only access to the playground appears to be from inside the fitness center. The playground equipment is in good condition.

lot is minimal with very thin layers of mulch at all plant beds. The sparse planting that is here provides very little visual interest and appears to be in generally good condition. The all white light poles and fixtures here look dated and seem out of place.

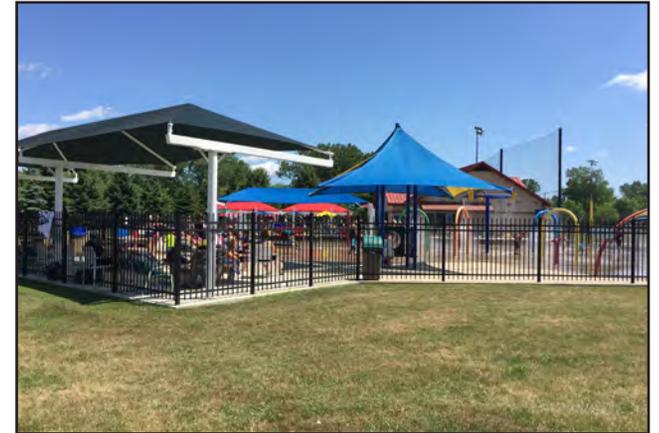
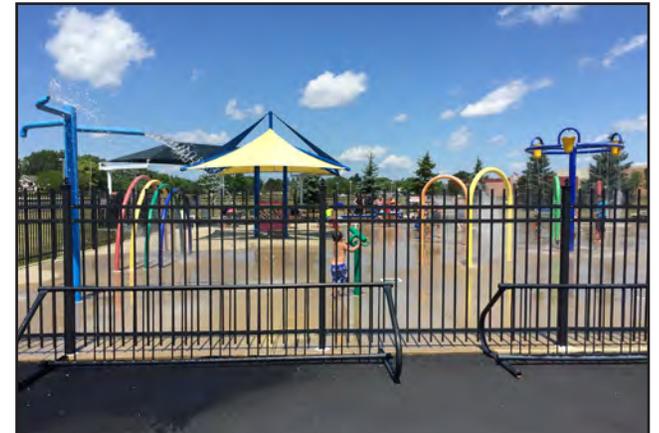
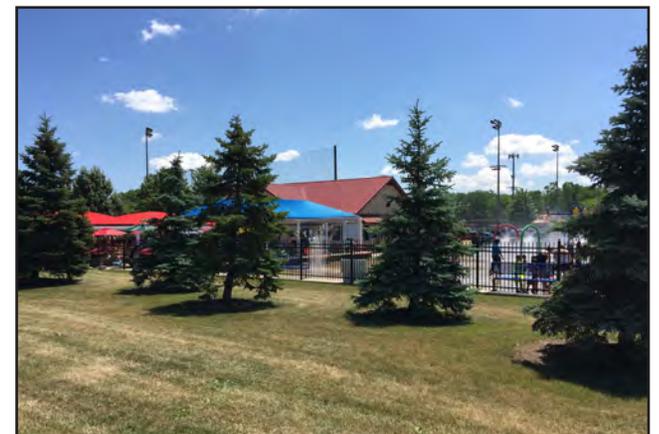
Spray N Play

The Spray 'N Play is a large splash pad west of the Golf and Sports Complex and shares the large parking lot along McHenry Road. The Spray 'N Play is entirely enclosed by 6 foot tall black ornamental fence with alternating evergreen plantings on the exterior which serves as a visual buffer. The water play equipment all looks to be newer and in very good condition. The main entry for the Spray 'N Play is through a clubhouse adjacent to the parking lot with concessions and locker/changing rooms on the inside. Public restrooms, drinking fountains and vending machines are accessible from outside of the gates.

A large playground for various age groups is located between the clubhouse and softball fields to the east. The playground equipment appears to be newer and in excellent condition. Poured in place rubber surfacing with concrete edging for all play equipment is in excellent condition. Plant material around the area is very minimal. A large open turf area separates the Spray 'N Play facility

from the Fitness Center to the west, with most of the turf areas at this location beginning to brown.

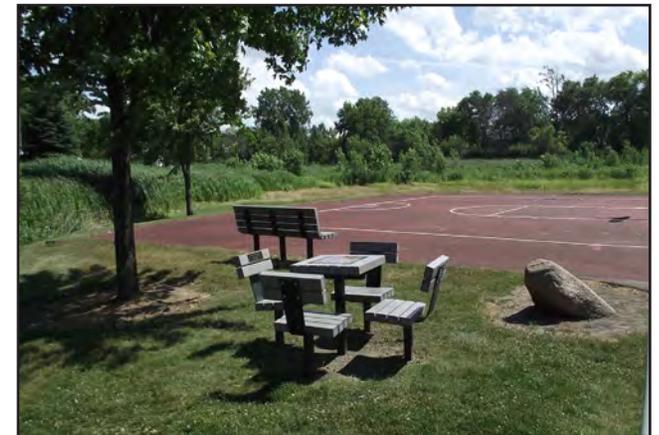
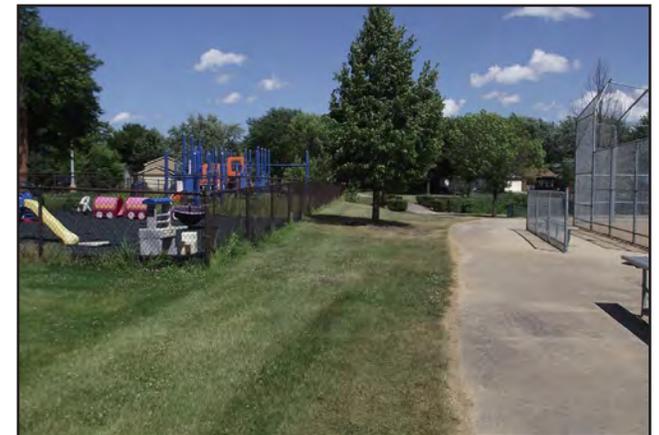
Mill Creek Park

The playground area includes an accessible composite play structure and independent spring toys. The apparatus itself appears to have been installed more than 15 years ago, exceeding its useful life with evidence of fading and peeling of the finish. The woodchips of the playground are contained by a concrete barrier curb which is in good condition. The woodchips are weed-free and at an adequate safety depth, though they have lost resiliency and feel very firm. The adjacent turf elevation should equal the top of the curb elevation.

The basketball court appears to be in poor condition and in need of replacement. There is evidence of cracking on the court surface and the color coat has lost its vibrancy. The basketball standards appear to be in fair condition.

The ball field is located north and west of the site. The ball field layout configuration does not face optimal orientation but is installed in the most space-efficient way possible given the existing site constraints and appears to be properly sized for the intended use. It is important to note, the outfield area of the ball field is adjacent to Arlington Heights Road. The ball field has a very short Right Field. Spectator bleachers appear in good condition, and accessible by the paved pathway that runs

east and west through the site. Generally the outfield turf is good. The ball field fencing and backstops are in fair to good condition.

The parks entry walk is in need of repair – the site’s main access is a paved surface area flanked by ornamental iron fencing with pickets over a water channel. Some erosion has occurred along the banks and in need of repair.

The landscaping is in good condition and has been maintained very well. There is one dead tree in need of replacement.

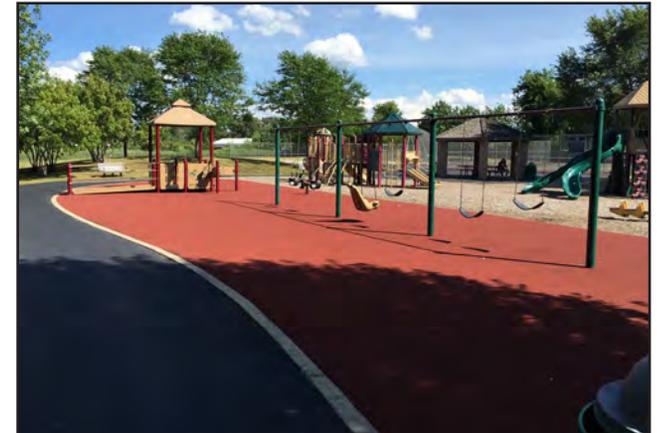
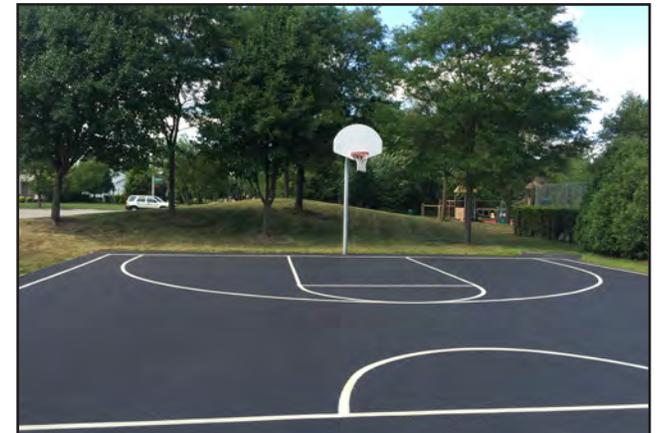
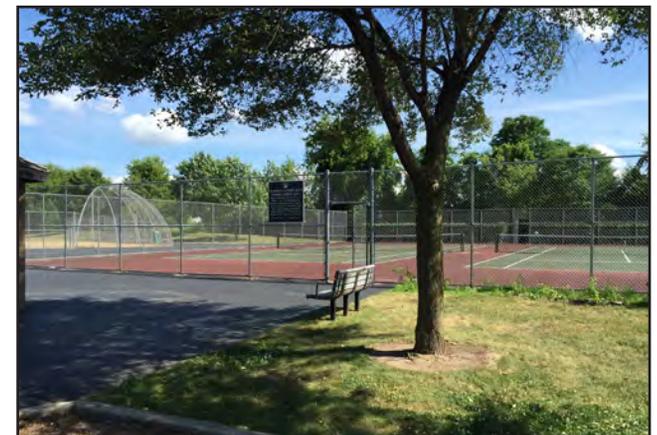
Mirielle Park

The sign at the park's main entrance from the parking area is painted wood and is in good condition. The asphalt parking lot and paths within the park all appear to be the same age and in very good condition with minimal fading and cracking present. The paths are wide enough for multi-use, pedestrian and bicycle traffic, and to accommodate maintenance vehicles. Several permanent benches are located along the asphalt path and all appear to be in good condition. A concrete walkway that runs along the back of the parking lot curb connects to the surrounding neighborhood's sidewalks is in good condition as well. The sheltered picnic area in

the middle of the park has seating for up to 16 people with checkerboards permanently attached to each picnic table, two per table. The playground area consists of two separate areas, one for school age and one for pre-school age. The pre-school age equipment has poured in place rubber surfacing below while the school age equipment's surfacing is mulch. All equipment is by Landscape Structures and appears to be in very good condition. Two tennis courts are located south of the sheltered picnic area. The courts are enclosed by chain link fencing and all nets, posts, fencing and court

surfacing are in good condition overall. The ballfields located east of the tennis courts are presumably for recreational use only as the chain link fencing and backstop appear older but in good condition. A small chain link fence acts as the outfield wall and provides a clear boundary for the park's eastern border. Small metal spectator bleachers are located behind each dugout and are in good condition. One basketball half court is located west of the tennis courts and all elements here,

hoop, surfacing and striping are in very good condition.

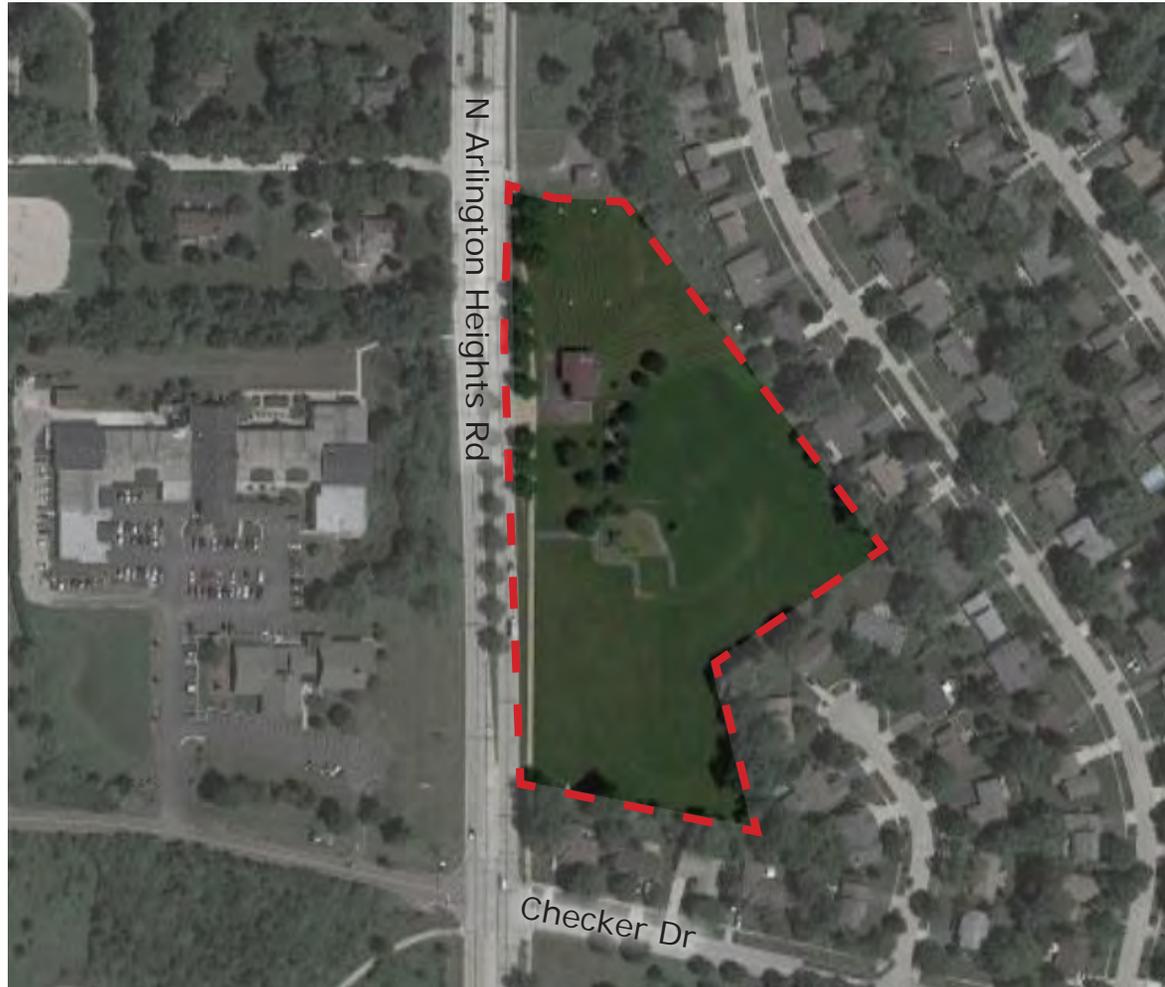
Existing plantings and landscaping of area between road and park area are overgrown and in need of renovation. Some plantings are dead and should be replaced.

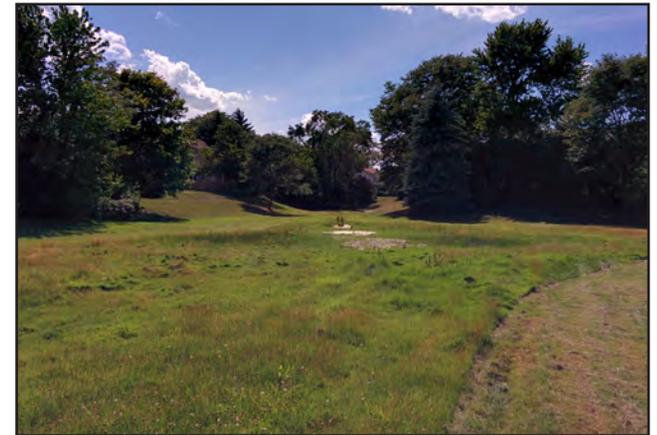
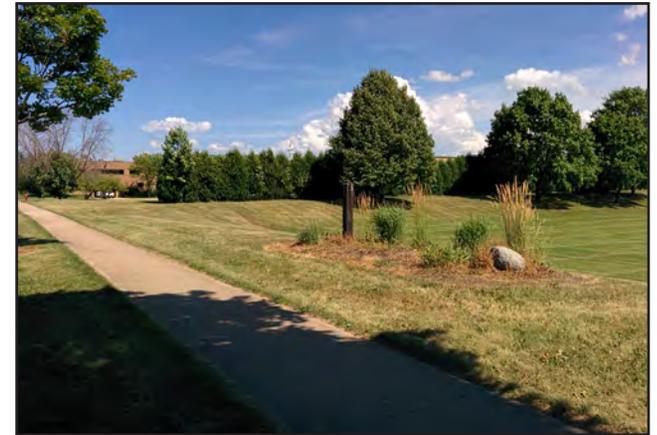
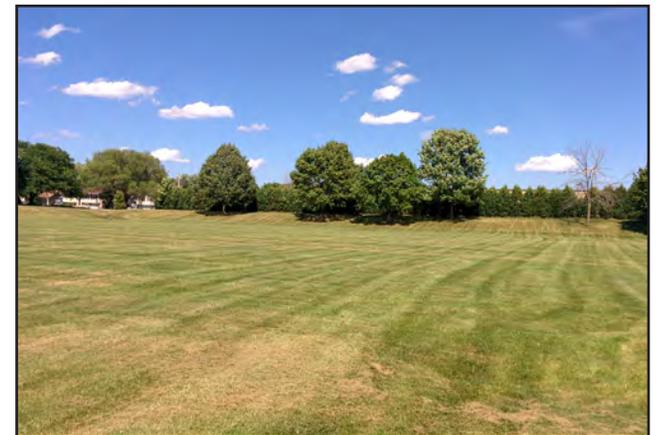
Northwood Park

Northwood Park/ Detention is a 3.29 acre open space located at 615 Pauline Ave. The park also has frontage on Horatio Boulevard to the west. There are no amenities; the park consists solely of a turf bottomed detention basin. Sidewalks along both street frontages provide access from the neighborhood. The turf is in good condition even in the wettest areas. Landscaping consists of shade trees and evergreens that are in good health. The park sign is missing; only a single post remains. The sign landscape bed has few plantings and is weedy.

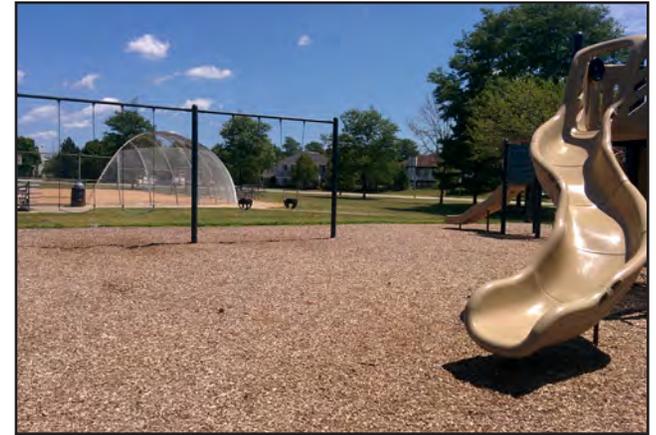
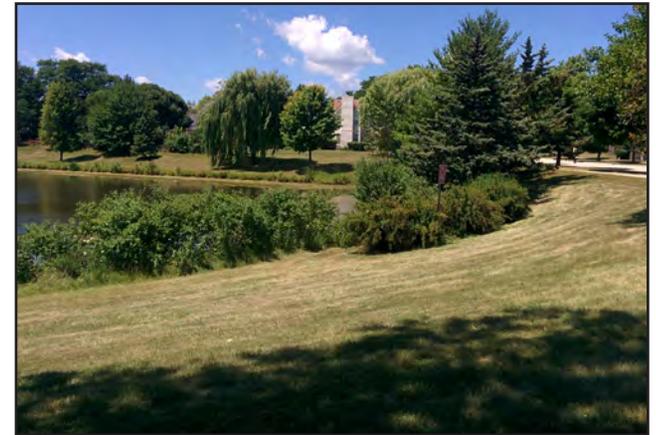
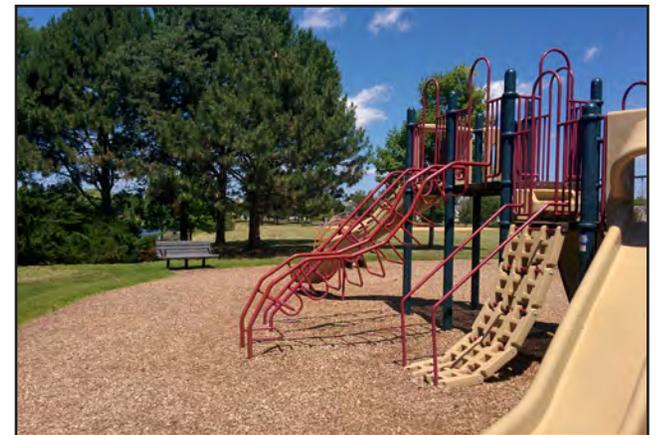
Old Farm Park

The playground is in fair to good condition. The woodchip surface appears to be of adequate depth but there is no edge containment. The turf edges are undefined in areas and encroaching into the woodchips. The play equipment consists of a composite structure for 5 to 12 year olds, a swingset with two belt and two bucket swings, and a unique seesaw. All equipment is free of major defects and is in good condition. Some colors have faded and the seesaw footpads are worn. There are two benches in fair condition along the edge of the play area. There

are no walkways to the benches.

The ballfields are in overall fair condition. The fences are fair to good with little heaving or warping but all components have minor to moderate rust. Both fields have good infields; the mix is level and stable though the turf margins are uneven in areas most notably along the foul line fences. The asphalt path

around the south field is undermined and failing around the backstop. The south field has minor weed growth along the fences and backstop while the north field has moderate weed growth. Erosion of infield mix is a concern at both fields. The south field has a moderate amount of transfer across the first base dugout and bleacher pad. The

north field has a significant amount across the first base dugout and bleacher pad as well as moderate amounts on the third base side and behind the backstop. The infield mix is built up significantly inside the backstop to maintain level; this contributes to the transfer of material off the field. The aluminum player benches and bleachers are in good condition at both fields.

Site furnishings include litter receptacles, a picnic table, a portable toilet, and benches. The litter receptacles are steel drums; around the playground and south ball field they have domed lids and at the north field they have no lids. The playground benches are recycled plastic and in fair condition. There is also a single backless, recycled plastic bench overlooking the pond. There is no path to this bench. The single aluminum picnic table is in good condition. The portable toilet is highly visible at the main south entrance, there is no fence or landscaping for screening.

Overall maintenance is good. The turf is in very good condition with no areas of thinning and very few weeds. Landscaping is primarily shade trees with some large beds of evergreen shrubs. Tree and shrub health is good except for some ash trees in need of removal and some overgrown areas along the pond. The park sign does not match the district standard but it is in

good condition. The mulch bed around the sign is mostly bare.

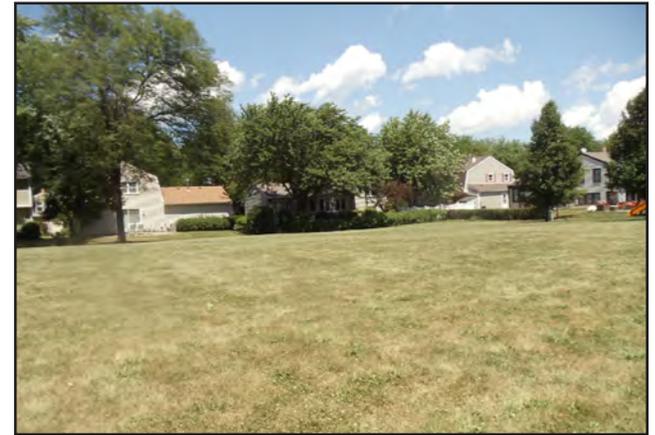
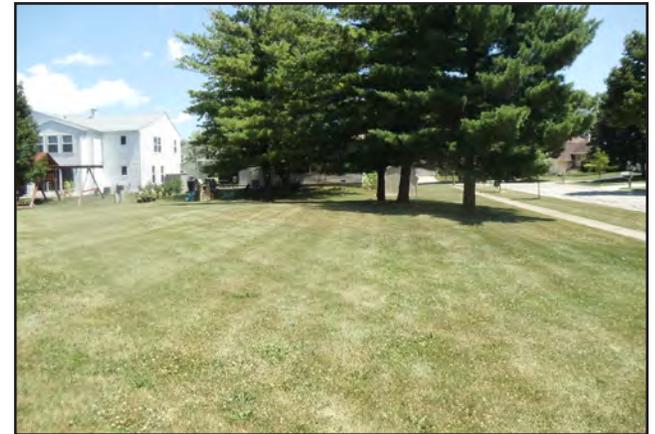
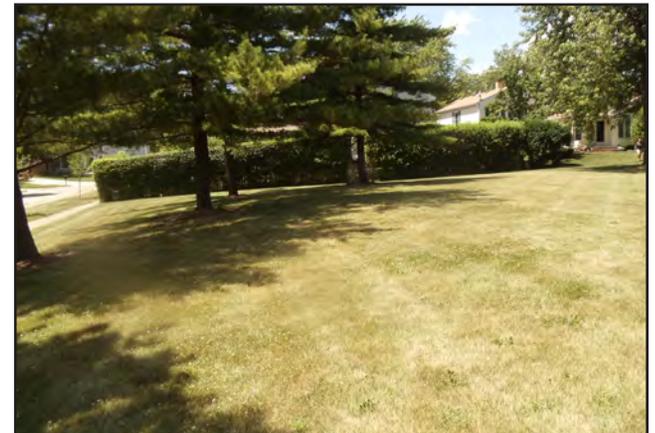
Oxford Park is a 1-acre neighborhood park located at 1450 Oxford Drive. The site is surrounded on three sides by single family residences with street frontage along Oxford Drive. There are no facilities or amenities at this park. The park has no identifying signage. The neighborhood has access to Bicentennial Jaycees Park to the south via a walk/path from Oxford Drive to Thompson Boulevard to public sidewalk along Logsdon Lane. The site has several mature trees and the turf is in good condition.

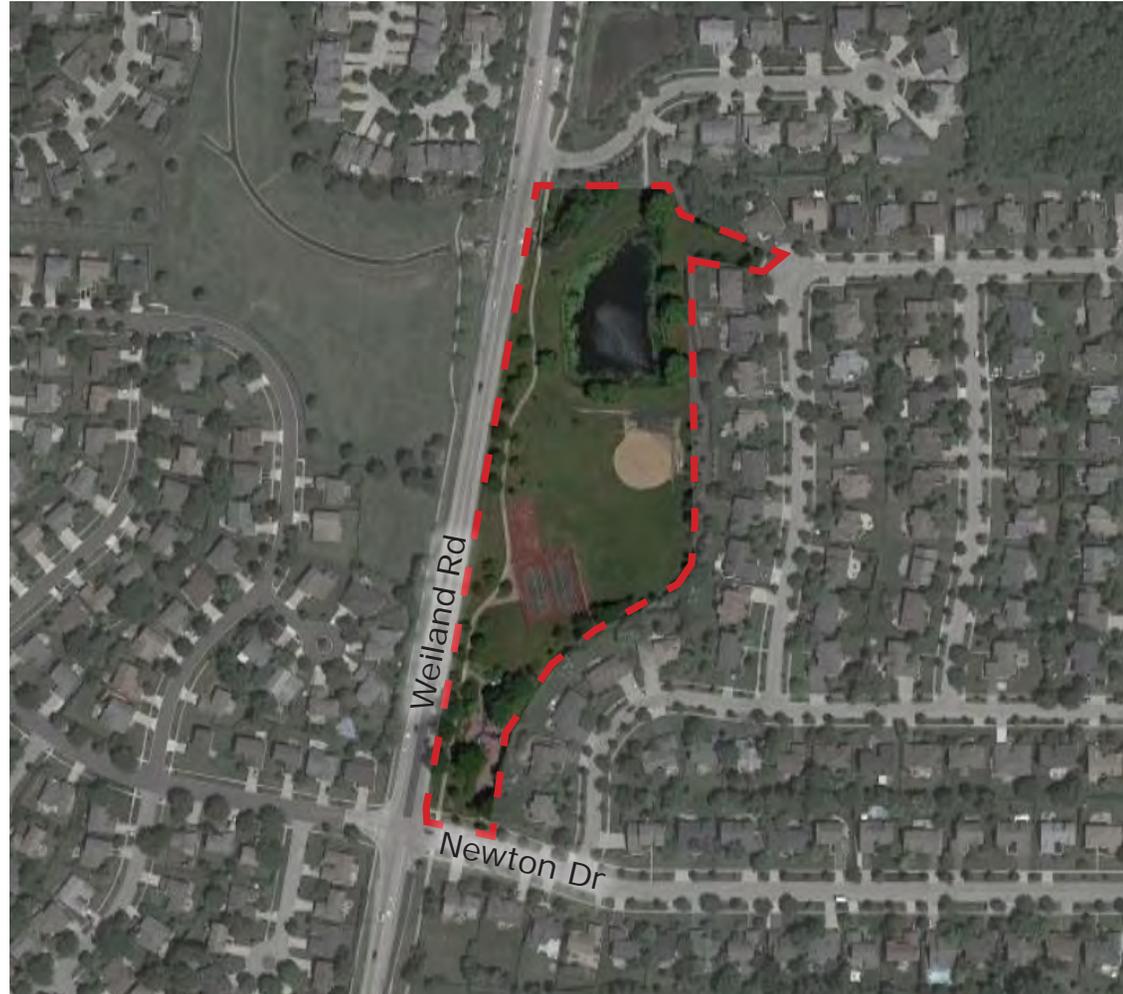
The basketball courts are in fair condition. Major surface cracks have been repaired. The color coating is fair to poor; it is peeling in several locations. The surface does not appear to drain adequately based on the large areas of staining. The basketball standards are in good condition.

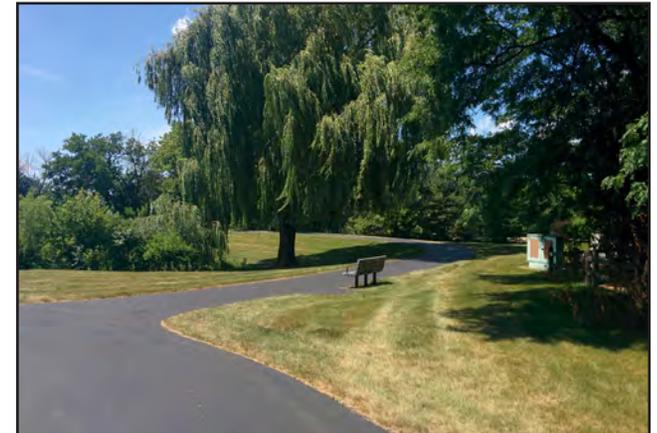
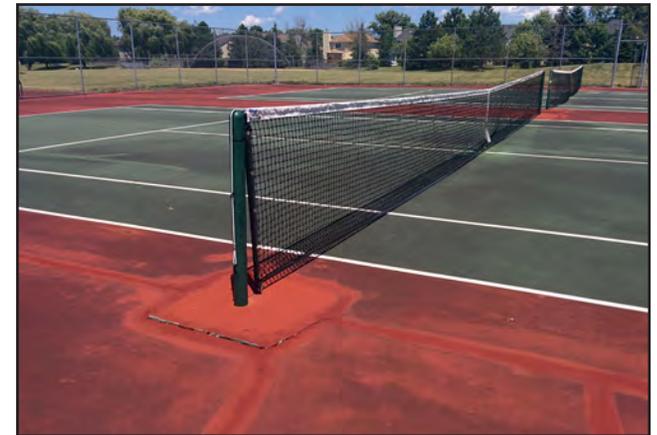
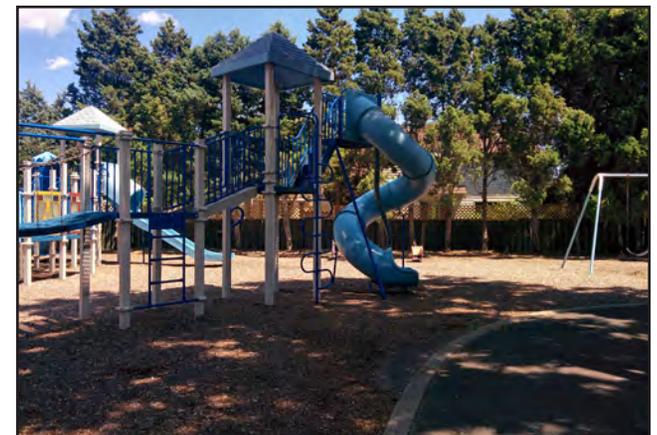
Parkchester Park

The ball field is in overall good condition. The fences and backstop are in good condition with little rust and little warping of fabric. The posts have a minor amount of heaving and the rails are generally level. The infield mix is fair. The surface is generally consistent except for some areas of erosion outside the baselines. Along the first base side the erosion has concentrated into a small channel. At the third base dugout, infield material has been transferred into the dugout and bleacher area. The unfinished aluminum player benches and bleachers are in good condition.

The tennis courts are in fair to good condition overall. The fence has little rust. Post heaving is minor, though some posts are leaning. The rails

are generally level and the fabric is free of warping and breakage. The surface is fair to good. There are major cracks that have been repaired and the color coat is free of peeling, however most of the court is stained. The nets and post finish are in good condition, though the post footings have heaved.

group, though some elements could be used by younger children. Overall the playground is in good condition. The woodchip loosefill surfacing appears to be of an adequate depth and had reasonable ‘give’. The apparatus appears to be more than 10 years old and, besides some fading, is in very good condition. Much of the apparatus is universally accessible by means of ramps. The swing set has four belt swings and two bucket swings. The finish is very faded and there is some rust on the chains.

Other site furnishings include picnic tables, litter receptacles, and benches. The benches are recycled plastic and are generally in good condition. The litter receptacles are steel drums with domed lids. There is no litter receptacle at the ball field, basketball court, or fishing pond.

Overall maintenance is good throughout the park. The turf is well kept and mostly free of weeds. Landscaping is fair, there is a good variety of trees, but the landscape beds around the playground and park sign are bare.

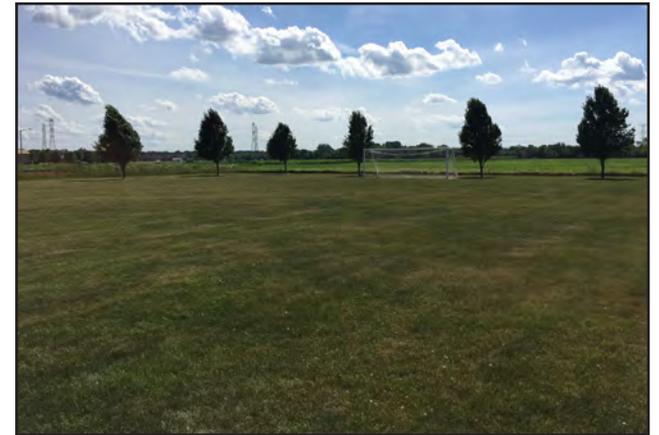
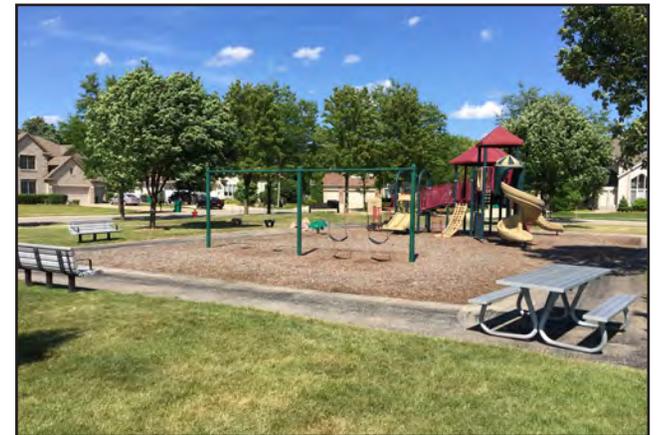
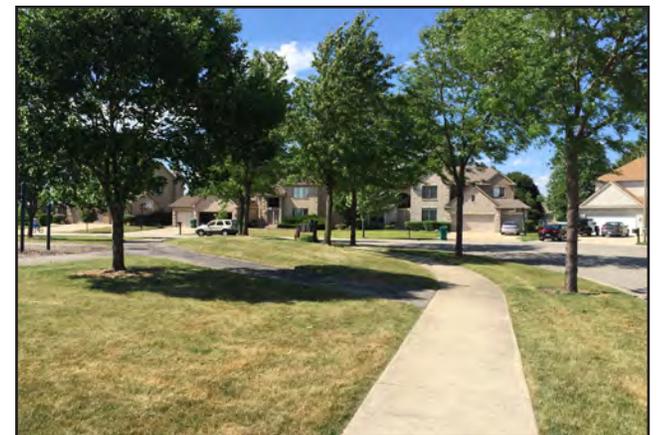
The painted wood sign at the north east corner of the park is in good condition. The playground equipment by Landscape Structures appears to be older but are in good condition as well. The hardwood mulch play surface looks to be lacking and worn down. Additional mulch may be needed to provide a more resilient surface for a play area. The three permanent benches near the playground area appear to be older and are in good condition. There is also one moveable picnic table in the area as well. The benches and picnic table all lack shade from overhead structures or any nearby trees. The asphalt path that surrounds the playground area and connects to the outer sidewalk is older, is beginning

to fade and is in fair condition with minimal cracking beginning to show. Two older litter receptacles are provided at the park, one near the entry and one at the playground area. The remaining area of the park consists of open lawn with one soccer net, in good condition, provided for practice.

are planted along the west, south and part of the eastern borders, with mature deciduous trees along the north border, around the playground area and the main entry at the northeast corner park. All trees look to be in very good condition, but lower level plantings are nearly non-existent. The turf areas of the park are all in very good condition and appear to be well drained.

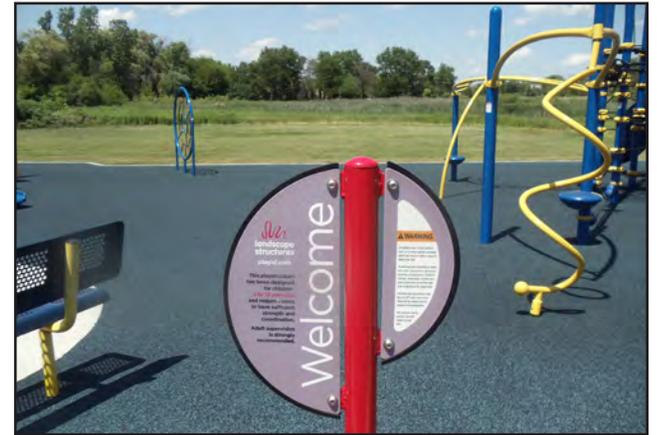
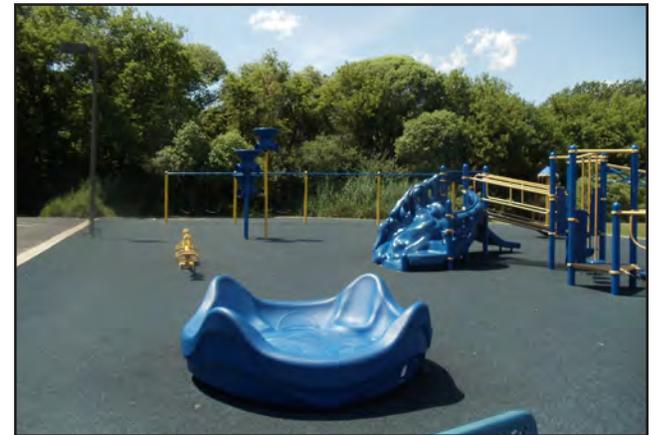
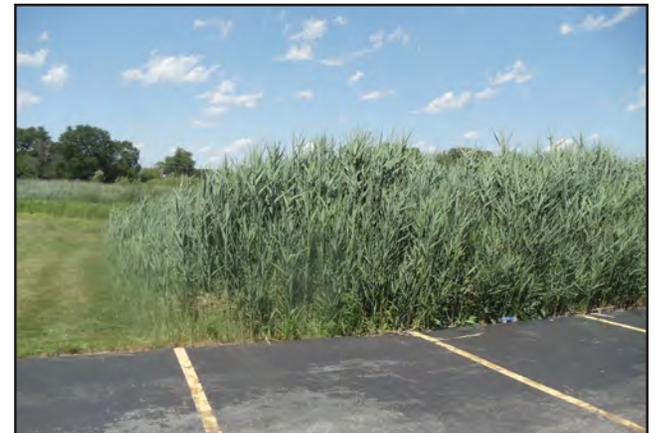
Prairie School and Park

The park in conjunction with Prairie School has play equipment for 5-12 age children. The equipment is in good condition. The play surface is a poured in place rubber surface that is in good condition. In addition to the play apparatus there is a large 18,000 square foot asphalt play space striped with multiple court games and two basketball goals.

The curb appeal is below average as there is no Buffalo Grove Park District marquee signage as well as the extensive landscaping effectively hides the elementary school building.

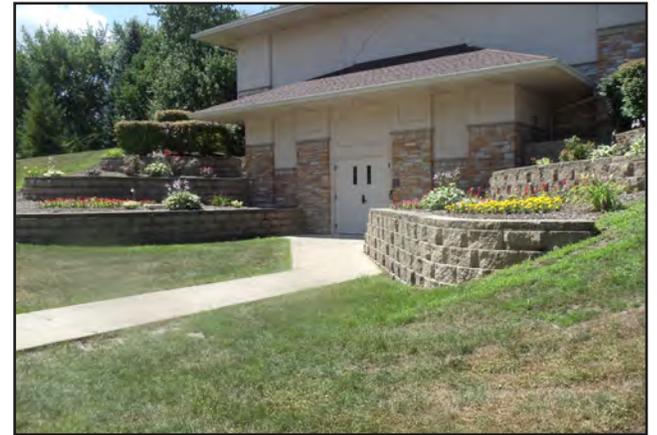
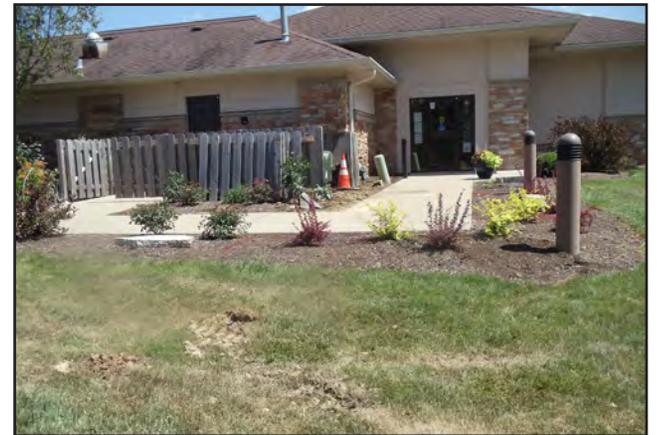
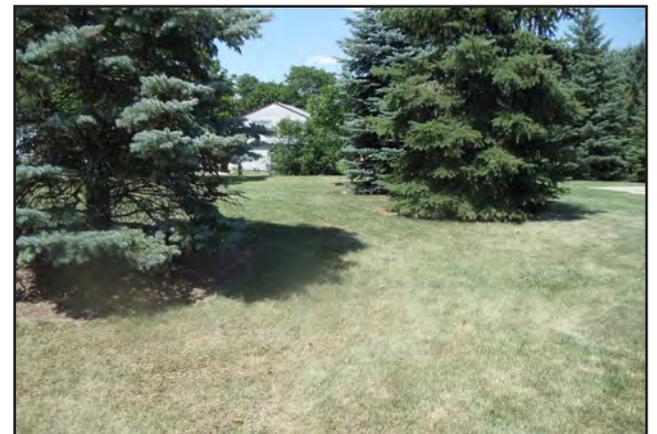
Raupp Memorial Museum and Park

Turf and landscape plantings are in good condition. Areas under the pines and heavy tree cover to the east (right) of the entry drive are being shaded out causing a thin, weak stand of turf.

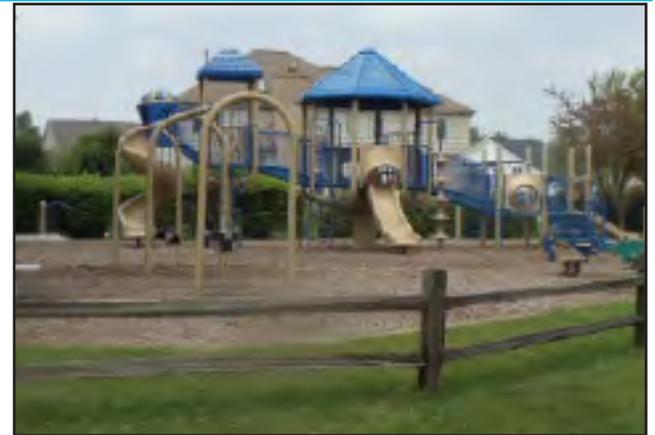
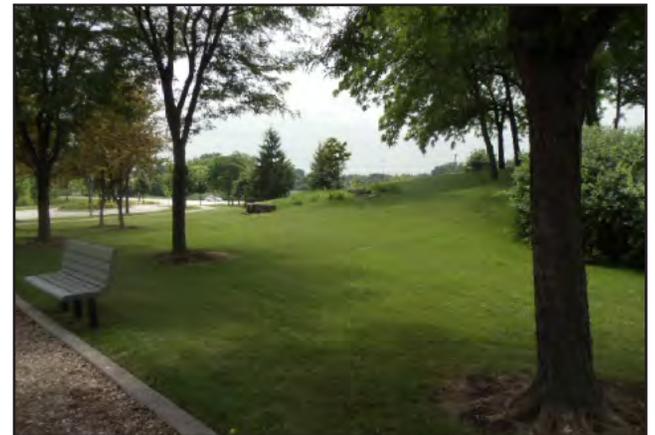
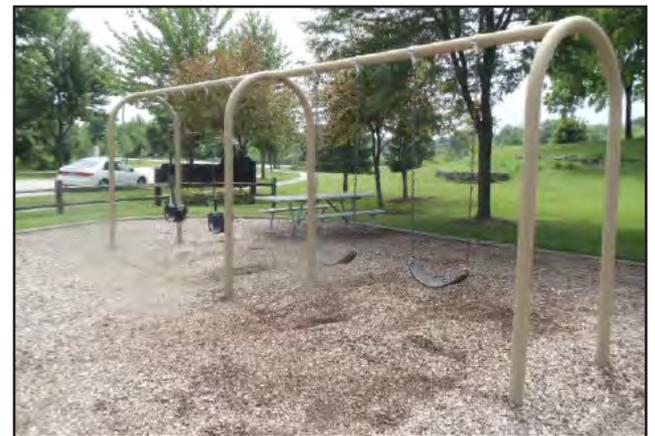
Rolling Hills Park

The turf is fair to good, there are some areas that are dominated by broadleaf weeds. The two rail fence provides reasonable separation between the play area and the public street. The fence posts show significant signs of deterioration from string trimmer damage. Landscaping is good and appears well maintained. Some planting beds could be “edged” to improve transition from woodchips to turf. Benches adjacent to play surface are accessible from the play area but not wheelchair accessible.

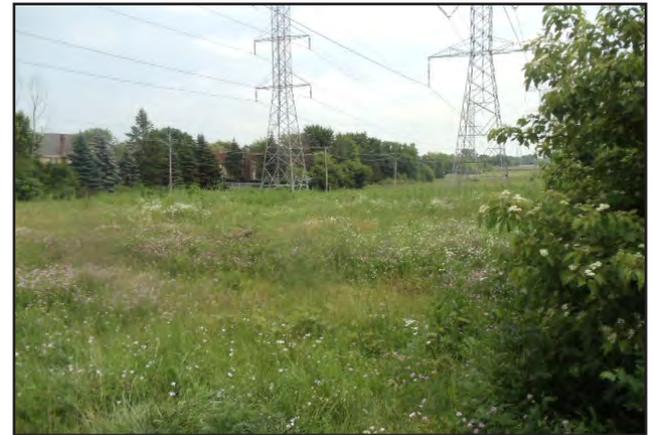
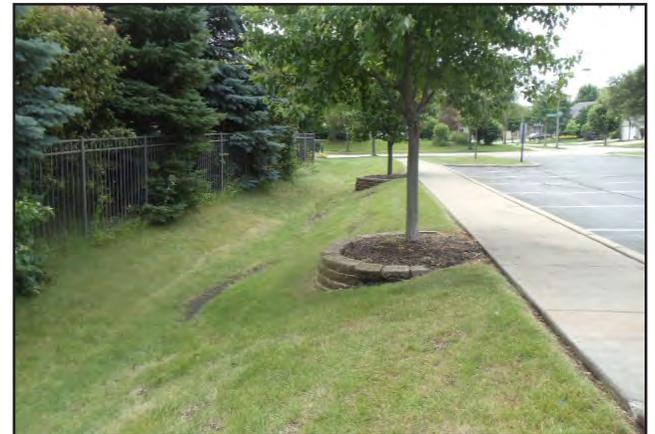
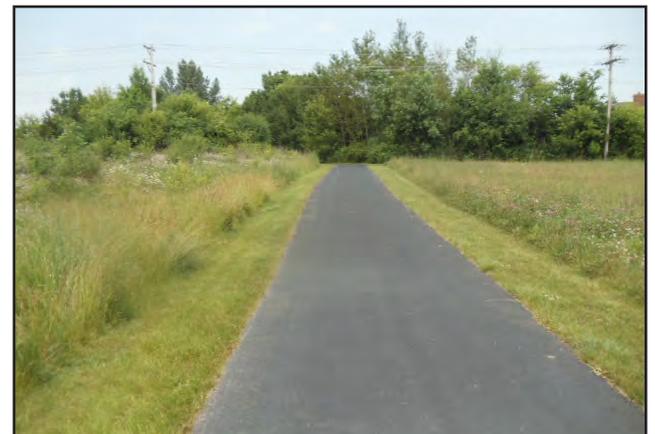
Rolling Hills Park North

Curb appeal is below average.

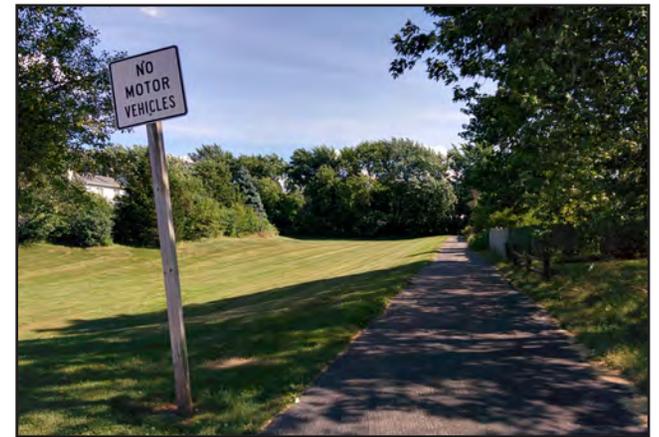
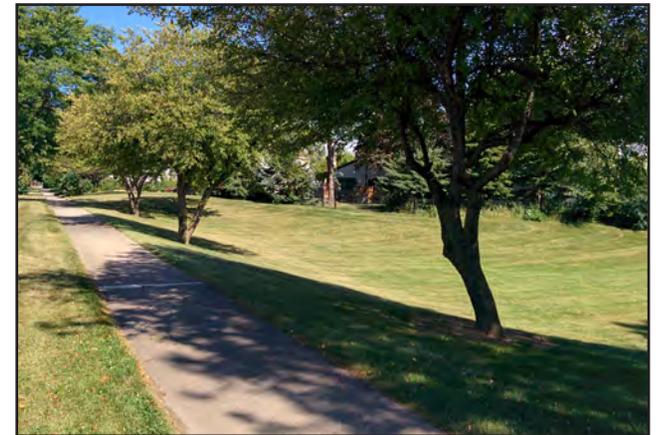
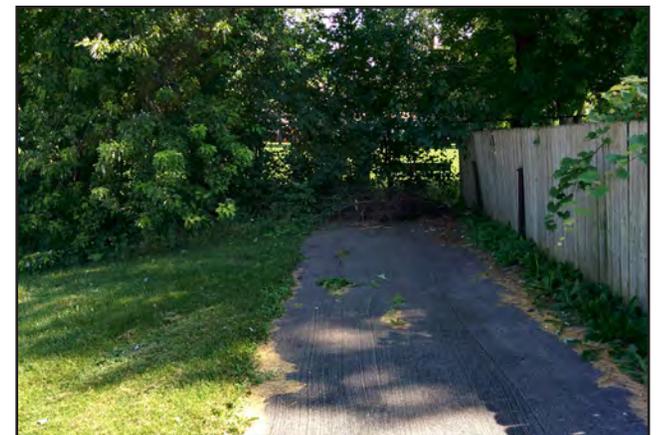
Sommerset Detention

The only amenity on site is a spur of the regional trail system. The spur is a dead end and only provides access to the homes that back up to it. The turf is in good condition. Landscaping consists of a mix of shade, evergreen, and understory trees along the property lines and ornamental trees along the street. There is no park sign.

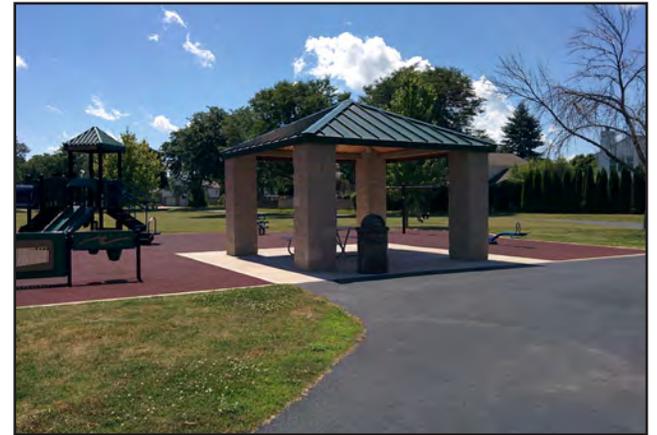
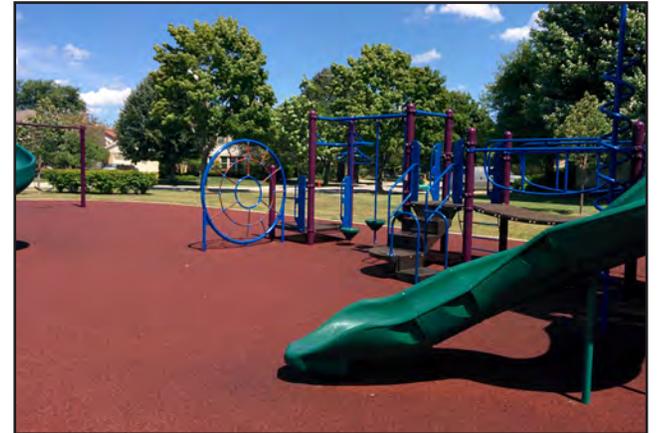
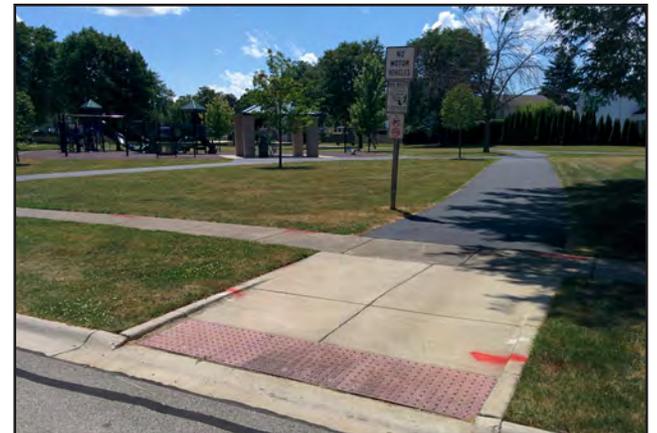
Tartan Park

The playground is new and in excellent condition. The rubber surface is resilient and has not faded or discolored. The apparatus serves both the 2 to 5 and 5 to 12 age groups with two main structures and several free standing pieces. All equipment is in excellent condition.

The shelter is new and in excellent condition. The concrete masonry unit columns are free of cracks and chipping and the roof components have no loose pieces. The concrete surface has not cracked, chipped, or discolored.

The bike paths run through the park and behind homes with spurs to each bordering street. The surface is in very good condition with little cracking and stable edges.

is good with consistent growth, though there are more weeds than at most other parks. Landscaping consists of shade trees and a bed around the park sign. The bed is unplanted in front of the sign and weedy. The trees are in good condition except for a couple of dead ash trees.
