BUFFALO
GROVE
PARK
DISTRICT

Comprehensive Master Plan

2017 and Beyond

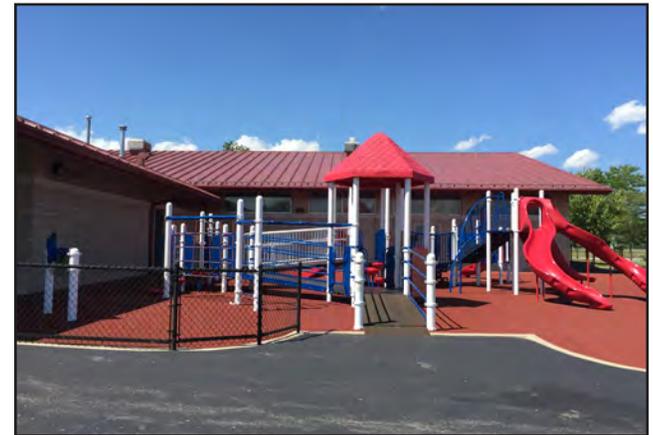
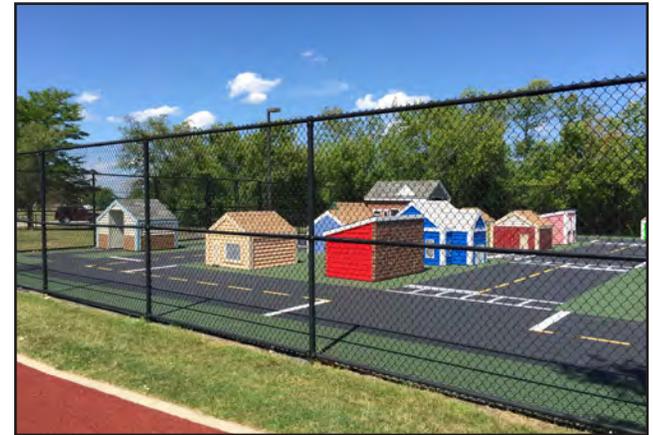
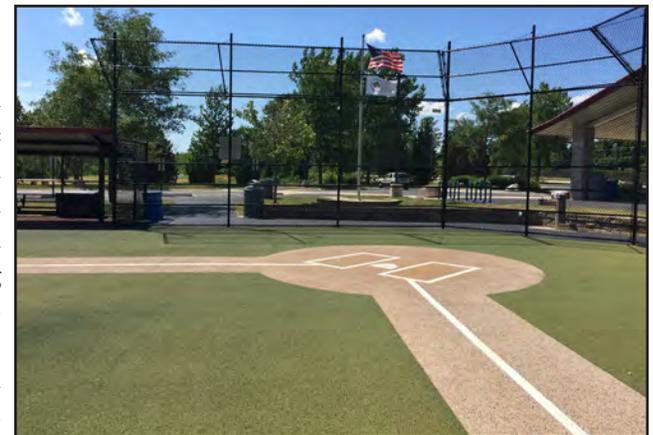
Twin Creeks Park

The park's sign at the entrance from Aptakistic Road appears to be newer, made from metal and sitting on a stone base. The sign is in very good condition and highlights the park's main features: Kendrigan Field, Safety Town and Disc Golf. The park offers plenty of parking by way of two separate areas with one near Aptakistic Road and the other closer to the ball and clubhouse. There

in excellent condition. Adjacent to the ball field and clubhouse is a playground area by Landscape Structures in very good condition and with poured in place rubber surfacing. The playground area caters to all age groups with equipment for school and pre-school age children. Just east of the playground area is a safety town completely enclosed by tall vinyl coated chain link fencing with a locked gate for restricted access. The small safety town buildings and poured in place rubber surfacing are all in excellent condition. Next to the safety town are two pickle ball courts enclosed by matching vinyl coated fencing. The court surface, net, posts and fencing all appear to be newer and are in very good condition.

Park shows utilization of existing vegetation supplemented with some newer plantings. The park's eastern boundary offers a heavily forested edge which serves as a good buffer and separation from Buffalo Grove Road. The passive southern portion of the park is laid out around existing trees which offer plenty of shade and frame views while traveling along the asphalt paths. All turf and remaining open areas appear to be in good condition and well drained with some dry areas

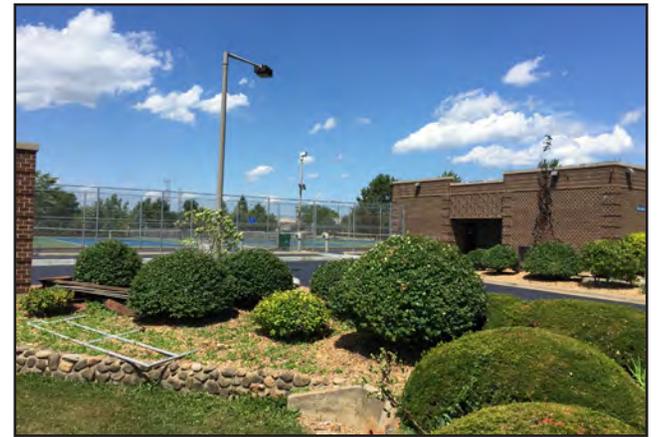
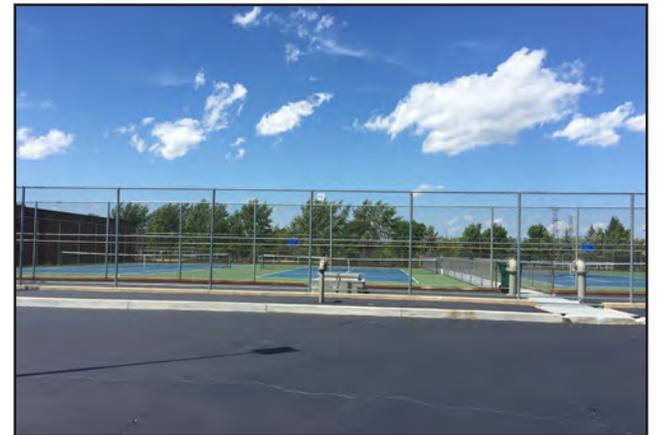
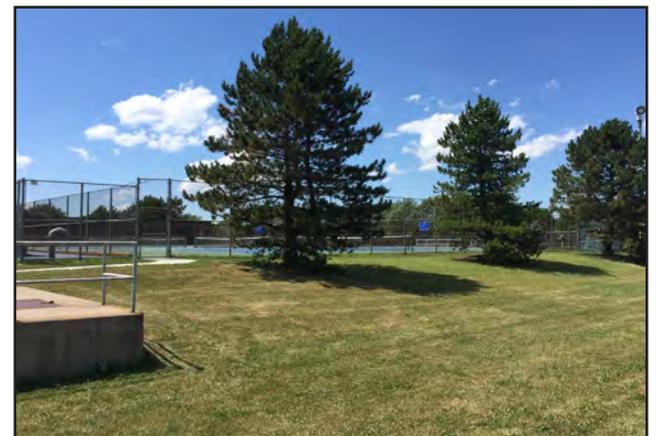
Twin Creeks Park, cont.

present throughout the park. The newer plant material around the ball field and parking areas are in good condition and appear to be regularly maintained. The foundation planting around the clubhouse is sparse and appears incomplete but the plants that are present here are in good condition. The clubhouse's maintenance area is effectively screened with tall evergreen trees and the minimal plant material present at the entry sign appear to be in good condition as well.

Reservoir #7 is a water treatment facility located at the south portion of Twin Creeks Park. The only park elements at this location are four tennis courts that are enclosed by chain link fencing. The courts and fencing are in good condition with some of the nets sagging and needing to be re-tightened. The surrounding tree and foundation plantings are all in good condition and appear to be well maintained. Evergreen and shade trees surround the tennis courts to offer some light shade and buffer the

nearby water treatment buildings. There are items, some debris and a metal railing, that are lying in planting beds are in need of disposal. There is no parking provided (other than for service vehicles) as this appears to only be used by nearby residents and visitors of Twin Creeks Park to the north.

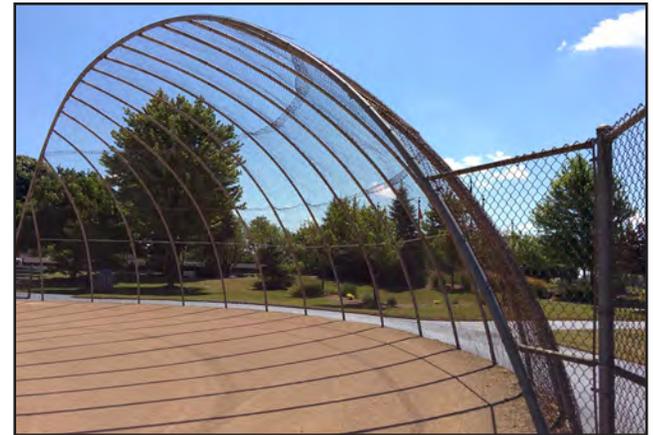
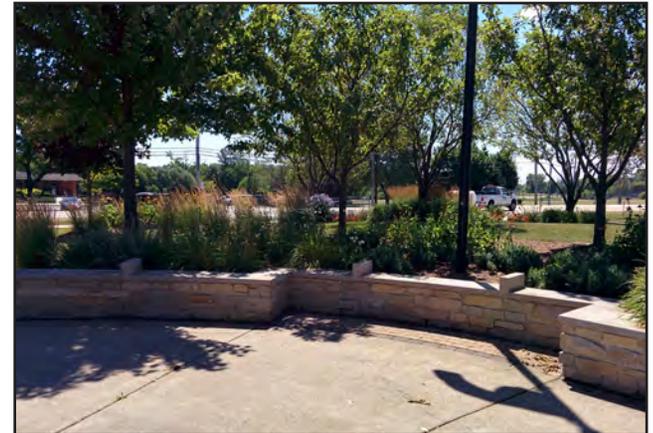
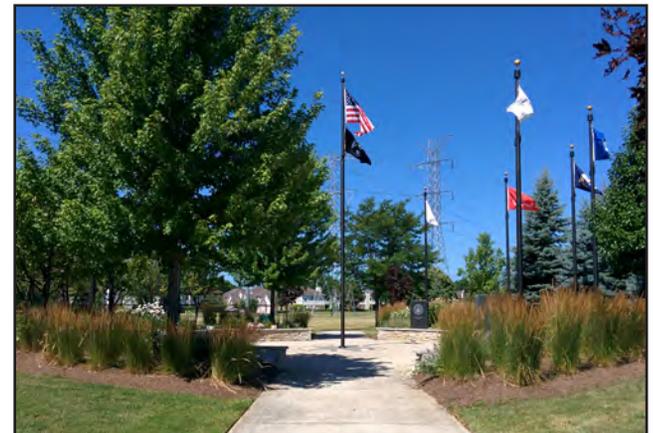
Veterans Park

The ball field is in overall good condition. The fence is fair. While structurally sound with minor fabric warping, all components have significant rust and some post footings have heaved. The infield skin and margin are in very good condition. The material within infield is level with no major wear or erosion, though material has transferred across the adjacent pavement and into the turf. The outfield turf is good with no major wear and is relatively weed free. Ball field furnishings consist of unfinished aluminum player benches, unfinished aluminum bleachers, and an equipment box. The bleachers are movable

The playground is fair overall. The equipment appears to be more than 10 years old, and although it is faded, it is in generally good condition. The composite structure and free standing climbers are oriented mainly toward the 5-12 age group. There is a three-bay swing set with four belt swings and 2 toddler bucket swings. The woodchip surface level is good though the material is degraded in areas. There is no edge containment for the surfacing, though the turf edge is fairly clean with

The basketball court is in fair to good condition. The color-coated surface is generally crack free but does have staining from apparent standing water. The basketball standards are in fair condition though one is leaning toward the court. The court is separated from the path by approximately 5' of turf and is therefore not accessible.

The fence is fair; the posts are plumb though most have heaved and all components have moderate rust. The color-coated surface is fair. Major cracks traversing the length and width of the court have been repaired in the past. Many of the cracks have re-surfaced. There are no areas of ‘alligator’ cracking. Much of the court has staining from standing water which may indicate poor surface drainage. The nets and post finishes are in good condition. All posts have heaved, which may indicate a subgrade moisture issue.

only landscaping is shade trees and bed around the park sign. The trees are in very good condition and there is a good diversity. The bed around the sign is well maintained. The park sign is in good condition and matches the district standard. It is set too far from the park entrance. It is also difficult to see from Weiland because it is set too far back, behind a chainlink fence, and oriented parallel to the road.

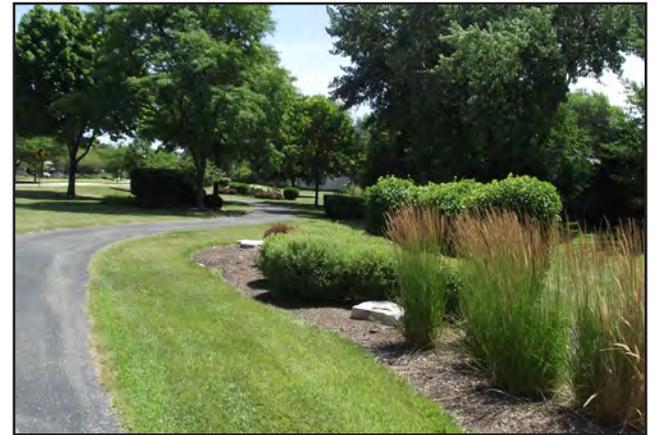
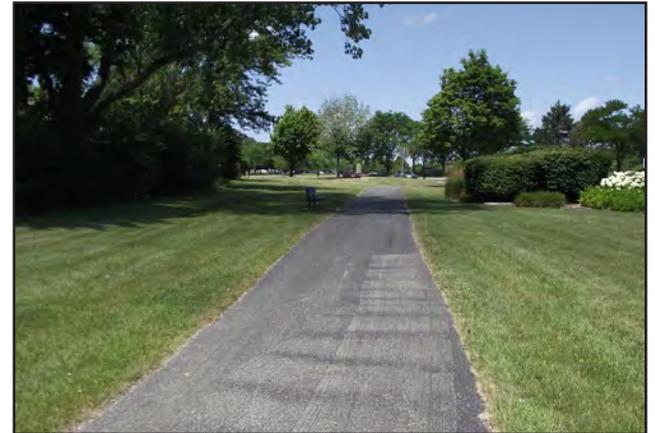
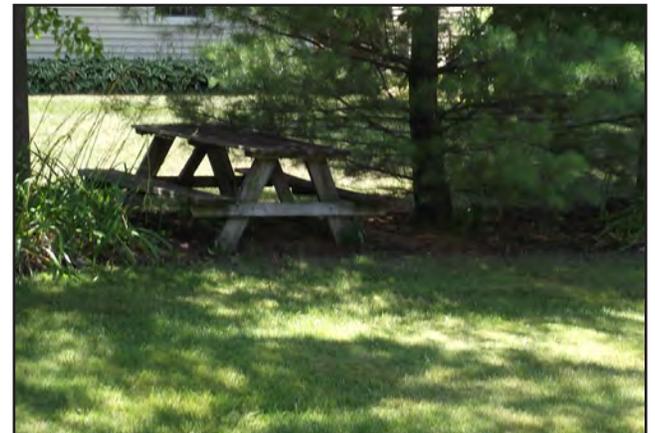
Weidner Park

The path is in good condition while the site furniture (benches) represent a variety of styles from different manufactures. The benches are located within turf areas making it difficult to maintain as well as presents accessibility concerns.

The site is irrigated and the turf areas are well drained. No on-site parking is provided. Likewise, there is no central node/gazebo structure to denote sense of arrival.

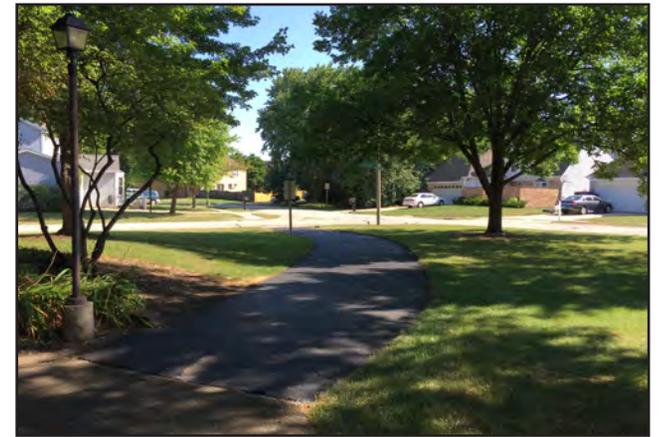
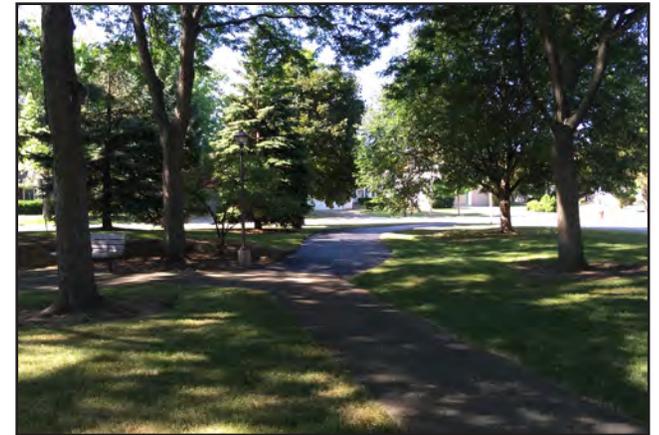
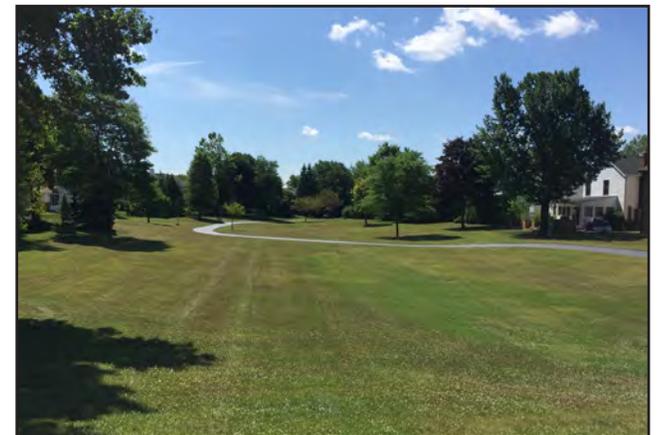
Wellington Commons Park & Detention

Commons Park is a square shaped, mini-park that functions as the focal point to the neighborhood when entering from McHenry Road / Route 83. Four asphalt paths, from each corner, lead to a central seating area beneath several tall, mature shade trees. The exterior connecting asphalt paths appear to be newer and in better condition than the asphalt at the park's interior. The central area offers four older benches, permanently set within the asphalt pavement and one nearby receptacle provided for guests. The benches and receptacle appear to be older but in fair condition. The park appears to be well-drained and regularly maintained. The park's sign is in very good condition, as well.

Commons Park is connected to the surrounding neighborhood by way of clearly defined asphalt paths with designated signage displaying “Bike Trail” and “No Motor Vehicles” at the beginning of each connection. One such path leads through nearby homes to the park's detention area. The asphalt path meanders through the lower turf areas with a drain inlet towards the top of the low end of the slope to catch any overflow during peak flow rates. The rear yards of several homes frame the space and the large turf area appears to provide adequate room for open play during dry periods.

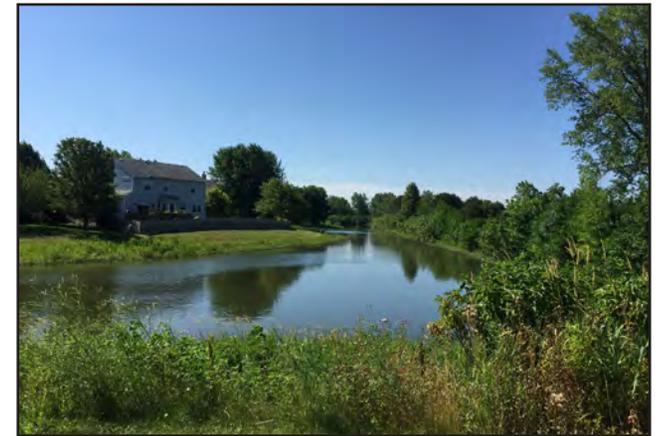
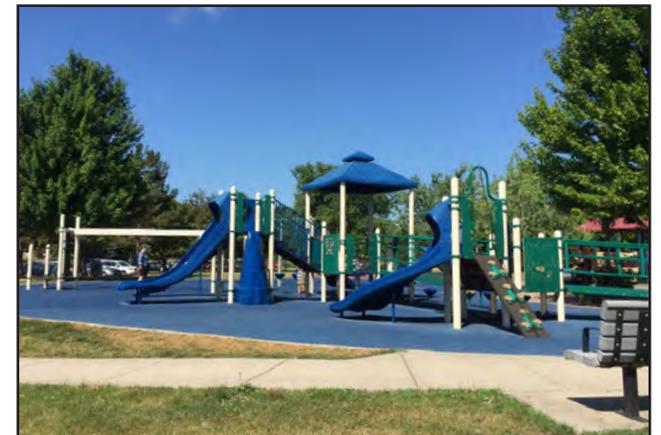
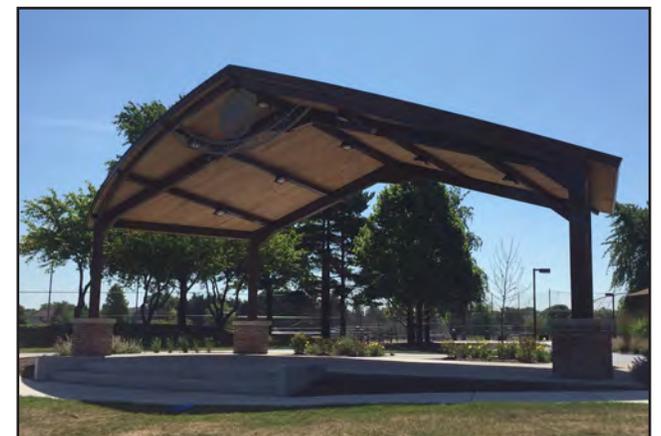
two concrete game tables for chess and ping-pong and a large playground are located close by and near the parking lot. All appear to be older with minimal use but in fair condition. Aside from the swale and retention area, the landscaping and plant material here is very minimal with some turf areas in need of repair. A newer, nature themed playground area by Landscape Structures, in very good condition with newer surrounding plant material, is located close to a large forested area along one of the connecting asphalt

trails heading south. All trails look to be in good condition and connect various elements throughout the park.

The south portion of the site features a band shell for performances, picnic tables and shelters, ball fields, practice soccer fields, two basketball courts, one sand volleyball court and a playground with newer equipment which looks to have been very recently installed. The south portion of the site has plenty of open lawn space with asphalt trails throughout and appears to be very well drained. The asphalt trails all appear to be in very good condition as well, but the asphalt pavement around the ball fields is beginning to show some minor cracking. The basketball and volleyball courts are in fair condition and do not feature any lighting for night time use. A wood and stone constructed band shell, in excellent condition, opens up to the practice soccer area which appears to function as a large seating area during performances. A multi-use building with public restrooms, covered picnic tables and seating and additional space for maintenance use is adjacent to the band shell and playground equipment. The building appears to be older but in good condition. Both the building and band shell areas have plenty of surrounding, visually attractive plant material in very good condition. The playground features newer equipment in excellent condition with different levels of play for varying age groups and has poured in place rubber surfacing below. The large parking lot is in poor condition with several cracks and pot holes. The north, middle and south portions of the site all function as one large park and is well maintained.

Conditions Assessment	
Curb Appeal	Excellent
Pedestrian Access	Excellent
Internal Access	Excellent
Playground	Good
Sand Play	N/A
Shelter	Very Good
Toilets	Very Good
Basketball Courts	Fair
Sitting Area	Good
Ball Field	Good
Soccer Field	N/A
Athletic Turf	Good
Lawns	Good
Landscaping	Good
Paths/Trails	Very Good
Parking	Fair
Park Sign	Very Good
Site Furnishings	Good
Maintenance	Good

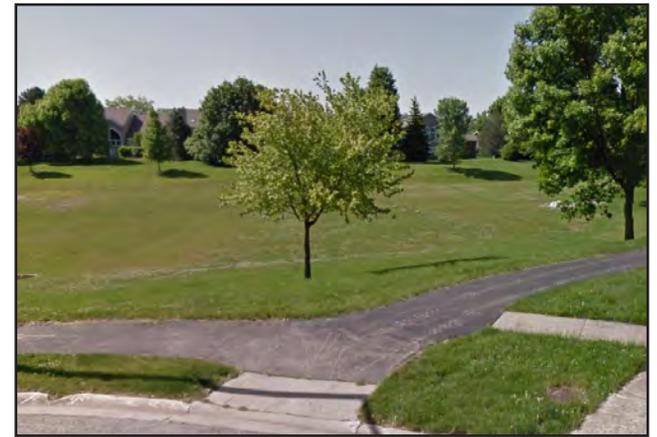
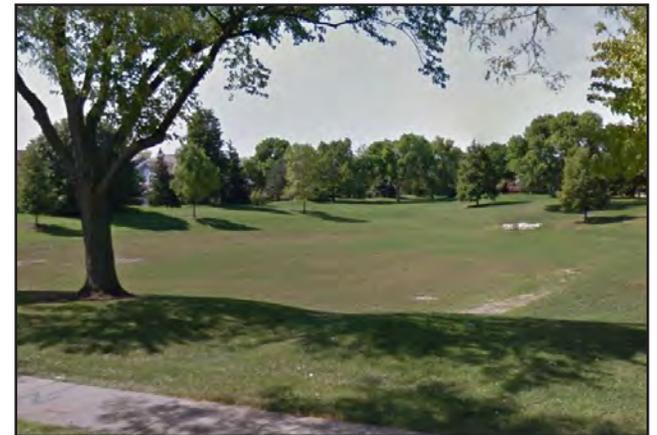
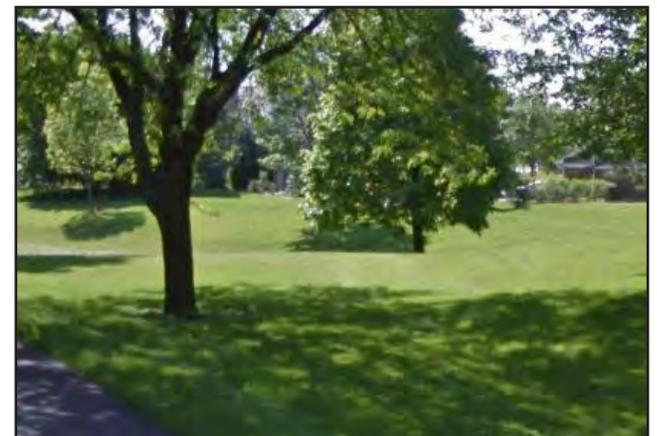
Windfield Park/Detention is a 2.4 acre neighborhood park located at 550 S. Arlington Heights Road. The site is surrounded on three sides by single family and multi-family residences with street frontage along Arlington Heights Road. There are no facilities or amenities at this park. The park has no identifying signage. The neighborhood has access from Rose Blvd. and Rose Court E. via a newly installed accessible walking path. Vegetation is sparse and the turf is in fair to poor condition.

Conditions Assessment	
Curb Appeal	Good
Pedestrian Access	Good
Internal Access	Good
Playground	N/A
Sand Play	N/A
Shelter	N/A
Toilets	N/A
Basketball Courts	N/A
Sitting Area	Poor
Ball Field	N/A
Soccer Field	N/A
Athletic Turf	N/A
Lawns	Good
Landscaping	Fair
Paths/Trails	Good
Parking	N/A
Park Sign	Poor
Site Furnishings	N/A
Maintenance	Fair

Signage is needed to identify this park given the major entry point appears as a private entry to the neighboring house lot.

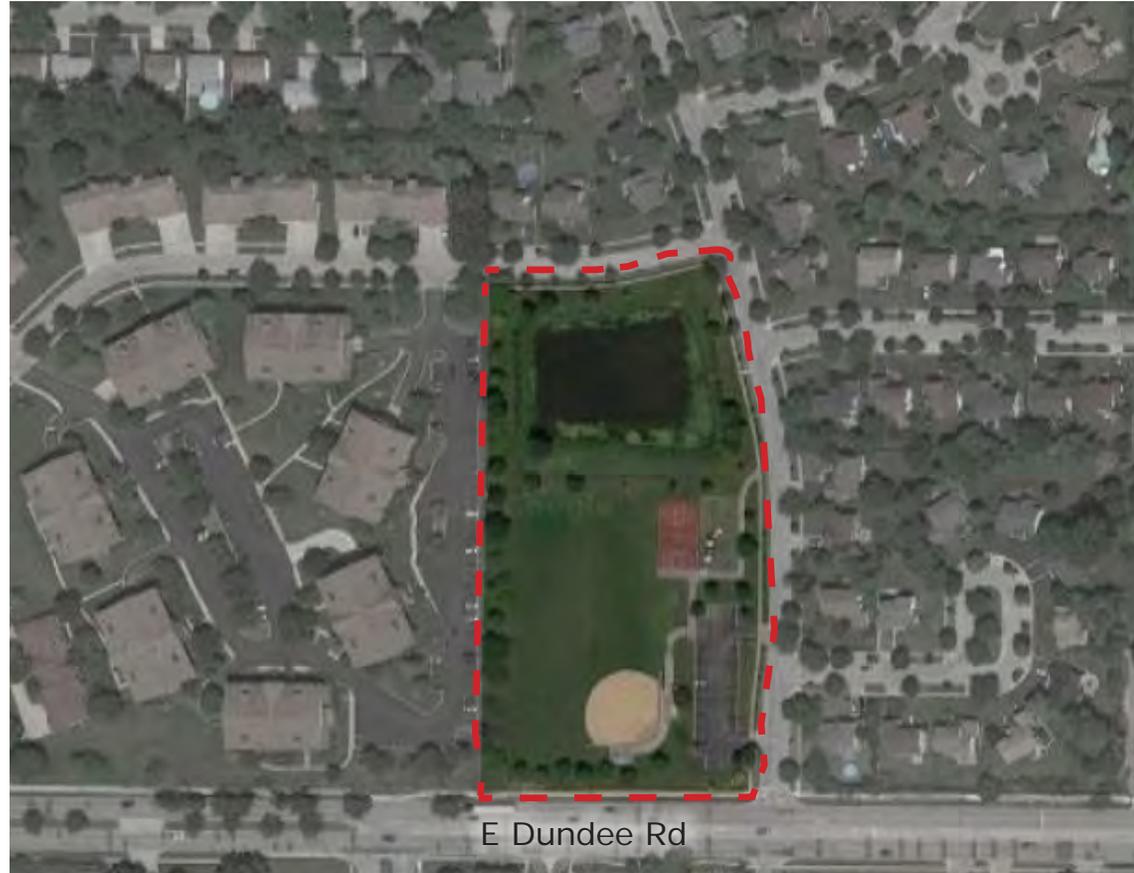
the courts from the adjacent playground area. This fence is in need of re-painting and repair.

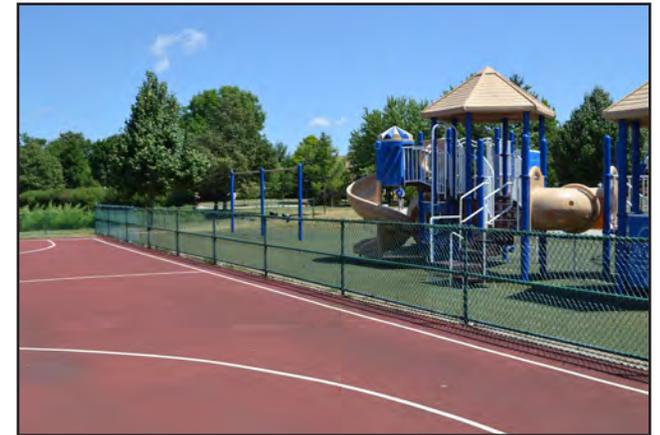
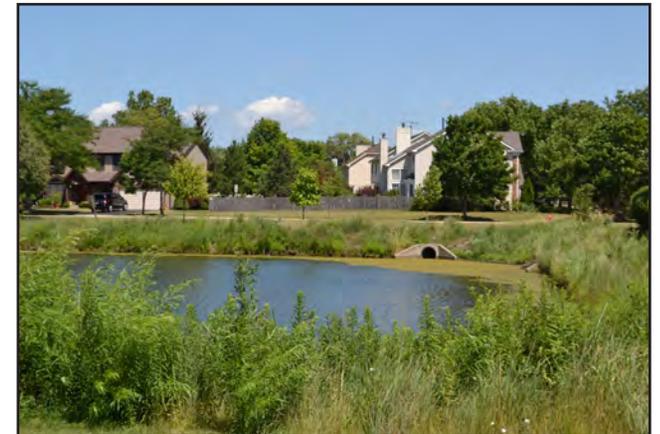
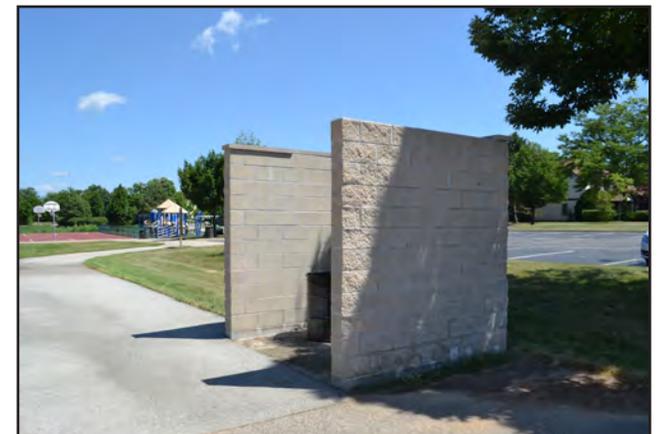
The ball field sits below the parking lot and is a skinned infield that allows a variety of youth play. The backstops in good condition and is the lower arched overhead style. Players and umpires may be encouraged to use full head protection with this style backstop. There is a medium age tree behind the backstop that is in poor condition and should be either removed or replaced. The ball field area does include a permanent screen enclosure for the porta-potty. Ample bleachers are present with good screen protection.

The basketball court shows signs of heavy use and the surfacing is in need of repair/recoating. The basketball courts also have a low fence separating

The pathways are in good condition and wide enough to accommodate multiple users. The general condition of the turf is worn. There are numerous areas of worn

turf that will need to be reseeded or sodded and should be a routine activity during the seasons. One are of worn turf is at the end of the basketball courts and most likely a result of it becoming a gathering area. This may present itself as an opportunity to establish and teen friendly gathering and seating area.

The parking lot has significant cracking and separation throughout the parking area. Pavement markings are worn and the lot should be considered for a mill and overlay.

Conditions Assessment	
Curb Appeal	Good
Pedestrian Access	Good
Internal Access	Good
Playground	Good
Sand Play	N/A
Shelter	N/A
Toilets	Good
Basketball Courts	Good
Sitting Area	Good
Ball Field	Good
Soccer Field	N/A
Athletic Turf	Fair
Lawns	Fair
Landscaping	Good
Paths/Trails	Good
Parking	Fair
Park Sign	Good
Site Furnishings	Good
Maintenance	Good

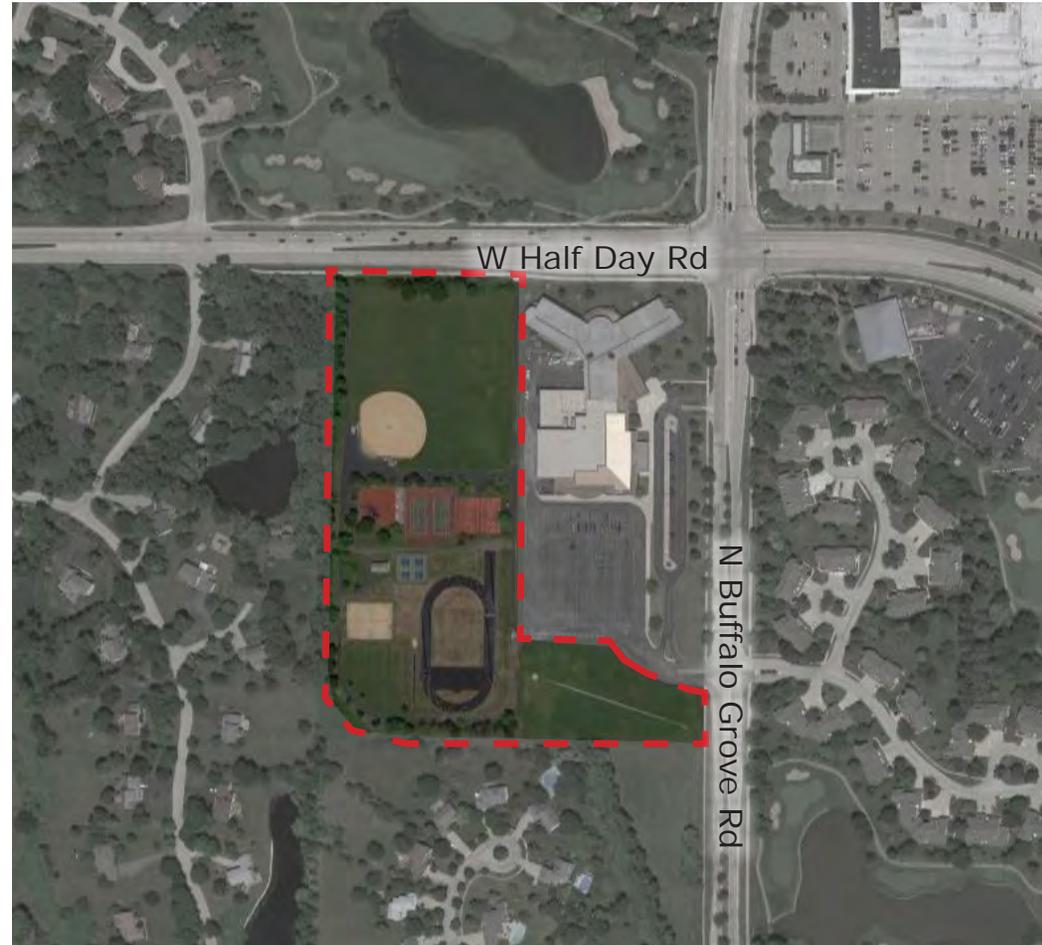
Court surfaces show evidence of poor surface drainage and sedimentation.

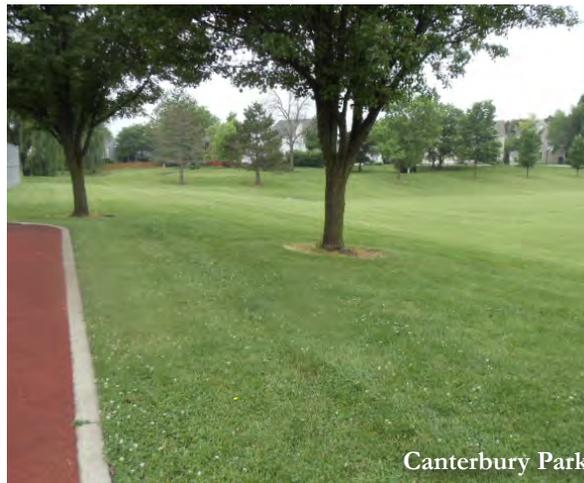
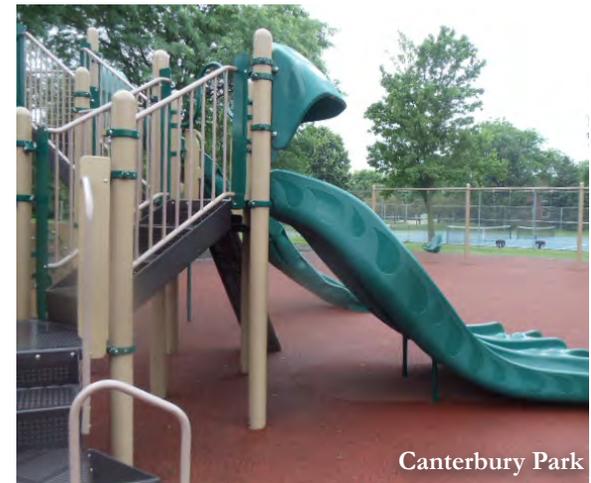
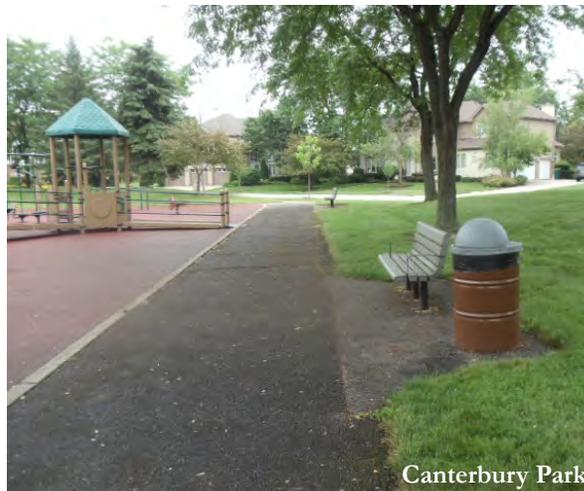
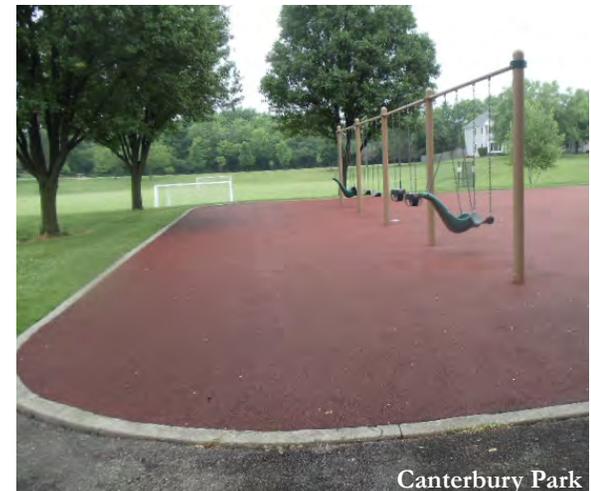
Canterbury Park

- Master plan for playground when time for equipment replacement to consolidate/ reduce play area and connect all park elements
- Naturalize detention area not needed for open play area to minimize mowing
- Develop connection from Port Road to playground and main activity area
- Install mulch rings on ornamental and canopy trees

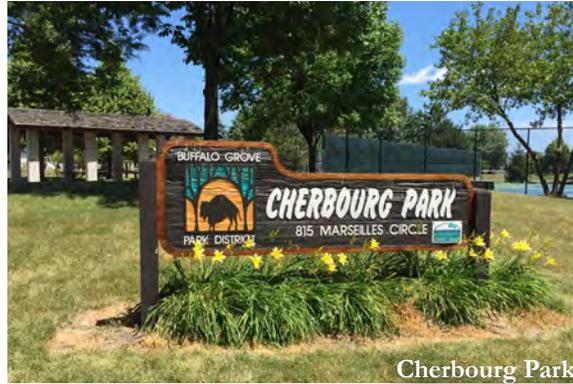
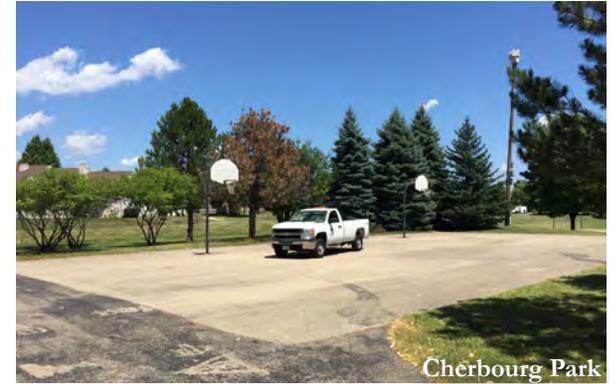
Cherbourg Park

- Repair all cracks and damaged asphalt at basketball court area.
- Install edge containment for sand volleyball court.
- Repair or replace sand volleyball posts and net.
- Rake and remove all rocks and debris from sand volleyball court and add sand for depth
- Plant additional shade trees at bench locations
- Recut to better define plant bed at park entrance sign.
- Trim daylilies below park entrance sign to allow for sign's full visibility.
- Top-dress all plant bed areas and tree rings with additional mulch

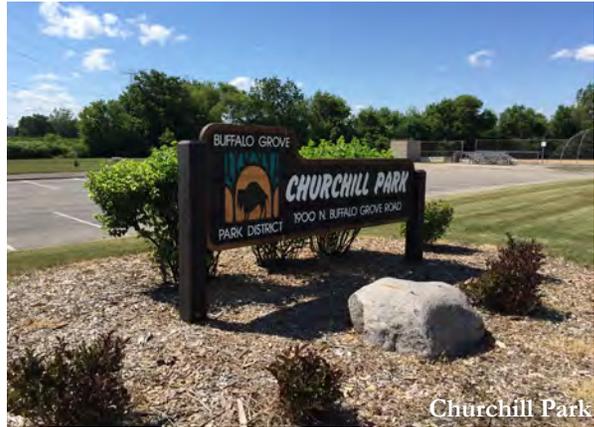
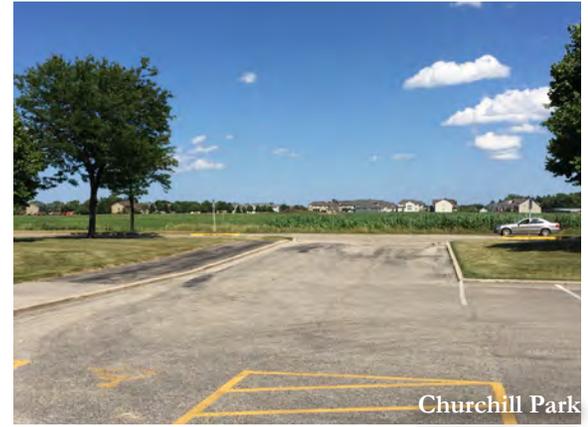
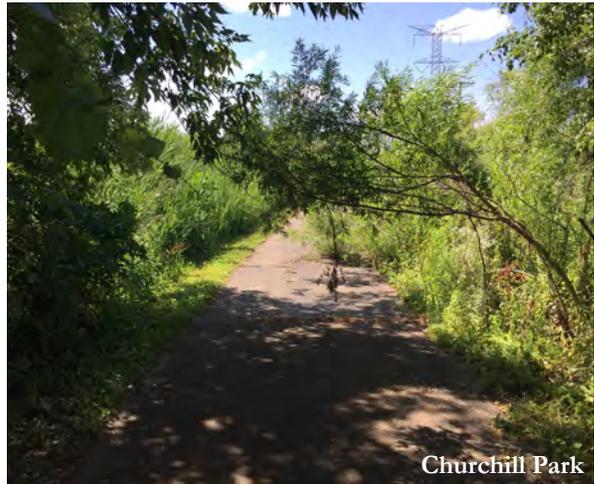
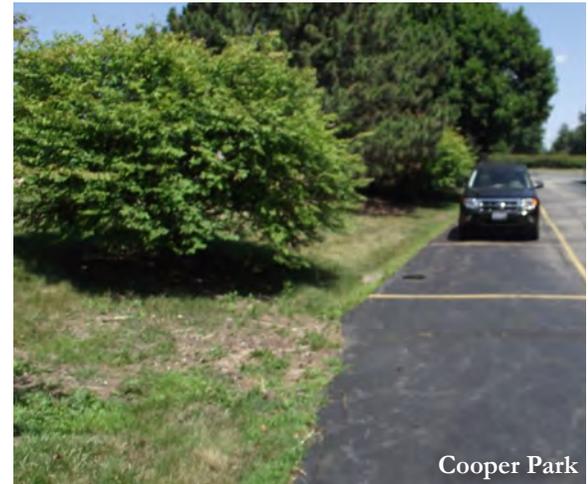
Churchill Park

- Repair all cracks and damaged asphalt within parking lot.
- Plant additional shade trees around parking lot perimeter to provide additional shade.
- Trim miscellaneous branch growth at the base of recently planted trees within turf areas.
- Trim and cut back all hazardous branches hanging over asphalt path within conservation area.
- Recut or define plant bed at park entrance sign.
- Plant additional low planting at park sign to supplement vegetation.

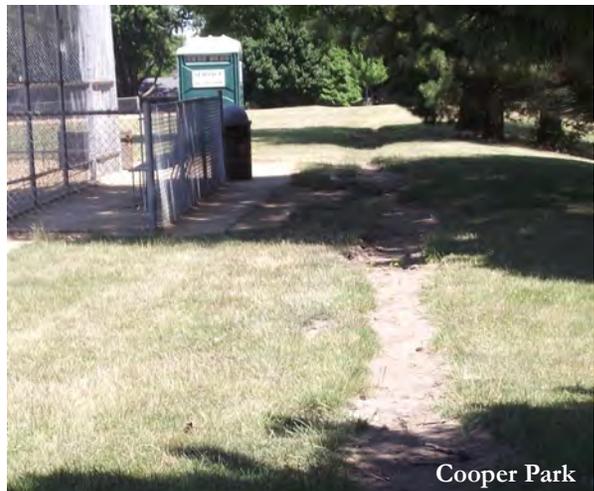
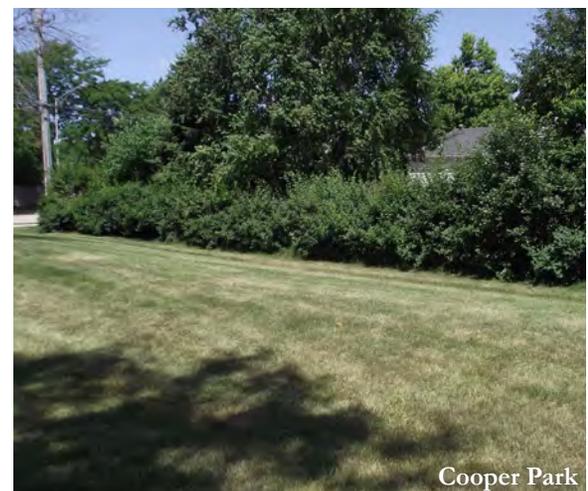
Cooper Park

- Provide an accessible pathway system from the parking lot to the ballfields.
- Provide an accessible internal path way system from ballfield to ballfield.
- Remove overgrown burning bush hedge from outfield area
- Remove “lip” from the perimeter of the infield mix area

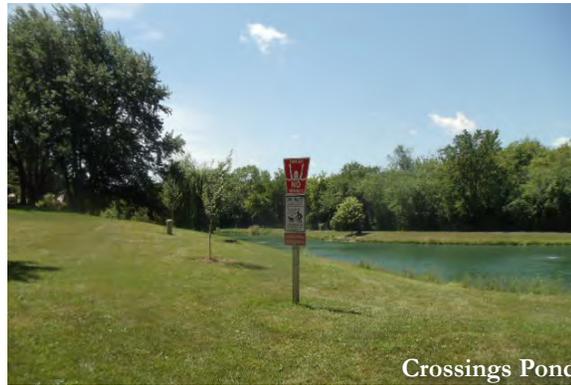
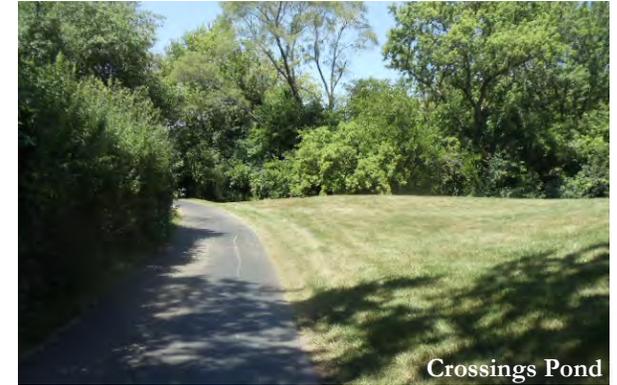
Crossings Pond

- Improve access to water for fishing
- Selective pruning of buckthorn and honeysuckle along path to open up views
- Sealcoat and stripe parking lot, add accessible parking space
- Install District standard marquee signage

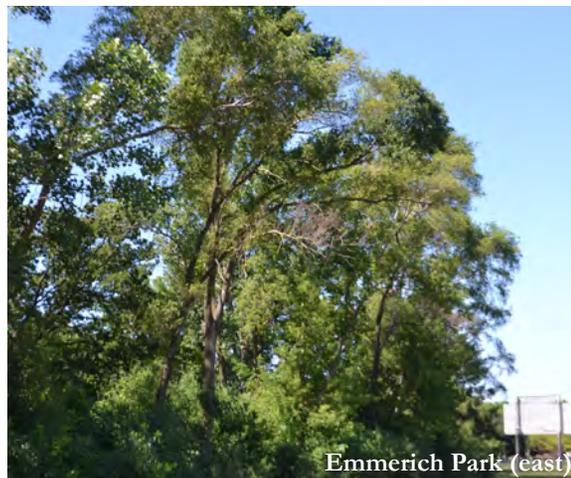
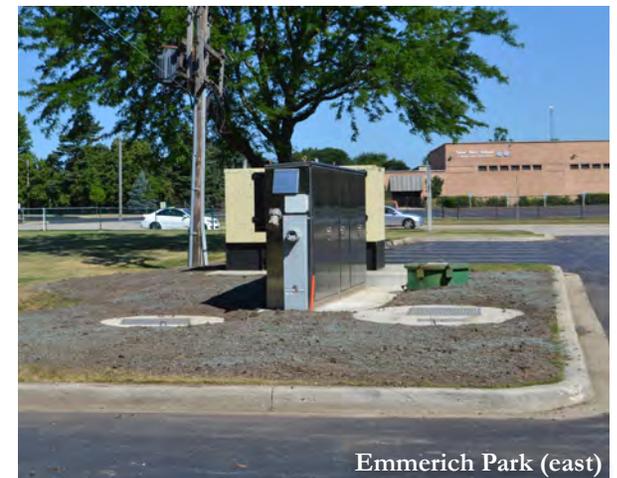
Emmerich Park (east)

- Conduct a tree risk assessment and pruning along the creek to remove dead limbs.
- Replace dead/removed trees and establish an overall tree replacement program.
- Regrade outfield turf edge of infield to remove soil lip. Consider altering infield dragging to figure 8 pattern to reduce mounding.
- Replace gate at far eastern end of park.

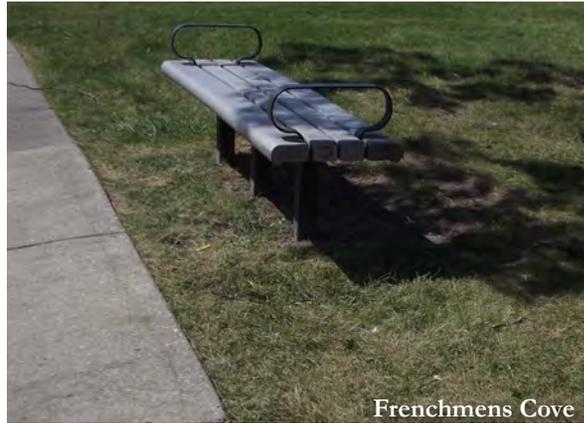
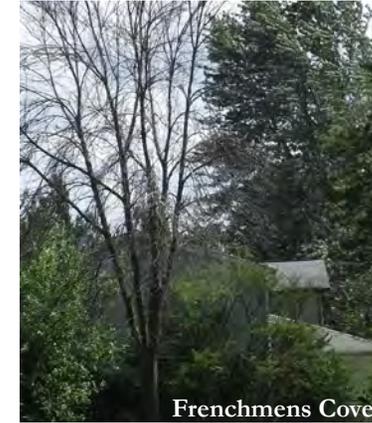
Frenchmens Cove

- Provide an accessible pathway system into the park
- Provide additional site furnishings i.e. benches, spectator bleacher areas with accessible surfacing.
- Remove and replace two dead trees.

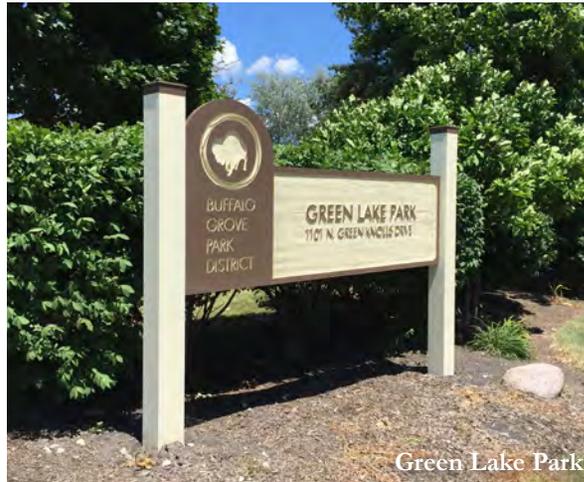
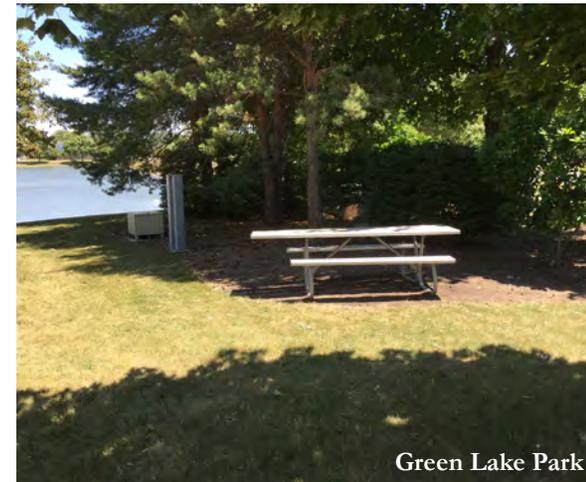
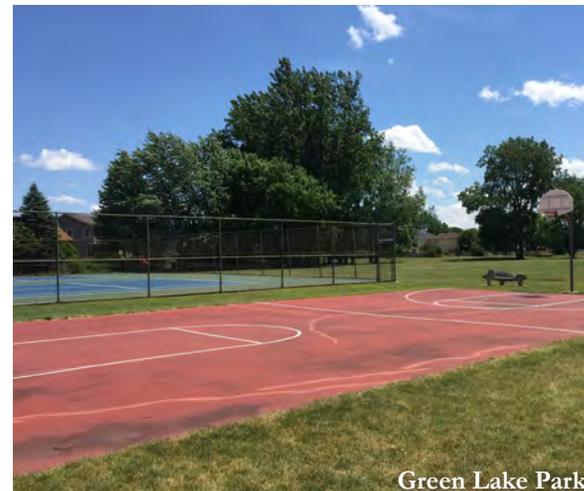
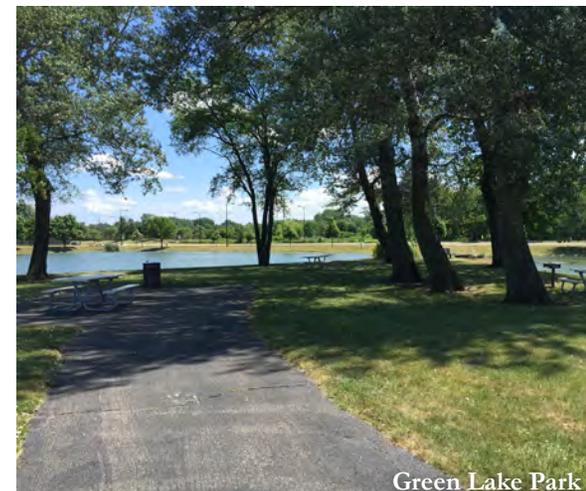
Green Lake Park

- Update seating area with new trash receptacles to replace existing.
- Consolidate picnic tables to main area by the pond to allow unobstructed paved access to all picnic and seating areas.
- Reset and tighten tennis court netting to eliminate sagging.
- Repair all cracks and damaged asphalt at basketball court area.
- Plant additional shade trees at bench locations surrounding playground area to provide additional shade to each seating area.
- Plant additional low planting at park sign to supplement existing vegetation.

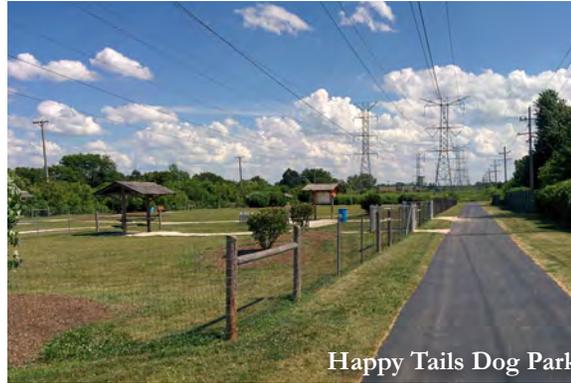
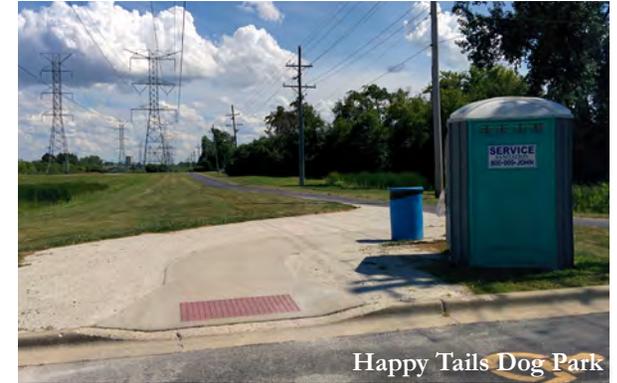
Happy Tails Dog Park

- In conjunction with Metra, improve signage to direct users through the parking lot.
- Install a park sign at the end of the lot/path connection to signal arrival at the park.
- Remove extra fencing to facilitate maintenance of planting beds.
- Install screening for the portable toilet.
- Install signage for users approaching on foot from the south.

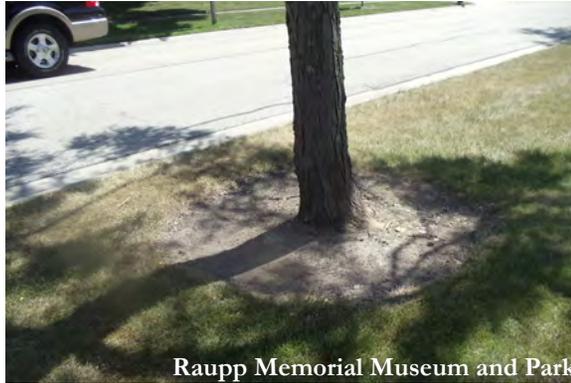
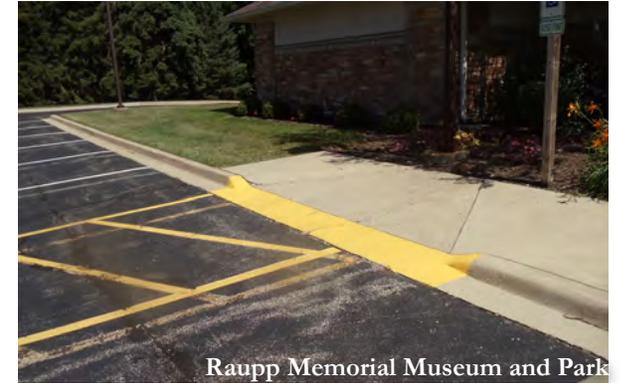
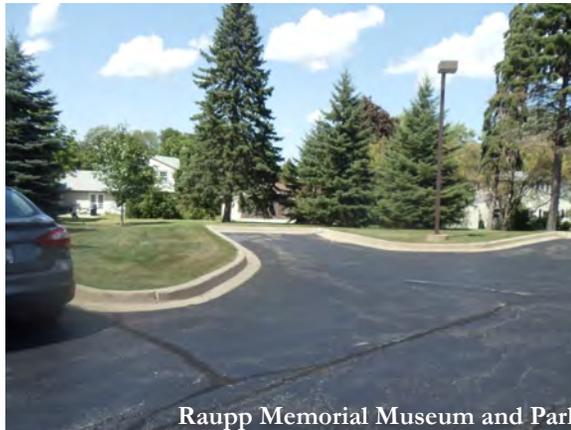
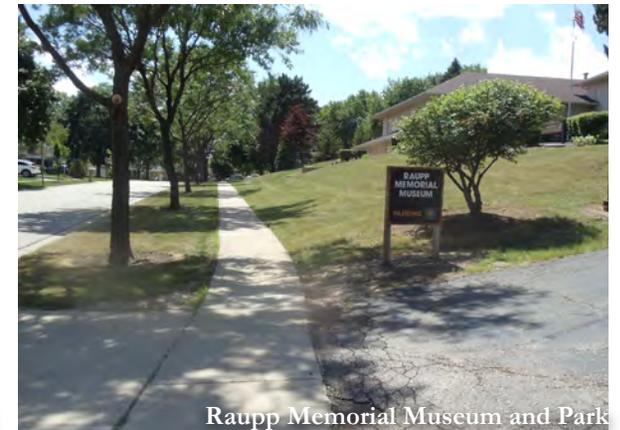
Raupp Memorial Museum and Park

- Address the alligator cracking near the sidewalk.
- Relocate the existing marquee sign closer to the street to increase visibility
- Consider transitioning areas below heavy tree canopy to east (right) of entry drive to plantings that tolerate heavy shade
- Add mulch rings around tree bases to preserve moisture, add organic matter to soil and minimize mowing requirements
- Shade structure for potential outdoor activities at the museum
- Revising parking pattern for more efficient traffic movement
- Outdoor education classroom in conjunction with museum
- Group plantings to consolidate planting beds and improve mowing efficiency

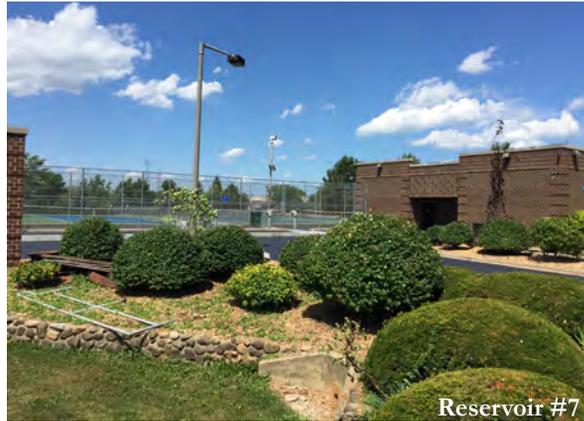
Reservoir #7

- Clean up and remove all debris and loose material from planting bed areas.

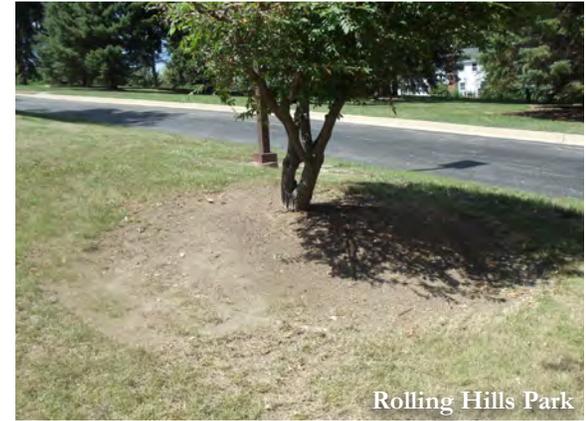
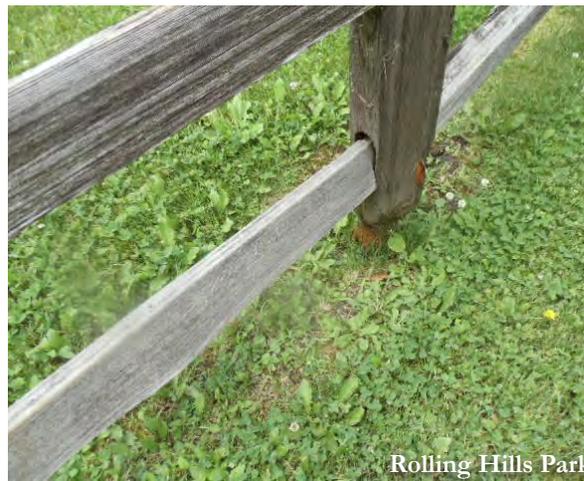
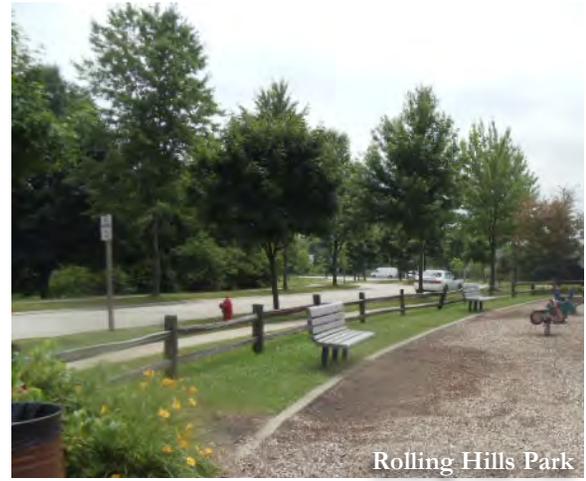
Rolling Hills Park

- When replacing wooden fences include mow strips or concrete collars around post bases
- Provide shade for benches
- Provide wheelchair accessible benches at play area
- Provide accessible ramp into the play area
- Mulch rings for trees to improve mowing efficiencies and appearance

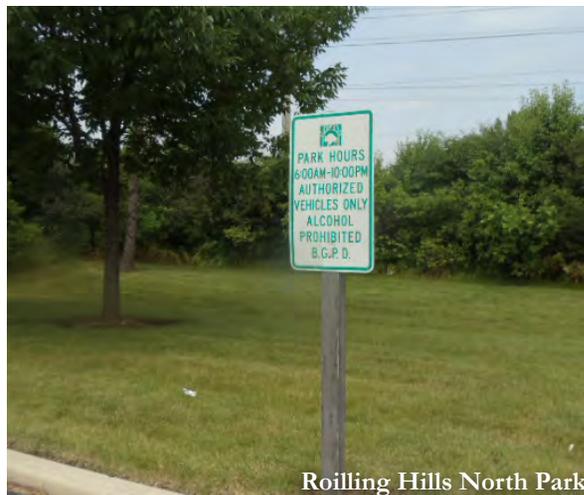
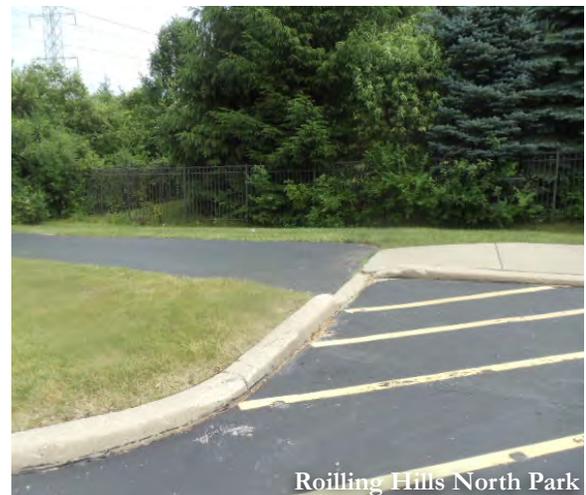
- Naturalizing significant portions of the area north of the Commonwealth Edison right of way to reduce mowing requirements
- Potential for parking lot to serve as trail head for regional trail network.
- Develop wayfinding signage that integrates Rolling Hills North Park into the regional trail network
- Develop shade shelters for park patrons
