BUFFALO
GROVE
PARK
DISTRICT

Comprehensive Master Plan

2017 and Beyond

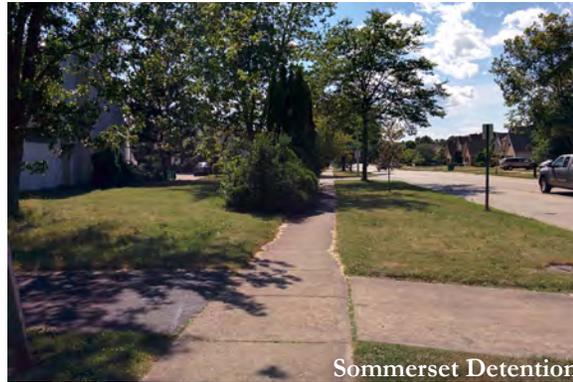
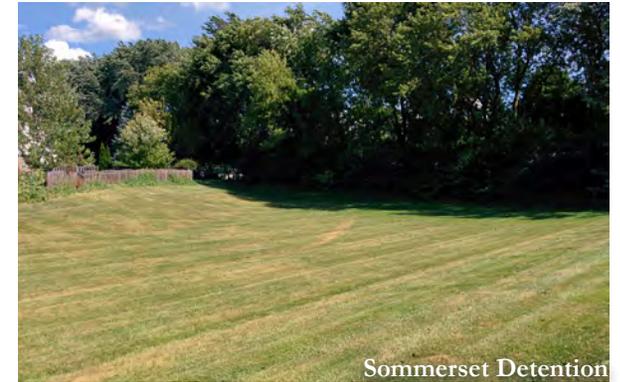
Sommerset Detention

- Install native plantings with interpretive signage to improve public understanding of natural areas and reduce maintenance.
- Install a park sign.

Priority	Recommendation	Estimated Cost
A	Install a park sign with ornamental plantings	\$3,500
C	Install native plantings with interpretive signage to improve public understanding of natural areas and reduce maintenance	\$8,000

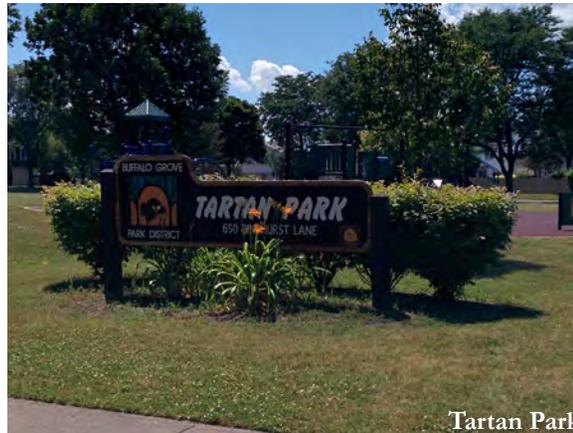
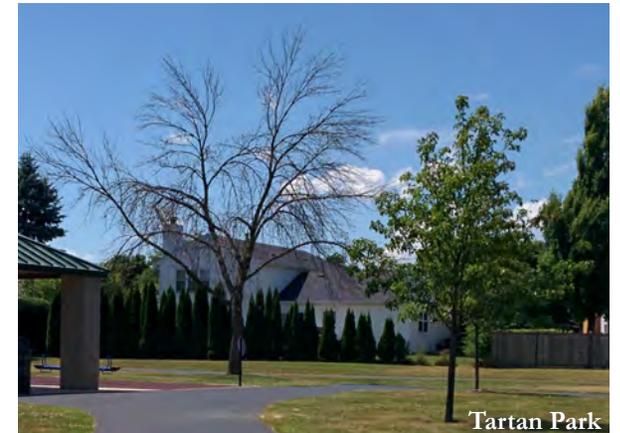
Tartan Park

- Install mulch around the trees.
- Enhance plantings around the park sign.
- Replace dead trees.
- Update site furnishings.

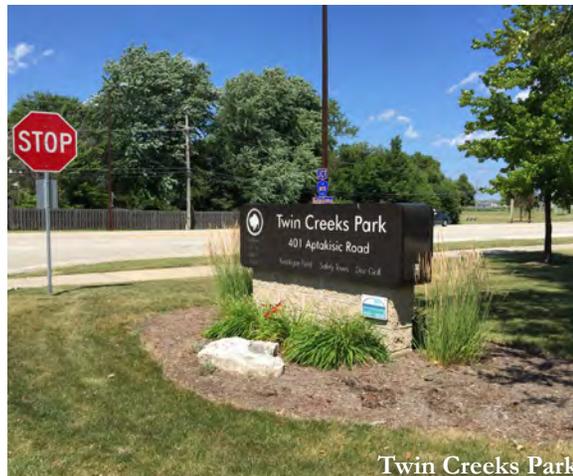
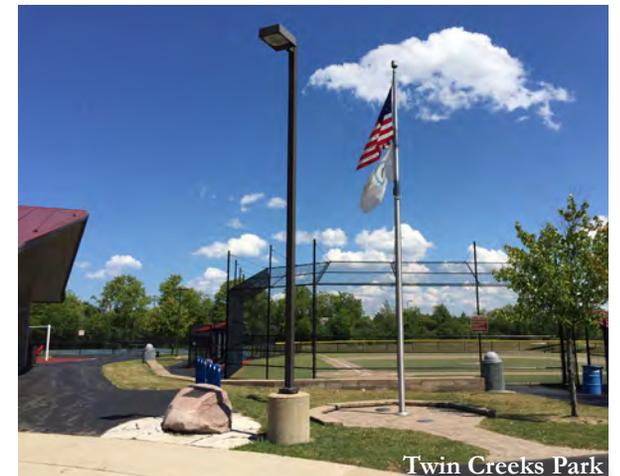
Twin Creeks Park

- Plant additional low shrubs and perennials around clubhouse and flagpole areas
- Plant additional low planting at park sign to supplement existing vegetation.
- Provide additional maintenance and weed control to damaged or stressed turf

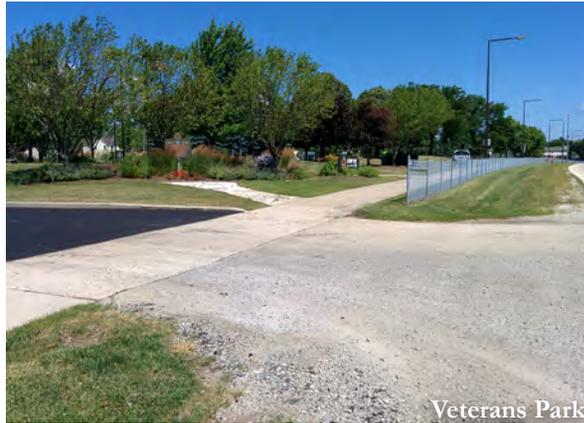
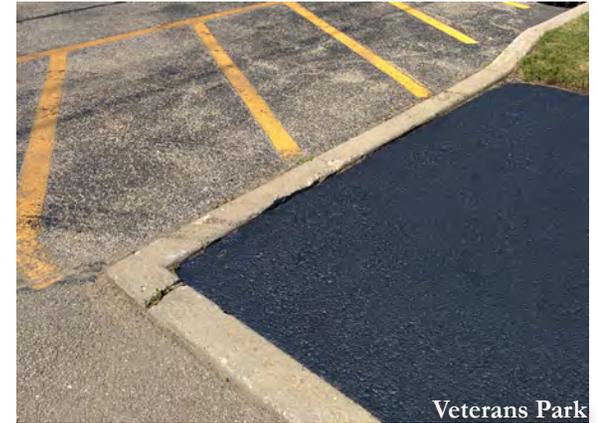
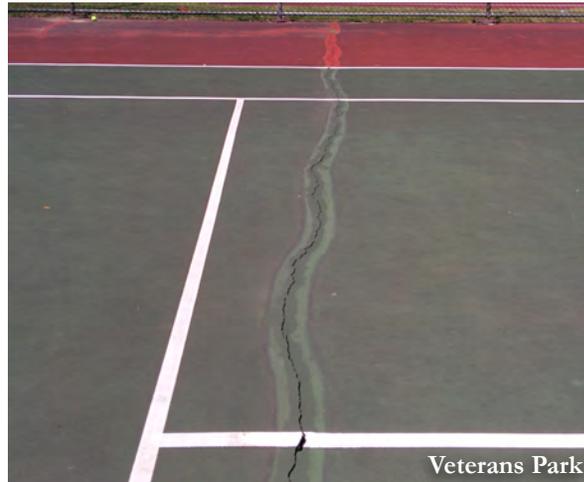
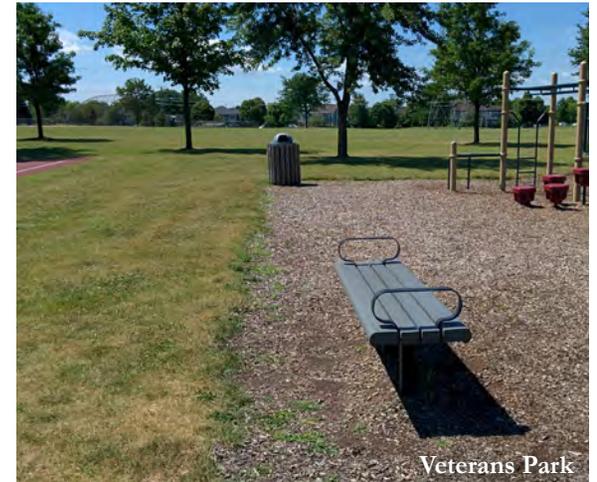
Veterans Park

- Enhance park entrance with improved drive way flare, ornamental fencing, landscaping, and sign relocation.
- Adjust pavement at handicap access to parking lot to eliminate abrupt grade changes.
- Relocate picnic area so that it is more a part of the park.
- Add pavement up to and around benches for accessibility.
- Install edge containment around playground.
- Regrade or install edge containment around ballfield fences to control spread of infield mix.
- Ballfield fence, tennis court fence, and tennis net posts should be a moderately high priority for replacement.
- Update site furnishings.

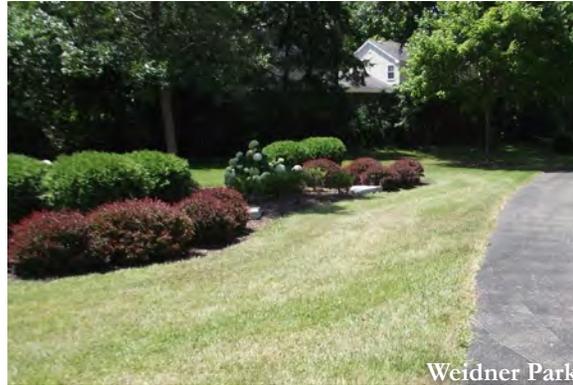
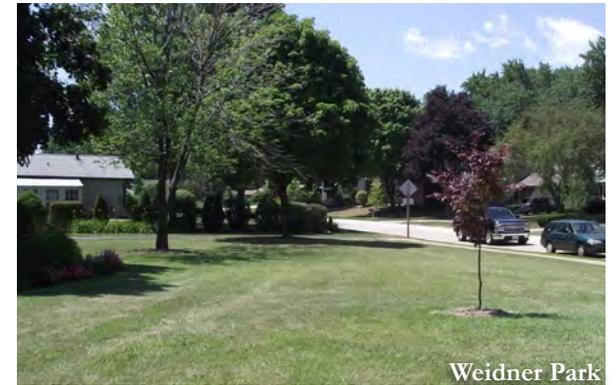
Weidner Park

- Park District to develop site furniture standards – provide bench that meets District standards.
- Provide accessible pathway to benches and site furnishings.
- Furnish and install small gazebo structure to provide focal element and central gathering place within the park space.

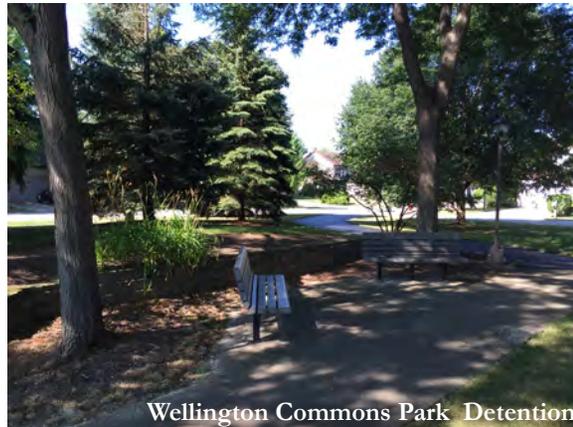
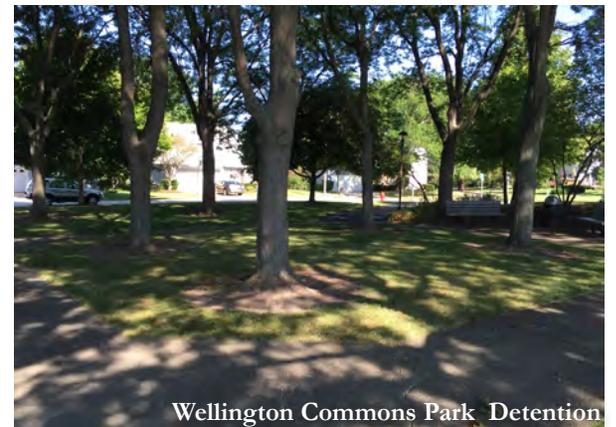
Wellington Commons Park & Detention

- Update central seating area with new benches and trash receptacles.
- Repair central seating area asphalt pavement surfacing.
- Plant additional shade tolerant shrubs and perennials to surround central seating area.

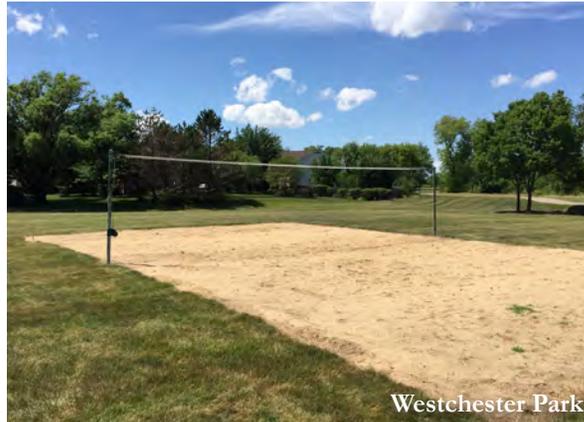
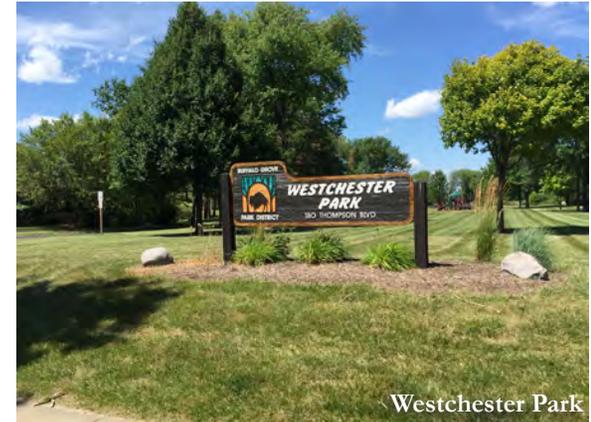
Westchester Park

- Install edge containment for sand volleyball court.
- Remove all weeds from sand volleyball court and add sand to provide adequate depth for play.
- Plant additional low planting at park sign to supplement existing vegetation.
- Repair damaged or patchy lawn areas by over-seeding with appropriate turf mix.

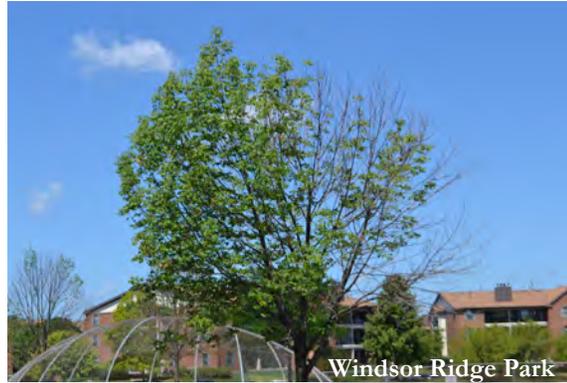
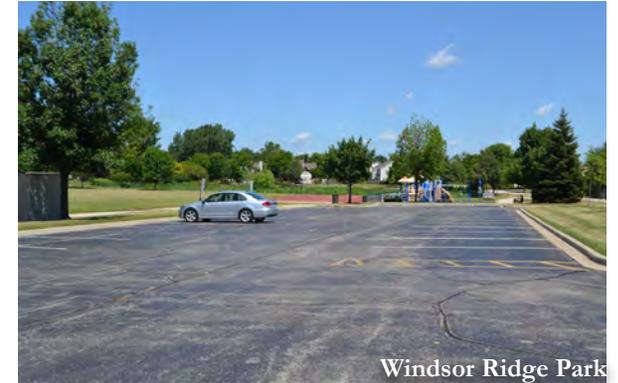
Windsor Ridge Park

- Parking lot should be resurfaced.
- Replace dead trees.
- Basketball court area should be recoated and striped.
- Replace low chain link fence separating basketball court and playground or consider having the fence recoated
